Chapter 4 Water Distribution Systems and Water Efficiency

Distribution System Standards

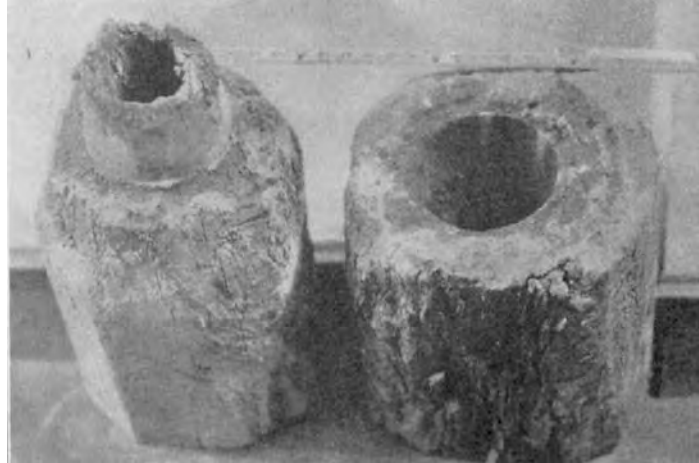
Wood pipes from 1796 Jamaica Pond Aqueduct

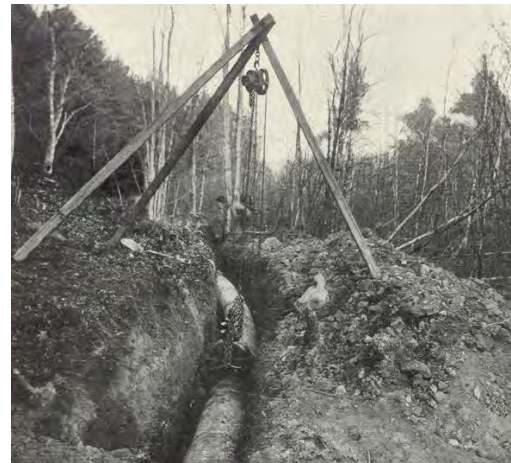
1916 14” wood stave pipe and valve, Pembroke NH

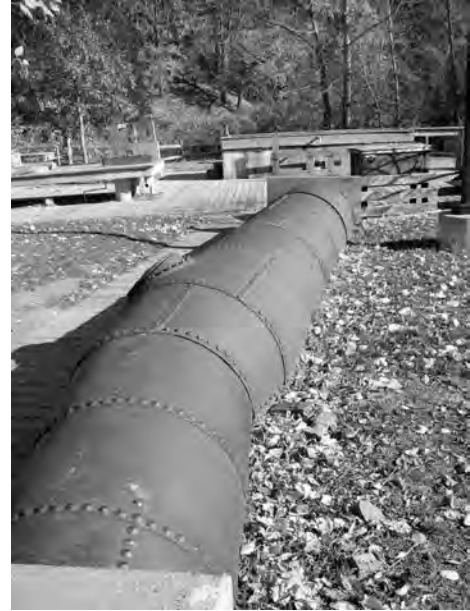
Example of wrought iron pipe, New Haven CT Water Interpretive Center

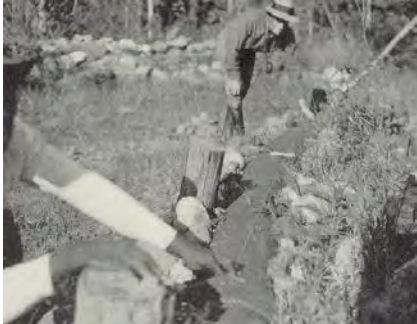
A 1913 NEWWA paper described bending of cast iron in lieu of fittings for gradual curves. The technique required heating the pipe on a bed of coals and applying force.

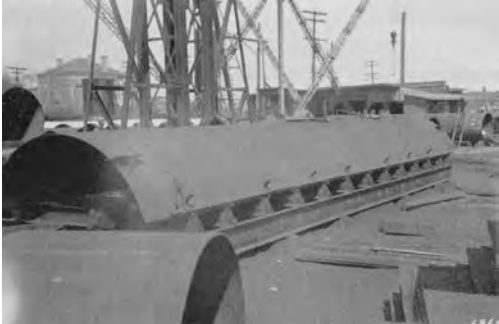
1942 unrolling pipe in Springfield MA – With the steel shortages experienced during WWII, 30" & 26" steel pipe was recycled by unrolling it and welding 2 halves together into a homemade 58" pipe.

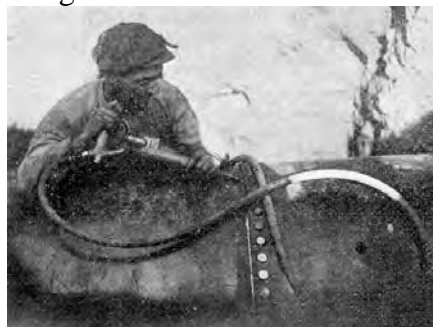
1924 caulking lockbar pipe

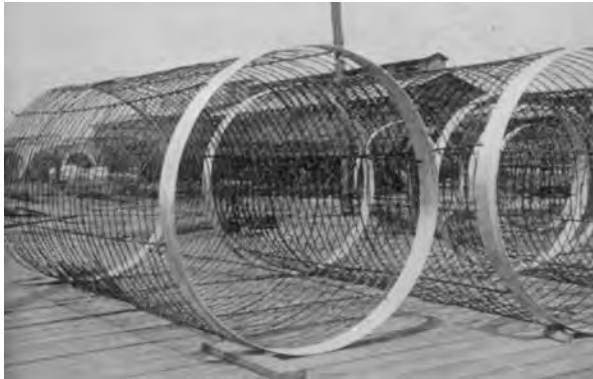
1924 reinforcing cage

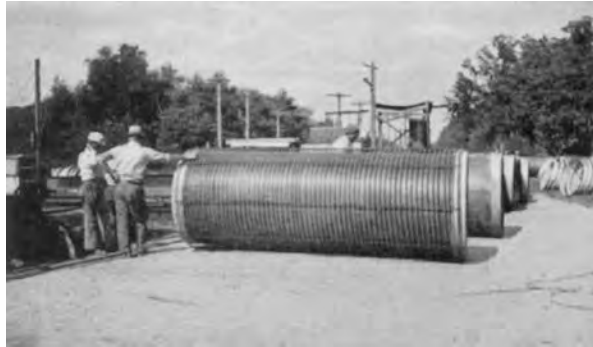
1935 Cage set over cylinder

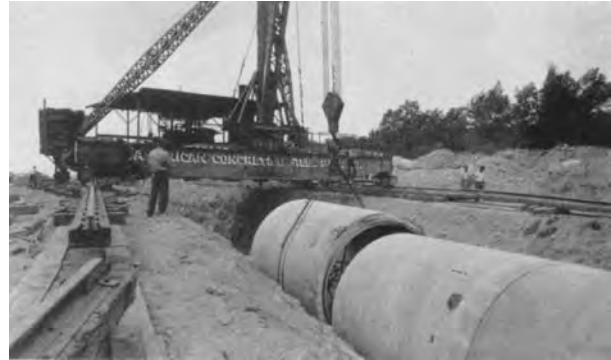
1946 laying Hultman Aq 138" RCP

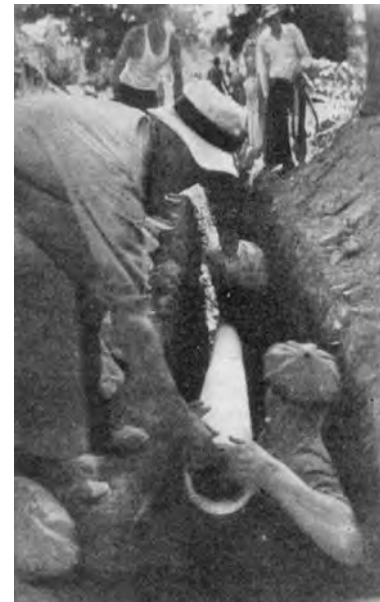
1937 Asbestos cement transite pipe laying, Note ease of handling.

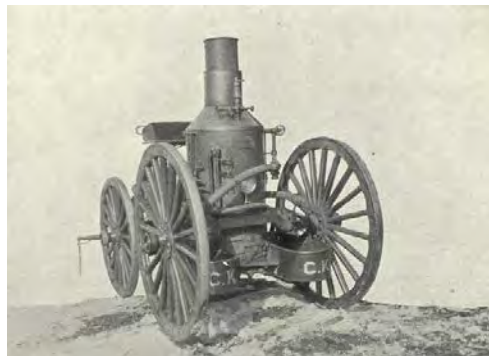
1904 Mobile boiler for pipe thawing,
Manchester NH

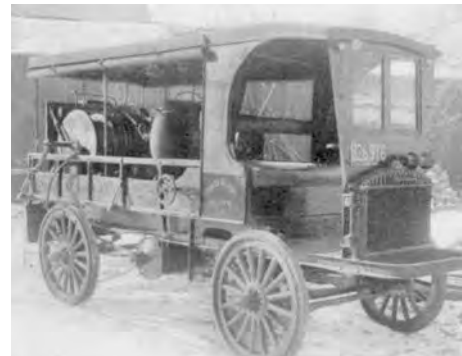
1920 pipe thawing truck using a portable
generator for electric current, Dedham
MA

The advent of electricity produced electrical pipe thawing using contraptions such as the one shown in the adjacent figure.

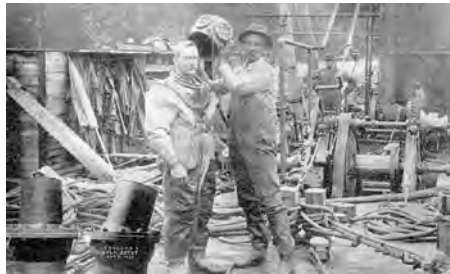
1895 Burlington VT diver, placing the intake pipe further in the lake.

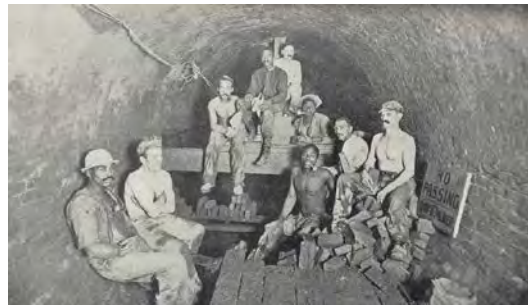
1908 Gloucester MA pipe tunnel – men working in pressurized tunnel

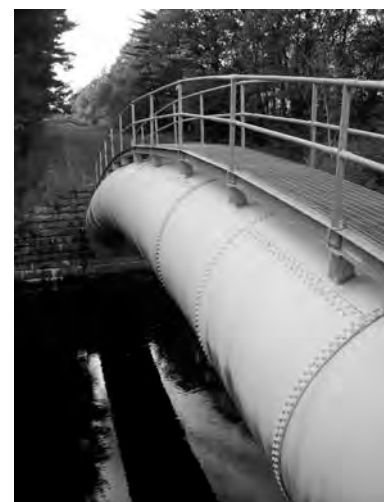
1903 Weston Aqueduct 84” steel self-supporting pipe bridge

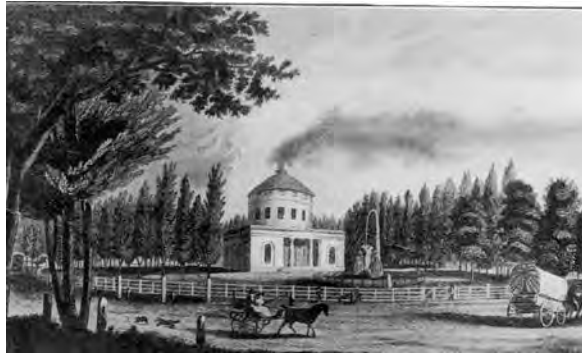
Philadelphia's 1815 Centre Square pump station, the first municipal water supply steam pump in the US

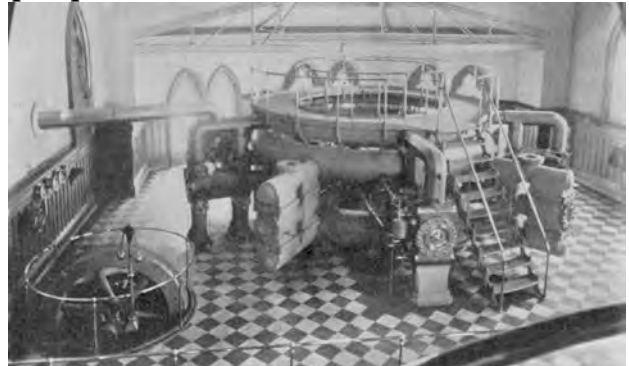
Corliss Spider – Installed in 1873 at Hope Pump Station, Providence RI, it had 5 steam cylinders, 5 pump cylinders and pumped 5 MGD

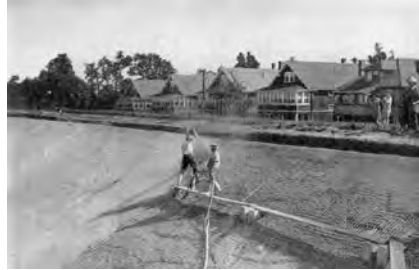
1927 Relining bottom with gunite

The life of an early distribution reservoir: Payson Park, Cambridge MA– Early puddled earth construction lead to concerns over leakage, the bottom is relined, then later columns and a deck are added to cover the water surface.

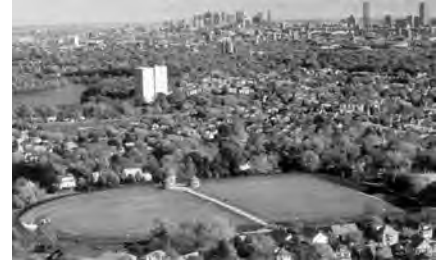
Modern day covered reservoir

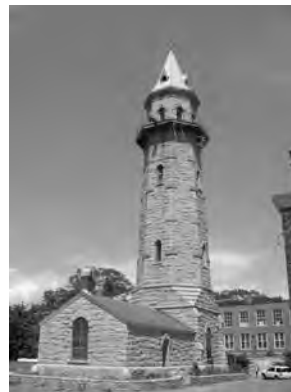
1884 Fall River MA Standpipe, contains two 42" riser pipes

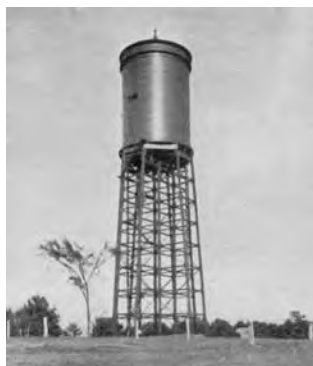
1905 East Providence RI Cast iron tank

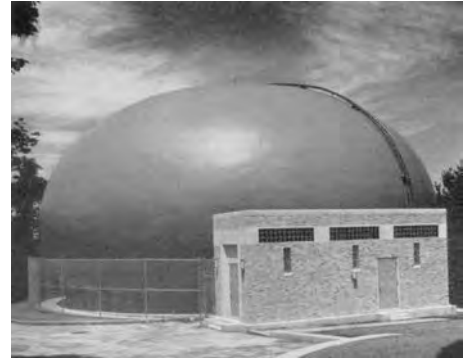
1938 Brookline MA – First spheroid tank in New England, it was chosen to protect against wind damage

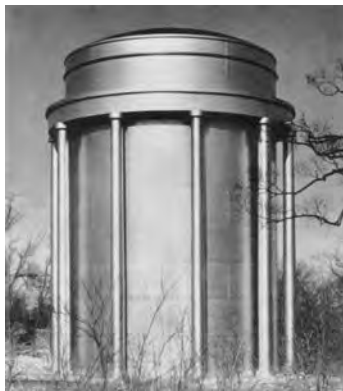
1963 Stamford CT standpipe featuring pillars

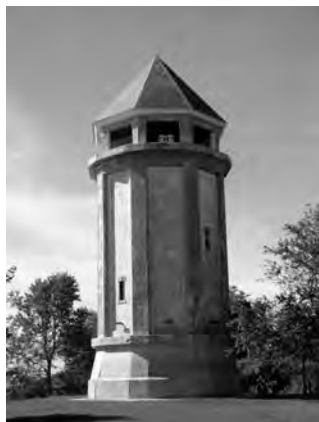
1903 Fort Revere Water Tower, Hull MA, was the first reinforced concrete standpipe in the US, AWWA Historical Landmark

The use of concrete for tanks began in 1903 when the first reinforced concrete tank was built for Hull MA. The structure, named for its location in Fort Revere, has been designated an AWWA Historic Landmark and was constructed using forms and reinforcing steel set in 8" lifts until the desired height was reached. It was also enclosed in a brick and concrete structure with a public landing that overlooks Boston Harbor. Other reinforced concrete tanks were built in the early 1900's using similar techniques but the lifespan of these tanks was short. It was difficult to get these early tanks watertight since the water pressure on the structure pushed outward and caused

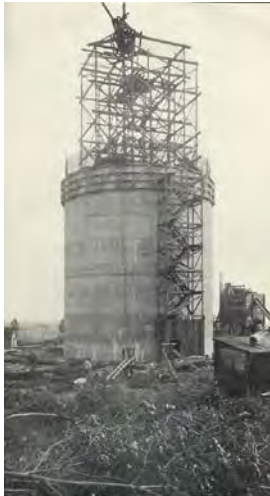
1906 Casting in place in lifts of several feet

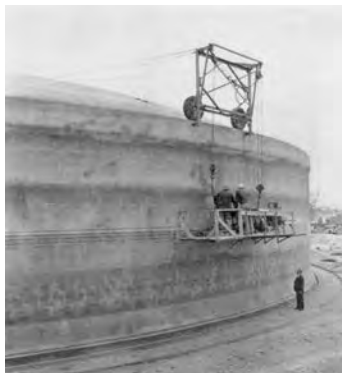
1942 cable winding

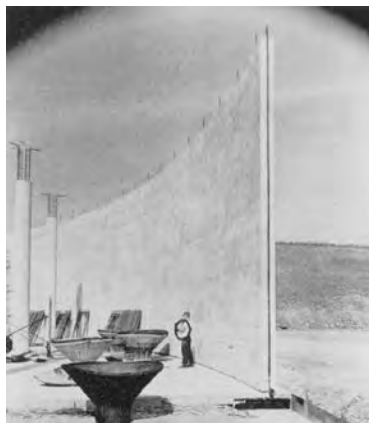
1959 Precast wall sections with integral waterproof core

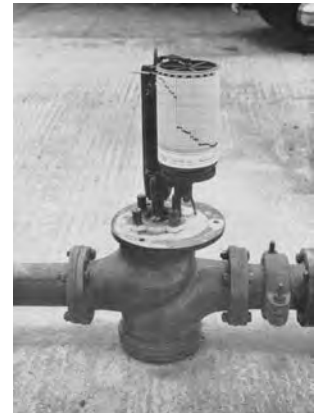
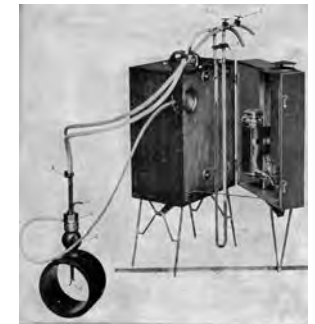
Top - Late 1800's Deacon Waste meter
Bottom - 1906 Cole pitometer

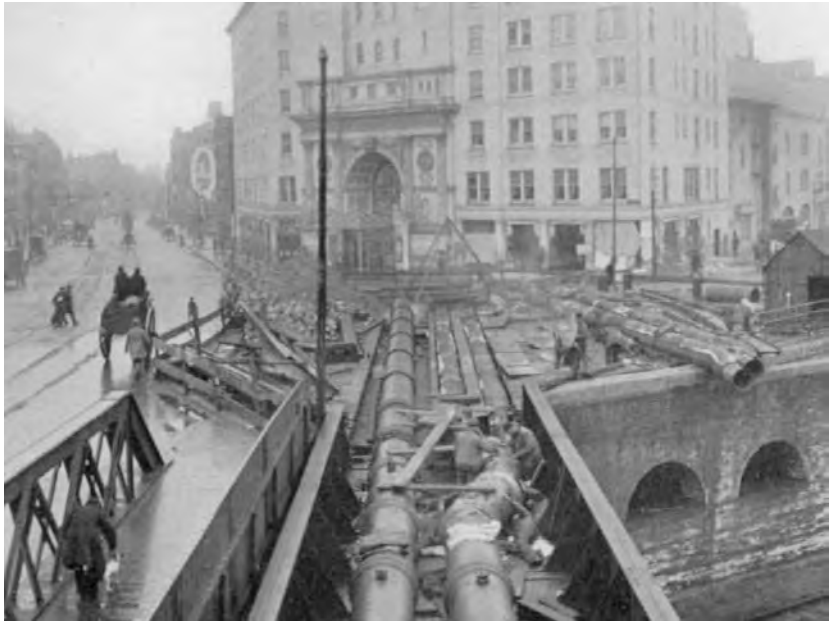
1912 pipe relocation for Boston subway, the original “Big Dig” for Boston
