# THE STATE OF BOSTON HARBOR MAPPING THE HARBOR'S RECOVERY

MASSACHUSETTS  
WATER  
RESOURCES  
AUTHORITY  
2002

TECHNICAL REPORT NO. 2002-09

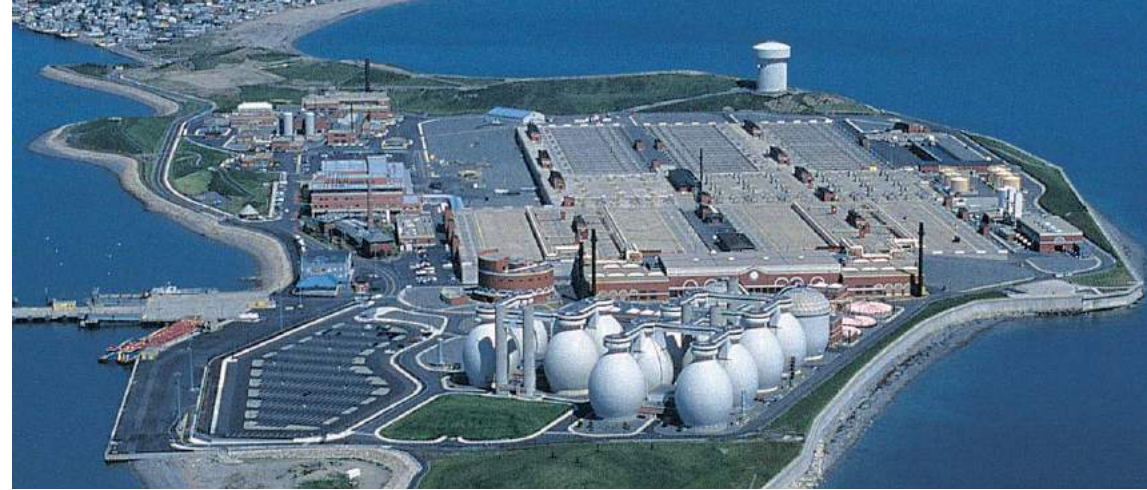
It is important to understand the effects that the major components of the Boston Harbor Project had on pollutant inputs to the harbor. The maps on this page illustrate how, for three time periods, MWRA minimized the impacts of sewage by improving treatment and changing the location of effluent discharges.

A. Before July 1998: Poorly treated wastewater was discharged from the Deer Island and Nut Island Treatment Plants. Sewage solids (sludge) were discharged into the northern harbor after digestion and

disinfection, a practice that ended in 1991. The first battery of secondary treatment of sewage, which more effectively removes solids and contaminants than primary treatment, was in place at Deer Island Treatment Plant in 1997, and in 1998 up to 65% of sewage was undergoing secondary treatment.

B. July 1998 to September 2000: With the completion of the inter-island tunnel from Nut Island to Deer Island, South System sewage was sent to Deer Island for secondary treatment, and the Nut Island Treatment Plant was closed, ending direct discharges to the southern harbor. Another battery of secondary treatment was in place by September 2000, when 85% of the sewage was receiving secondary treatment.

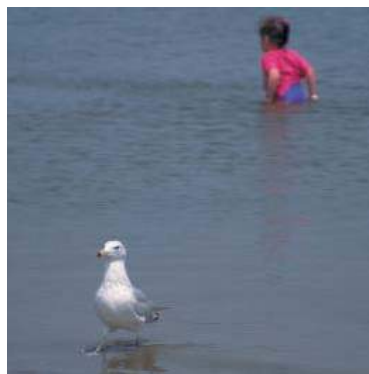
**FIGURE II-5. ENTEROCOCCUS BACTERIA IN BOSTON HARBOR.** *Enterococcus* is the indicator recommended by EPA for monitoring the quality of marine recreational waters. The maps show contours generated from average *Enterococcus* counts collected during MWRA's harbor surveys (since 1989) and from MDC's beach monitoring (since 1987). The contours are drawn at the detection limit (5 colonies/100 ml), and at the EPA guidelines for a designated bathing beach (35 colonies/100 ml), moderate use (158 colonies/100 ml), light use (276 colonies per 100 ml) and infrequent recreational use (500 colonies/100ml).

**A: 1987-1998.** Data averaged from 1987-1998 show that Boston Harbor as a whole was generally within swimming standards. The contour plots show a pattern of elevated bacteria levels around the treatment plant outfalls. Most of these high counts were in the early part of this period. Bacteria were elevated at the shoreline, in embayments, and the Inner Harbor. The highest bacteria levels were in the rivers and in Fort Point Channel.

**B: 1998-2000.** Data averaged from July 1998-August 2000 show the cumulative impact of the Boston Harbor Project and early CSO control projects, even before the new ocean outfall came on-line in 2000. The addition of south system flows to DITP discharges was accomplished without increasing bacterial contamination around DITP outfalls. Now, almost all the outer harbor is at or below the detection limit or within the swimming standard. However, problems still remain along the shoreline, especially in the rivers.

Figure II-5 compares the patterns of *Enterococcus* in the harbor, averaged over time. *Enterococcus* is the measure of recreational marine water quality recommended by the U.S. Environmental Protection Agency (EPA). From 1987 to 1998, bacteria counts were high around Deer Island, Nut Island, and the sludge outfalls; they were also high in the Inner

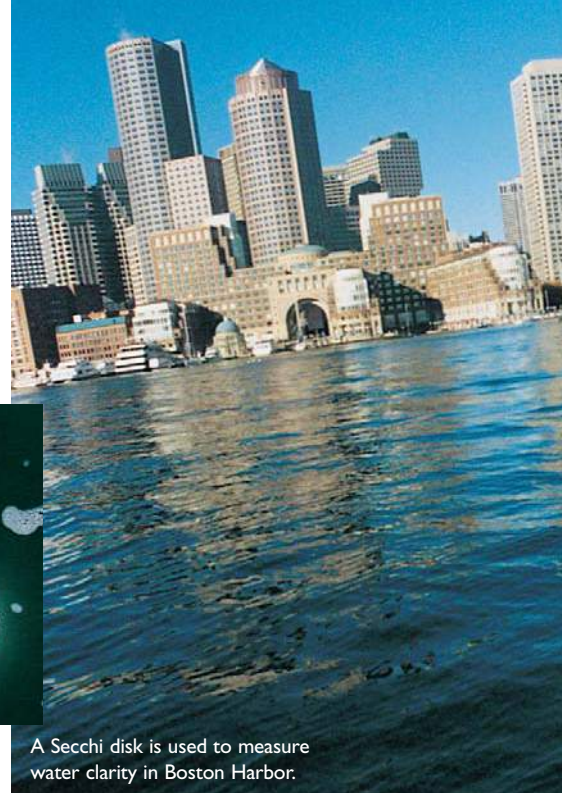
A Secchi disk is used to measure water clarity in Boston Harbor.

Measurements of clarity in the harbor (and anecdotal observations by the public) indicate that water clarity has improved since 1993. One of the measurements that has shown this improvement is Secchi depth. This is the depth at which a white disk, a Secchi disk, lowered into the water is no longer visible.

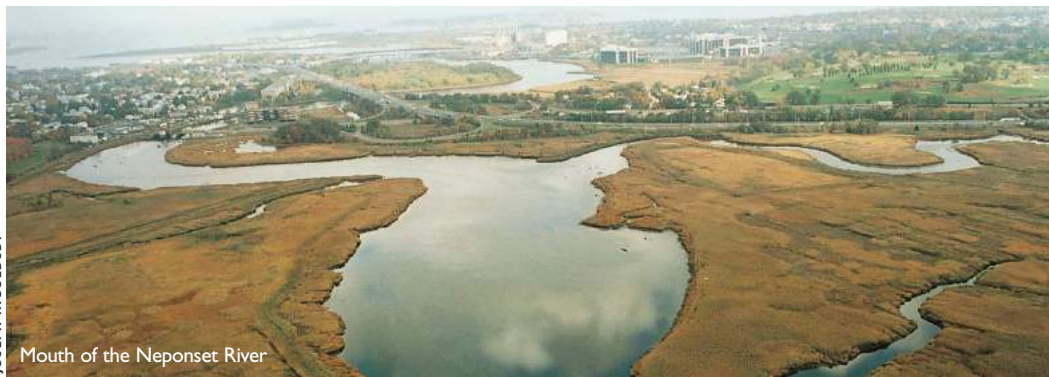
**FIGURE II-9: SUMMER CHLOROPHYLL IN BOSTON HARBOR.** Changes in the amounts of algae in the harbor have been seen since 1995.

**A: AUGUST 1995-JULY 8, 1998.** While both DITP and NITP were discharging, chlorophyll had a west-to-east decreasing gradient, with the highest levels in Quincy Bay and at the mouth of the Neponset River.

**B: JULY 9, 1998-AUGUST 2000.** With the transfer of South System flows to DITP, the shape of chlorophyll contours shifted subtly, with lower chlorophyll levels in the southern harbor and a small, localized increase in chlorophyll at the outer North Harbor.

As expected, one of the changes we found was a decrease in the amount of microscopic algae (phytoplankton) in the water. Figure II-9 compares concentrations of chlorophyll across the harbor before and after NITP flows were transferred to DITP for secondary treatment. Chlorophyll, a photosynthetic pigment in algae cells, is used to measure quantities of algae. The amounts of chlorophyll in the water decrease away from the shoreline toward the bay. After harbor discharges from NITP ended, chlorophyll in the South Harbor decreased to more natural levels.

The North Harbor showed only a small increase in chlorophyll confined to the region near Deer Island. Overgrowth of algae was offset by the greater dilution of effluent at this site. The outer North Harbor is the region where we expect to see the largest decreases in algae in the years to come.

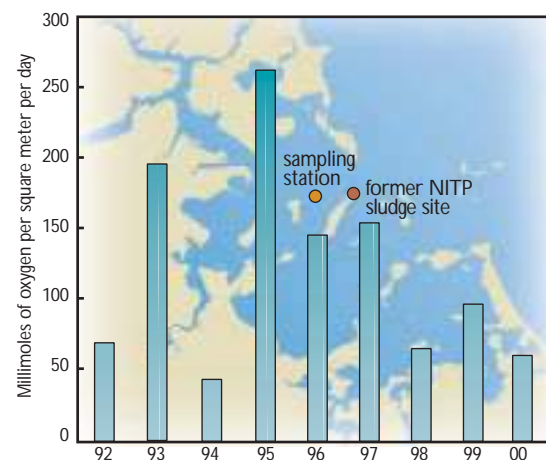
FIGURE II-15. SEDIMENT OXYGEN DEMAND IN BOSTON HARBOR, 1992-2000. The rate at which sediments use up oxygen indicates if they are degraded by too much organic matter. This graph shows the change in sediment oxygen demand from 1992-2000 near the former NITP sewage sludge discharge site near Long Island. Extremely high rates were recorded in 1993, and even higher rates in 1995, as burrowing and feeding activities by benthic animals ventilated the sediments, making more oxygen available to bacteria. Metabolism rates have declined in recent years to normal levels—indicating that the sediments have been “mined out” of organic matter. (Tucker *et al.* 2001)

Bacteria and other organisms metabolize organic matter, depleting oxygen. If the sediments use up oxygen too quickly, it can mean that they are polluted by excess organic matter. In the early 1990s, Boston Harbor sediments showed some of the highest rates of oxygen use ever measured in any sediments! In the decade since MWRA stopped discharging sludge, rates of metabolism in the harbor's sediments have dropped to levels that are more typical of a healthy ecosystem (Figure II-15).

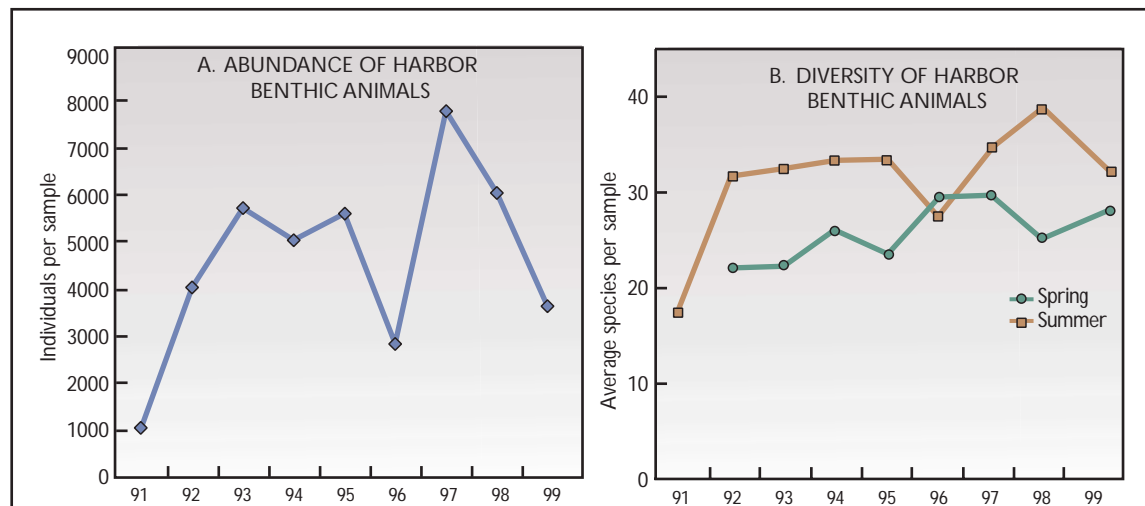
FIGURE II-20. ABUNDANCE AND DIVERSITY OF ANIMALS ON THE HARBOR FLOOR 1990-1999. Each summer since 1991 MWRA has collected sediment samples at eight stations in Boston Harbor. At each station, three sediment grab samples are collected, and the animals in these samples are preserved, identified, and counted in the laboratory. These graphs are from averages of all eight stations. **A: ABUNDANCE.** The number of animals brought up per sample has increased dramatically since 1991. In 1991, a single grab sample brought up approximately 1,000 individual animals. By 1998, there were about 6,000 animals per sample. Increases were most noticeable in the early 1990s, as communities quickly recovered after sludge discharges stopped in December 1991. **B: DIVERSITY.** Measured by the number of different species found in a grab sample, diversity has also climbed since 1991. In 1991, a grab sampler would bring aboard about 18 different species per sample. By 1999, an average of 33 species per sample was collected. Thus, in less than a decade, the biodiversity of the harbor almost doubled. Although the increases are not at all stations or in all years, a statistical analysis of the data confirmed that the overall increase is significant. As with many other benthic measurements, biodiversity increased sharply in the 1990s after sludge discharges to the harbor ended.

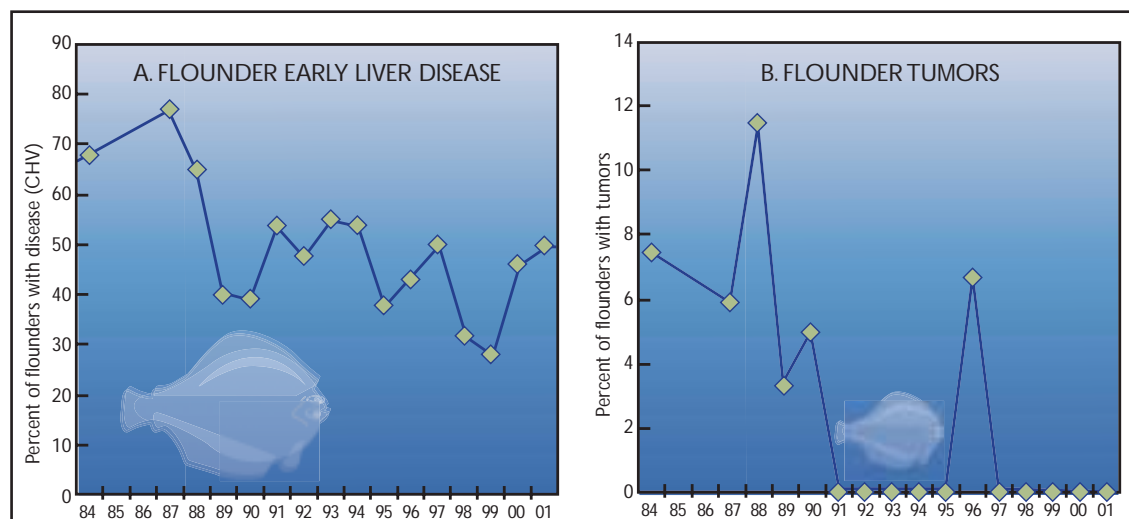
FIGURE II-22. LIVER DISEASE IN WINTER FLOUNDER, 1984-2001.

Liver disease is a sensitive indicator of pollution effects on Boston Harbor flounder because the liver can be damaged as contaminants are metabolized. **A: EARLY LIVER DISEASE.** On average, the rate of early liver disease (measured as centrotubular hydropic vacuolation or CHV) is about two-thirds the levels found in the 1980s, when nearly 70% of fish were affected. **B: LIVER TUMORS.** This more serious abnormality, once found at an unusually high incidence, has not been seen since 1996 (when one tumor was found out of 16 fish collected). Other forms of liver disease (not shown) also have dropped substantially since the late 1980s but seem to have leveled off over the last decade. Although encouraging, these observations should be interpreted with caution, because the fish caught in Boston Harbor recently have been younger, and younger fish tend to have a lower prevalence of liver disease.

Since 1992, the flounder caught near Deer Island have not exhibited gross abnormalities, such as fin erosion, that had been observed during the mid-1980s; the fish generally appear healthier. Of the liver lesions, a type called “centrotubular hydropic vacuolation” (CHV) has been the most common. Figure II-22A shows that, on average, the rate of CHV is about two-thirds of the levels found in the 1980s, although this may be partially explained by the age of the fish: the tested fish from Boston Harbor have been younger, and younger fish tend to have lower CHV levels. Liver tumors, which indicate more serious health effects, have not been observed since 1996 (Figure II-22B).

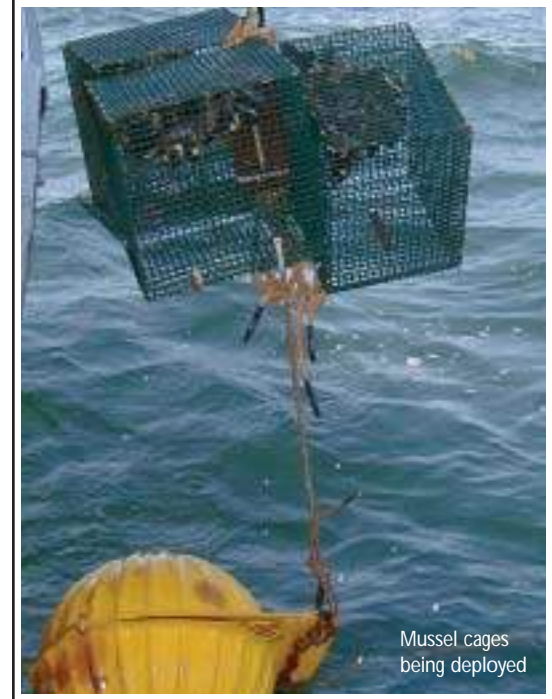
Mussel cages being deployed

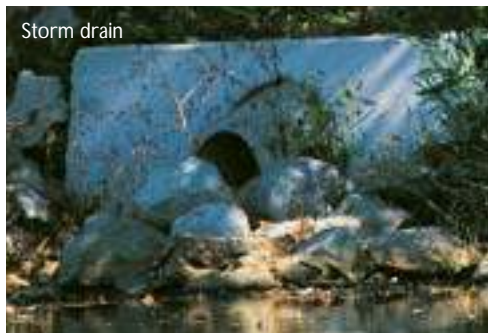
Storm drain

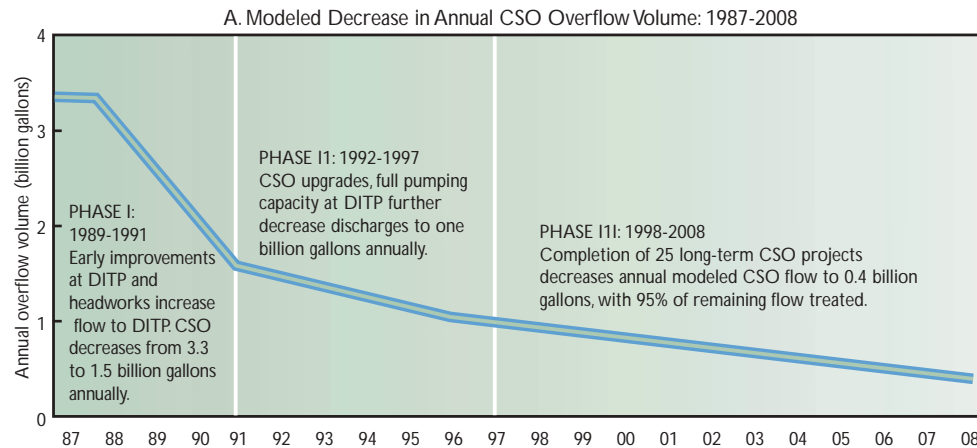
**FIGURE III-2. PATTERNS OF RIVER BACTERIA COMPARED TO PHASES OF CSO CONTROL.** Bacterial counts for the three rivers are grouped in time by the three phases of the MWRA's CSO Plan. **A:** Model predictions for CSO discharges, CSO Control Plan. **B:** Average bacteria levels in the Charles have decreased 80%, while the Mystic and Neponset Rivers have shown little or no improvement. The Mystic and Neponset are more affected by stormwater than by CSO. Improved pumping and hydraulic capacity at DITP greatly decreased discharges from Charles River CSOs. Also, communities along the Charles have been working to clean up stormwater discharges. Although there have been local improvements at the mouth of the Mystic River near MWRA's Somerville Marginal CSO Treatment Facility, the overall average water quality in the Mystic has changed very little. While CSOs have been eliminated in the Neponset, stormwater still contaminates that river. (Lines above bars indicate margin of error.)

In the Charles, improvement in water quality over the past ten years has been dramatic; fecal coliform counts (geometric mean) fell by over five-fold. Although the Mystic River shows slight improvement over this period, the Mystic and Alewife Brook are still plagued with contaminated stormwater and CSOs. Implementation of MWRA's CSO Plan will control CSOs, but stormwater is a major source of bacteria. Although closing CSOs and better CSO treatment at MWRA facilities has reduced inputs of bacteria to the Neponset, stormwater sources are so much larger than were CSOs that water quality in the lower Neponset has remained about the same since monitoring began.

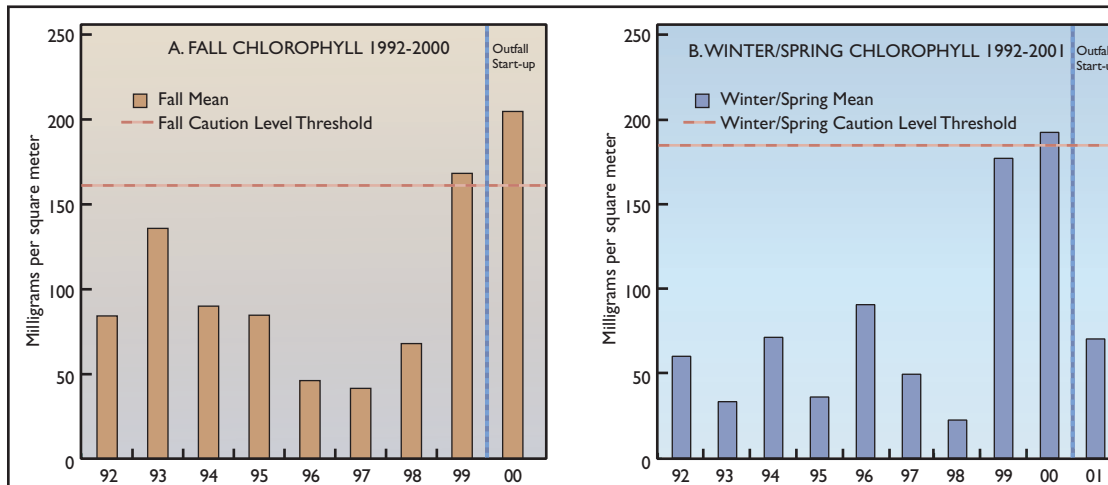
FIGURE IV-8. SEASONAL CHLOROPHYLL LEVELS NEAR THE BAY OUTFALL, 1992-2001. These are average nearfield chlorophyll levels for each year by season.

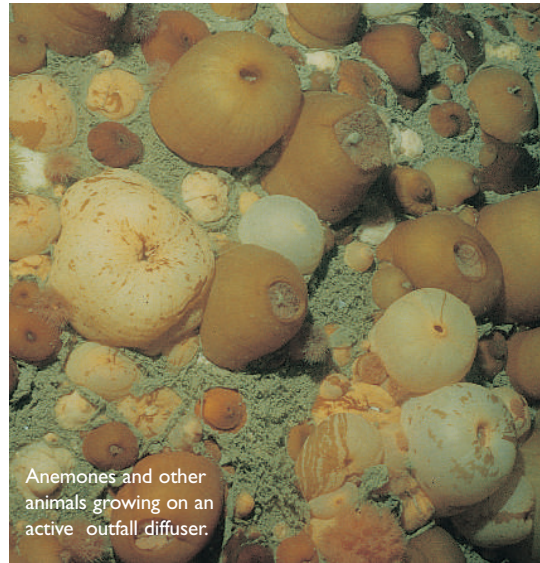
Anemones and other animals growing on an active outfall diffuser.
