Massachusetts Water Resources Authority

2014 Update on I/I Local Financial Assistance Program

Update on Invasive Aquatic Plant Management at Wachusett Reservoir

Ware Disinfection Facility Valve Shut Down

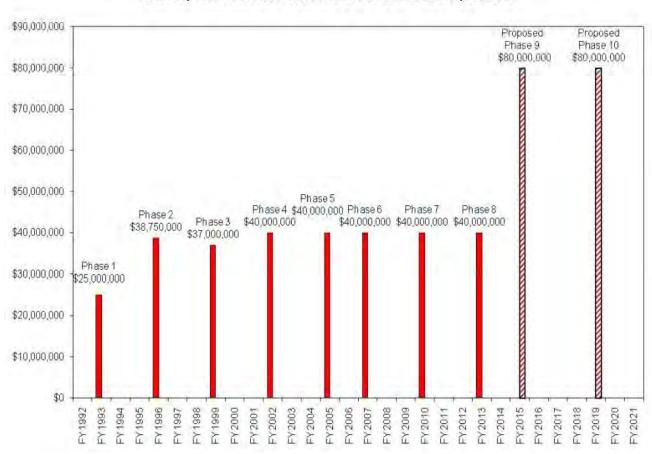
Financial Assistance Program Phases

I/I Local Financial Assistance Program - Timing of Phase 1 through 8 Funds and Proposed Addition of Phases 9 and 10 at \$80 Million per Phase

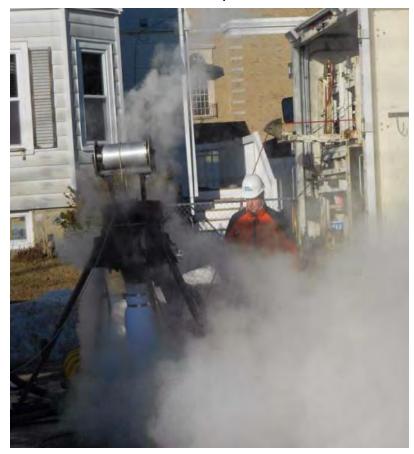
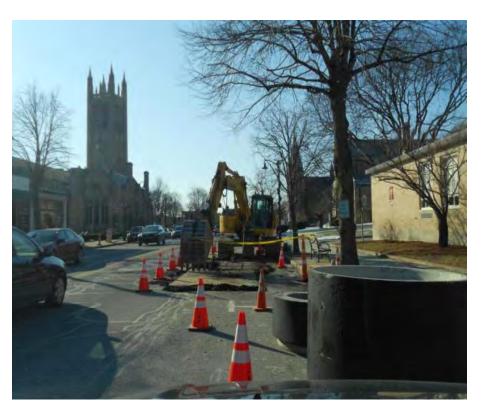
Cured-in-Place Pipe Installation

Sewer Spot Repair and New Manhole

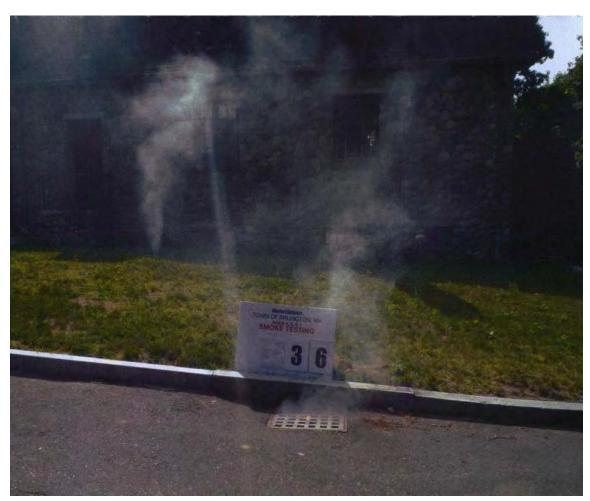
Arlington Smoke Testing

Catch Basin and Service
Connection Cleanout Direct
Connection to Sewer

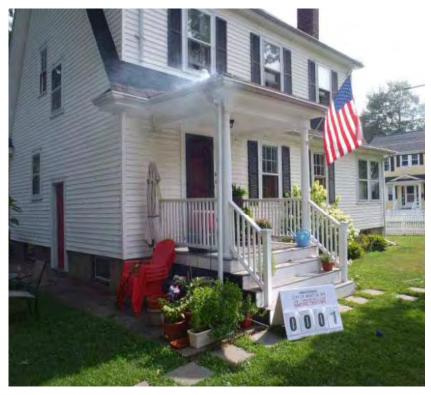
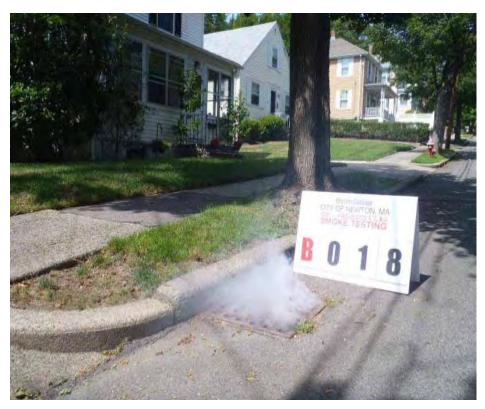
Newton Smoke Testing

Downspout Direct Connection to Sewer

Catch Basin Direct Connection to Sewer

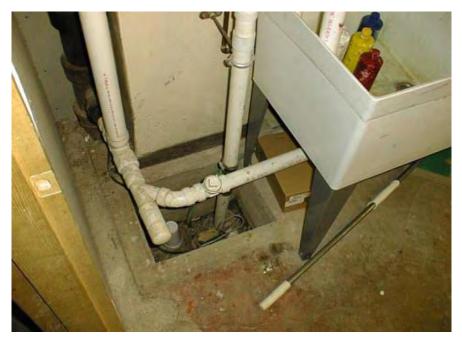
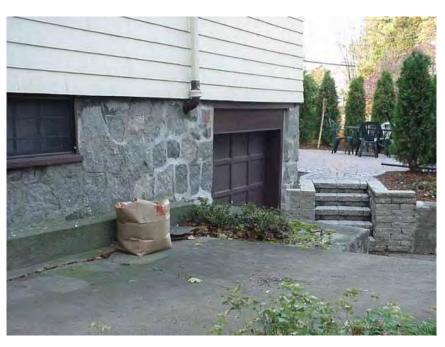
Boston Private Inflow Identification

Sump Pump Direct Connection to Sewer

Downspout Direct Connection to Sewer

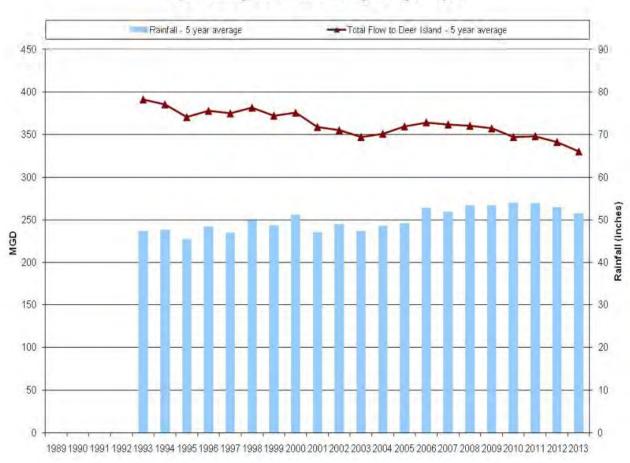
MWRA Long-Term Flow Data (5-year running average)

MWRA Long-Term Regional Flow Data 5-year Running Averages 5 year running NOAA Rainfall Average at Logan Airport

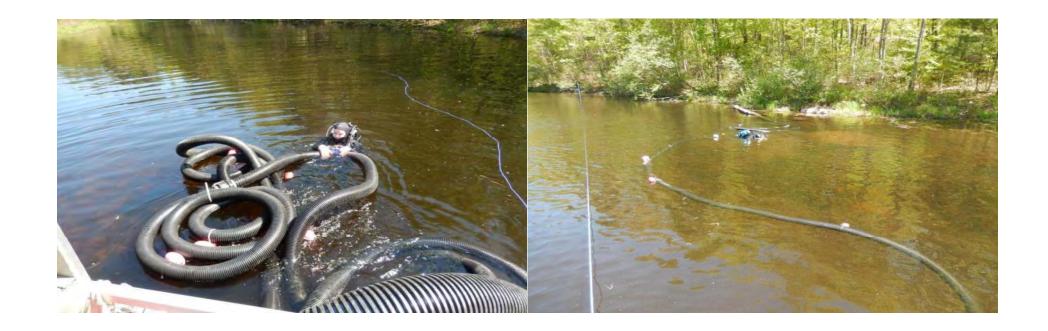
Divers Deploying Suction Hose

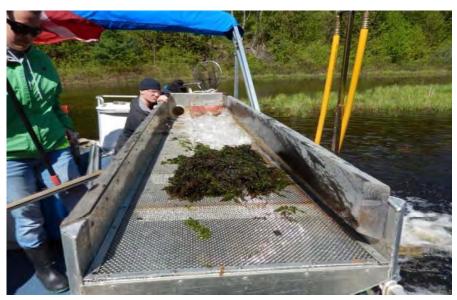
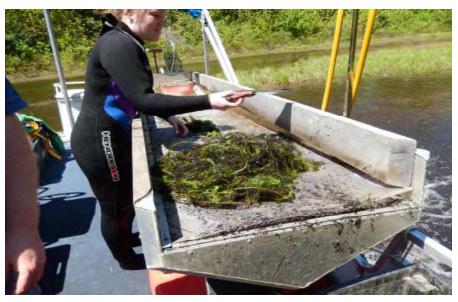
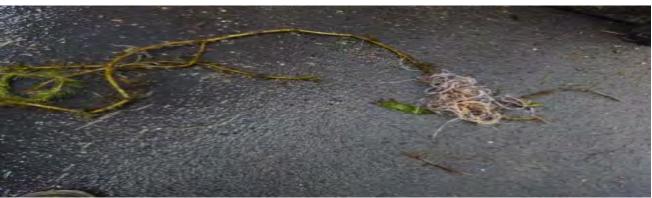
Suction Harvested Plants Collected Aboard DASH Boats

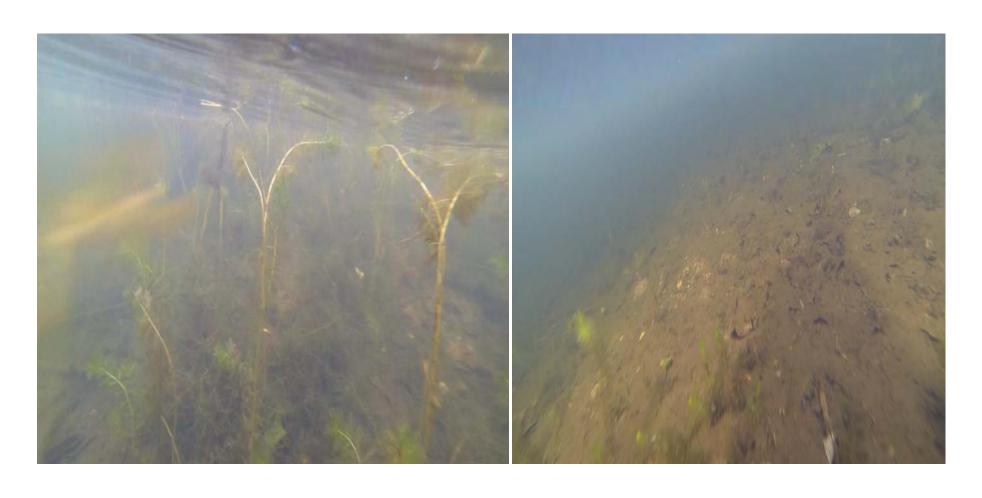
Underwater Views – Before And After

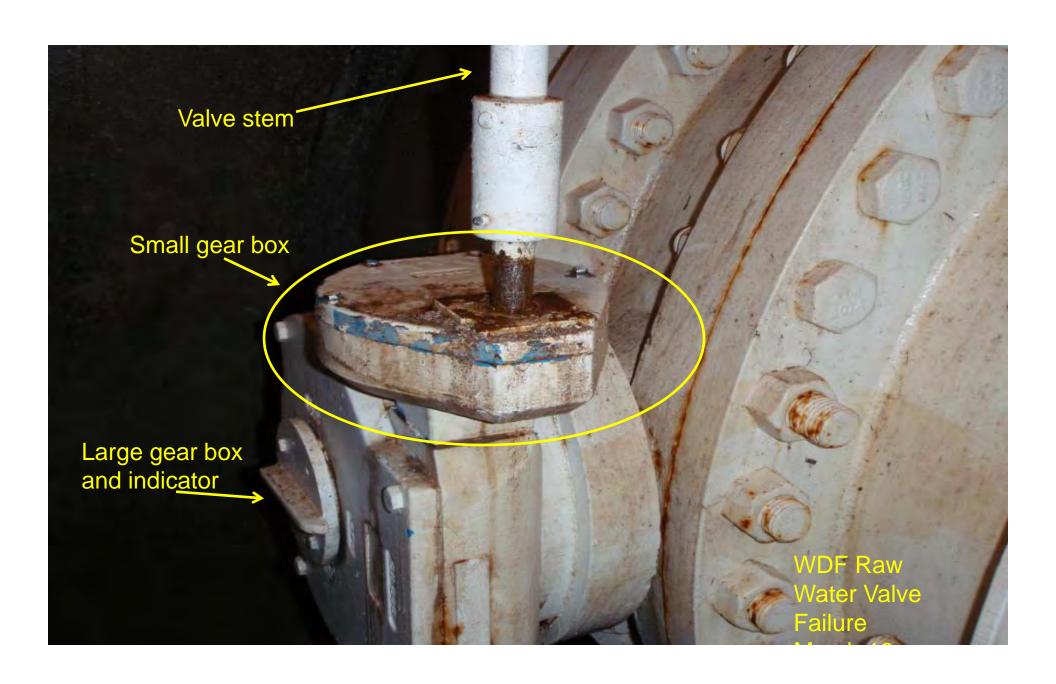
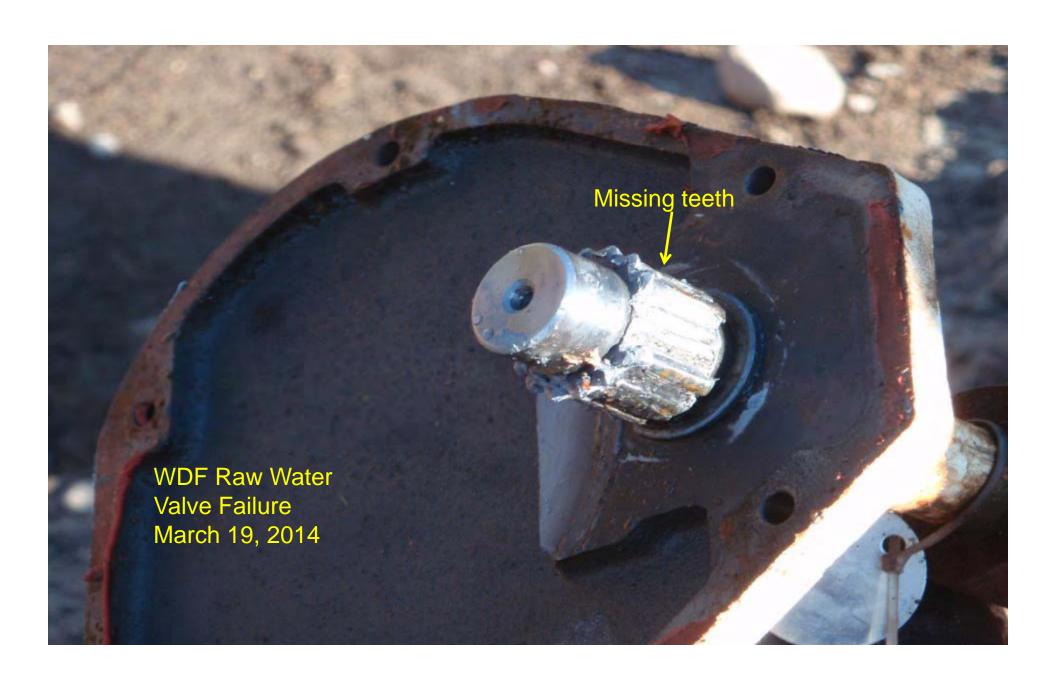
MASSACHUSETTS WATER RESOURCES AUTHORITY
WARE DISINFECTION FACILITY
SUBSURFACE POWERHOUSE VAULT

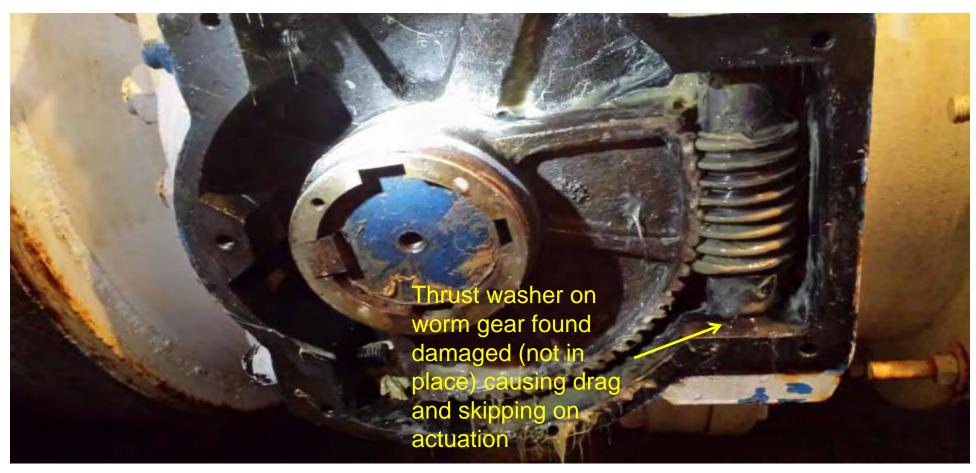
Actuator Plate removed

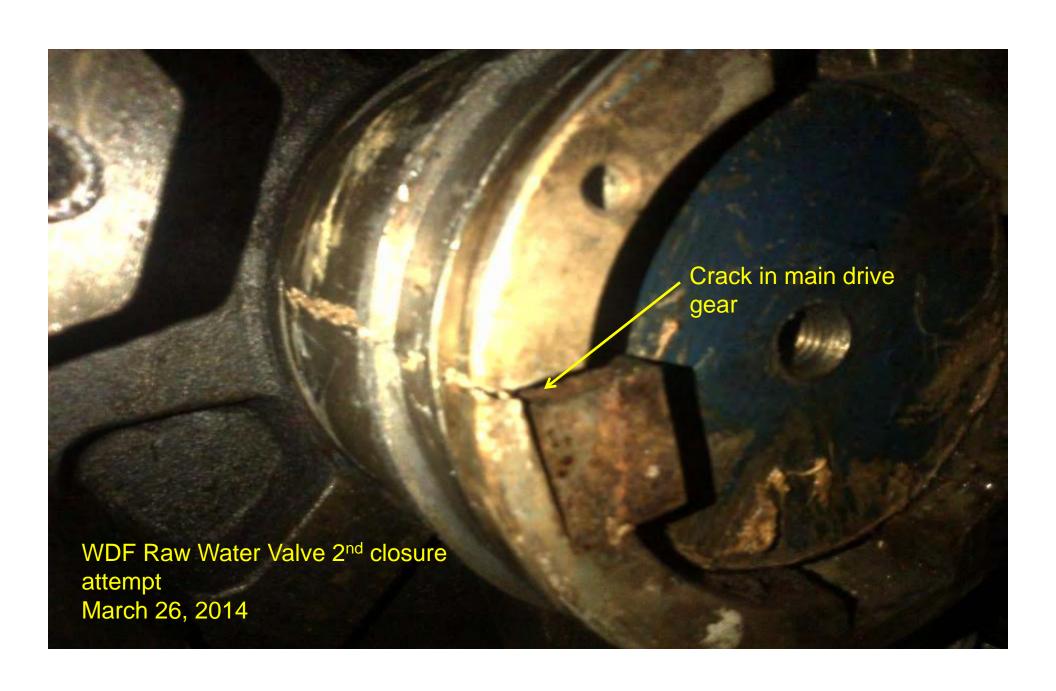
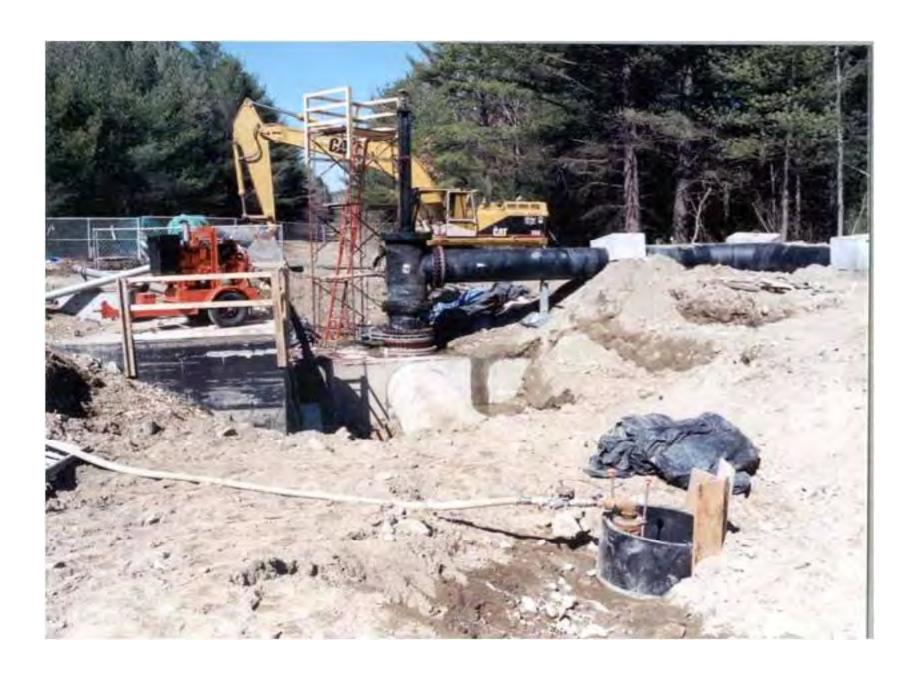
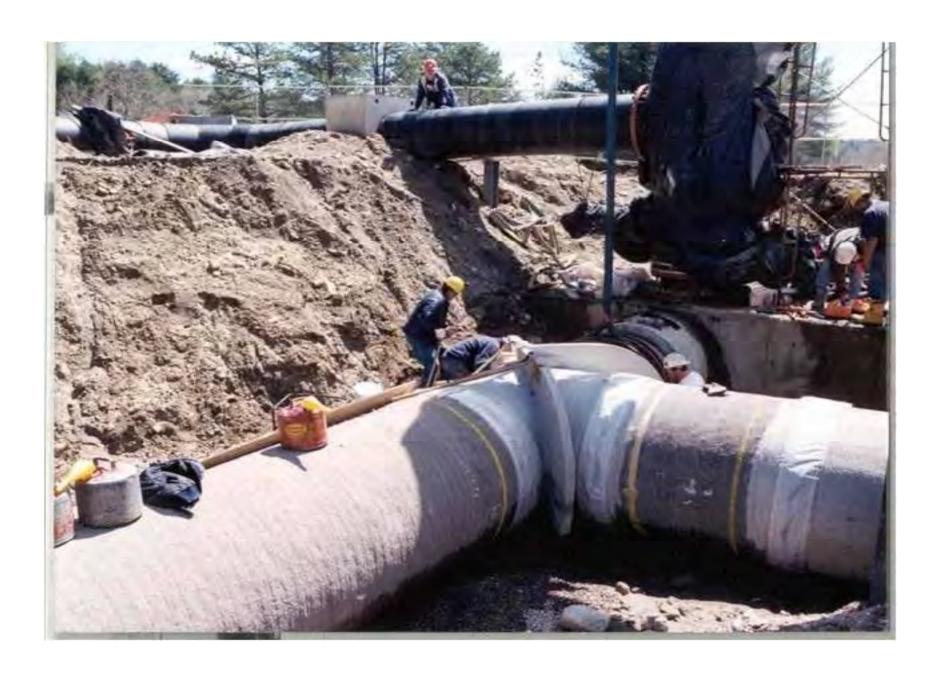
WDF Raw Water Valve Actuator Inspection March 21, 2014
