Massachusetts Water Resources Authority

**MWRA Fiscal Year 2016
Proposed
Current Expense Budget**

MWRA Annual CSO Progress Report 2014

MWRA's Dam Safety Program 2005 - 2015

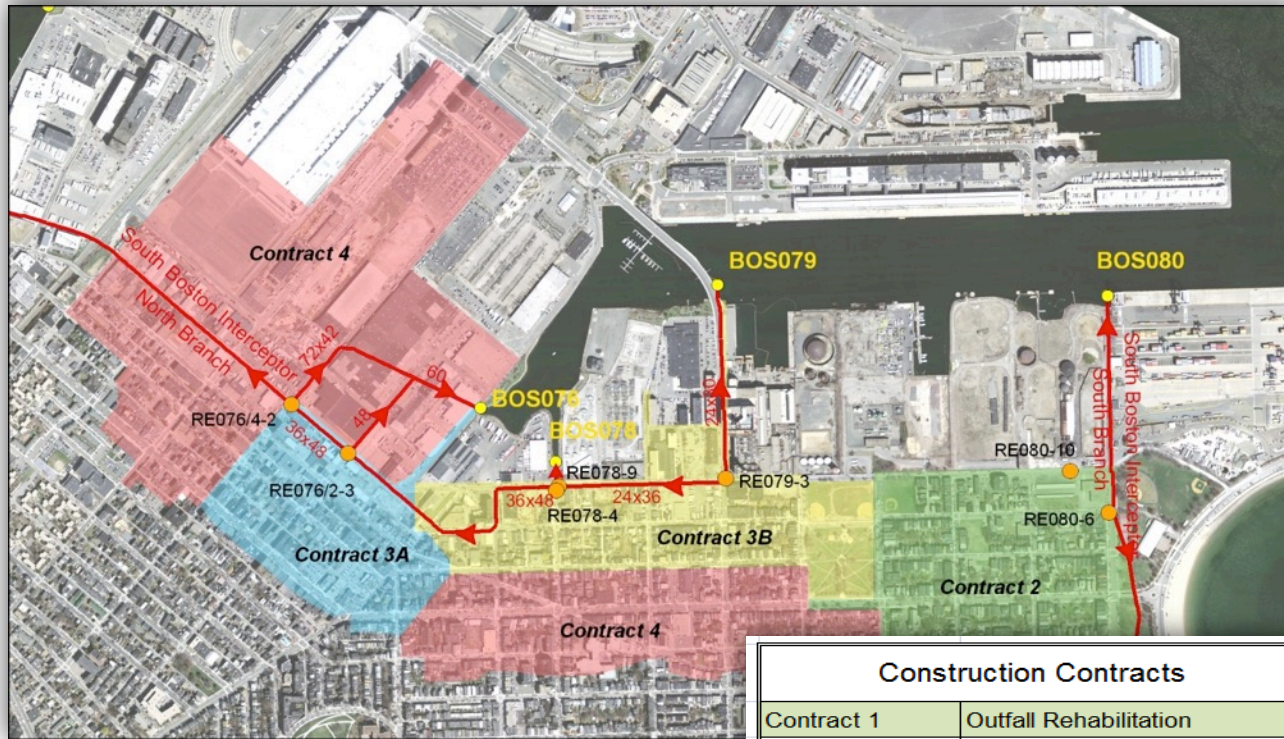
\$69M BWSC Reserved Channel Sewer Separation

3 of 4 major sewer separation contracts are substantially complete.

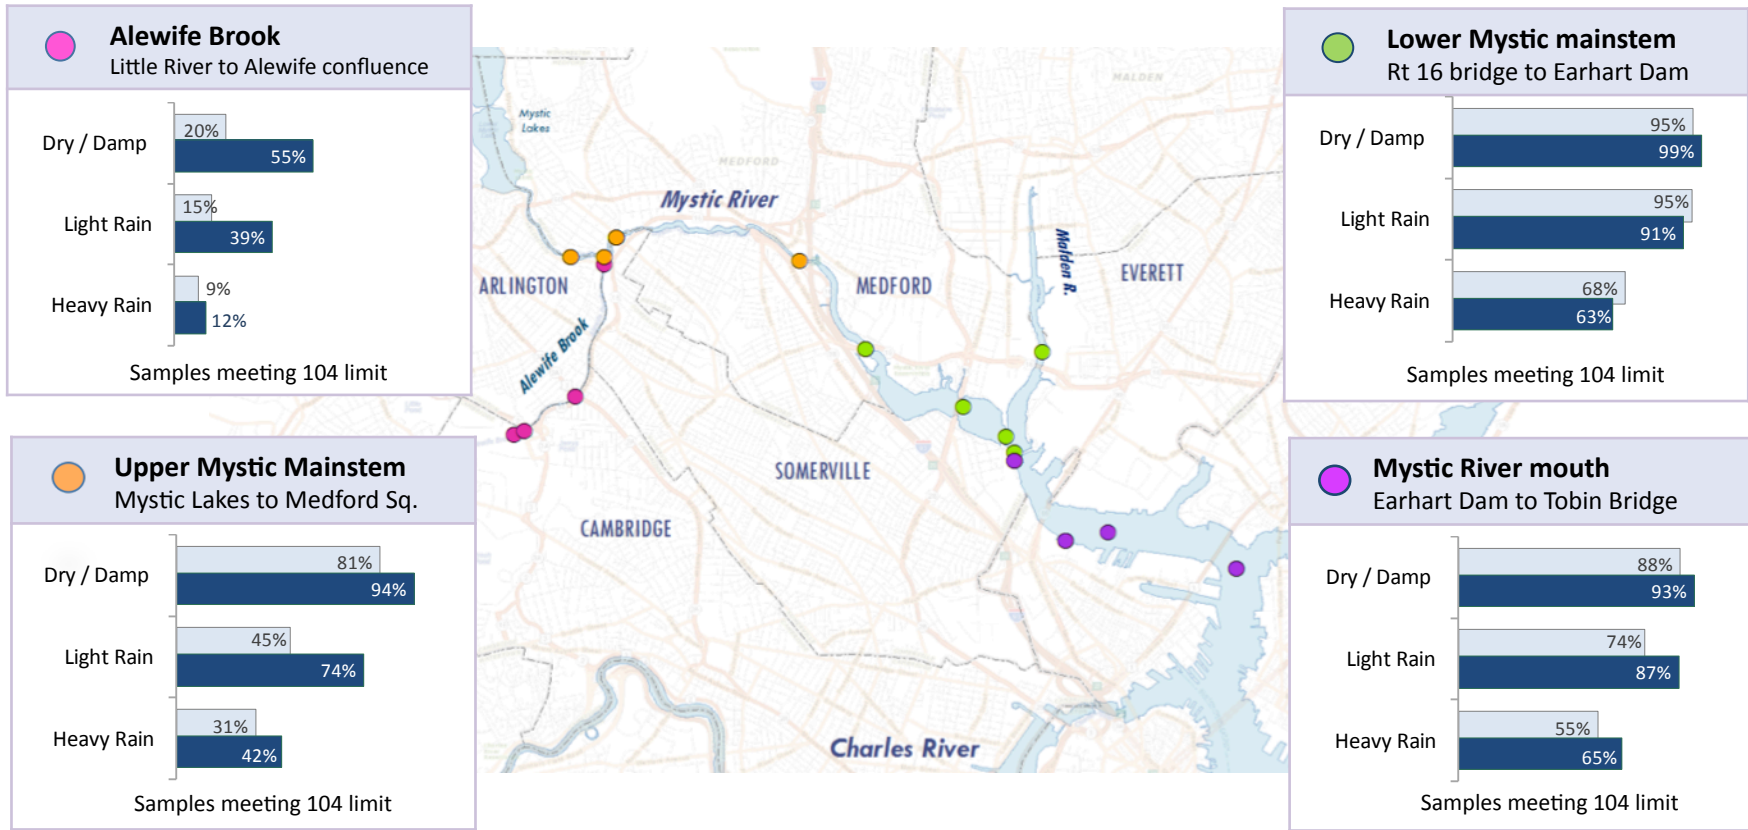
Change in Mystic River Water Quality Over Time

Graphs show the percent of samples meeting the *Enterococcus* bacteria limit for swimming, by river reach.

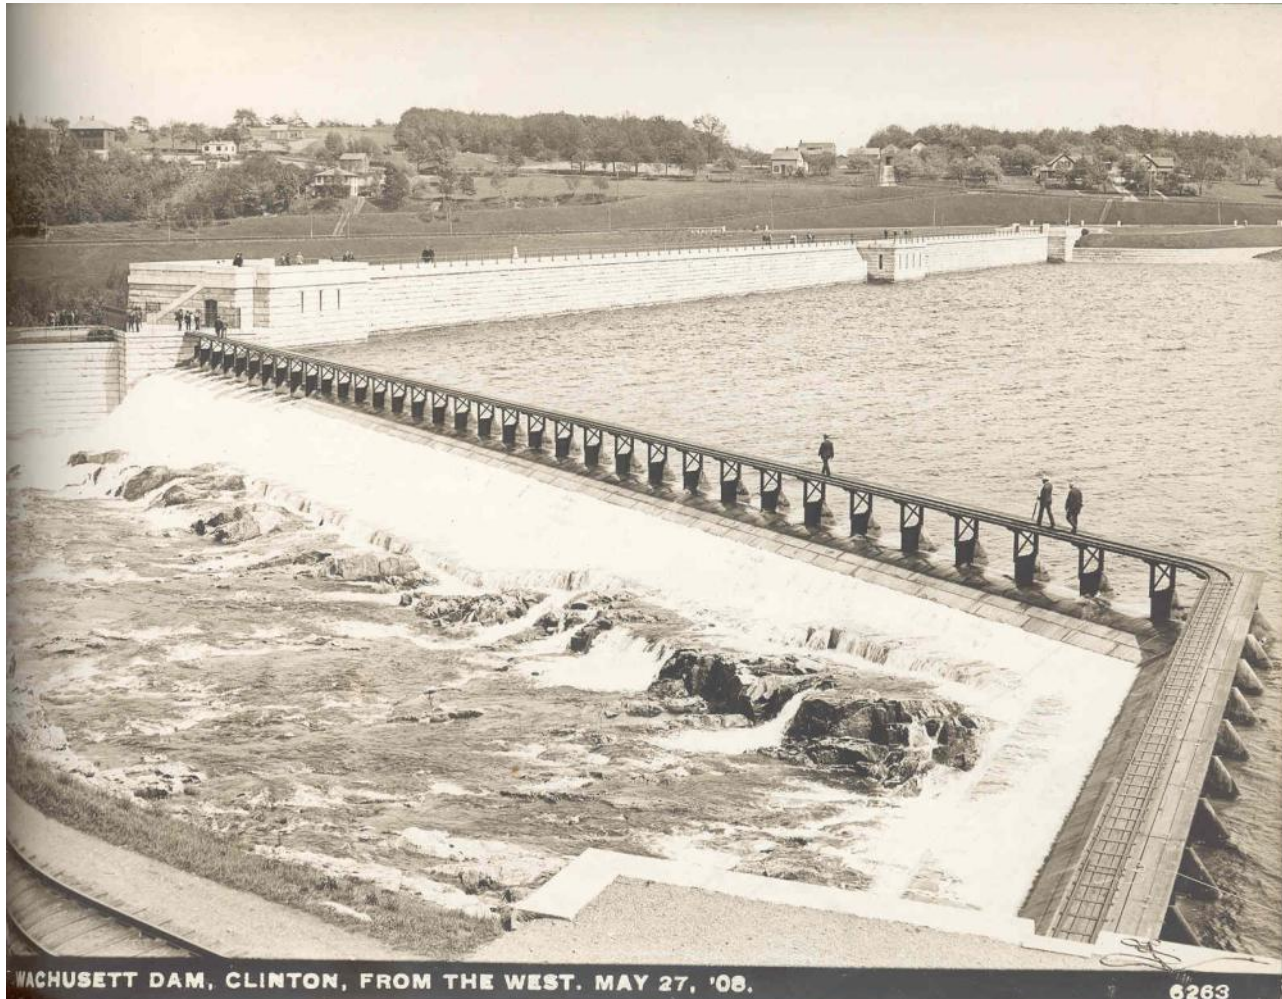
Wachusett Dam 1908

WACHUSETT DAM, CLINTON, FROM THE WEST. MAY 27, '08.

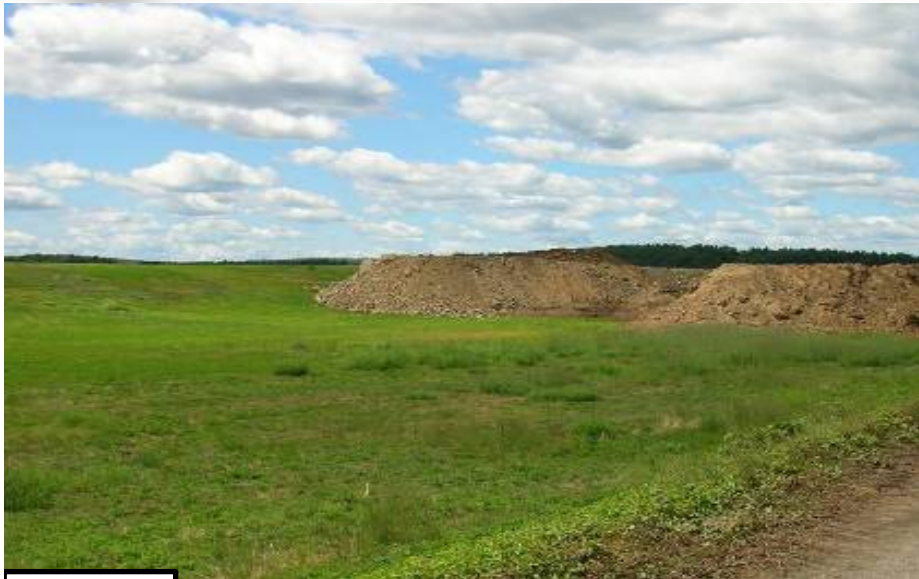
North Dike Structural Stabilization of Historic Failure Zone

Before

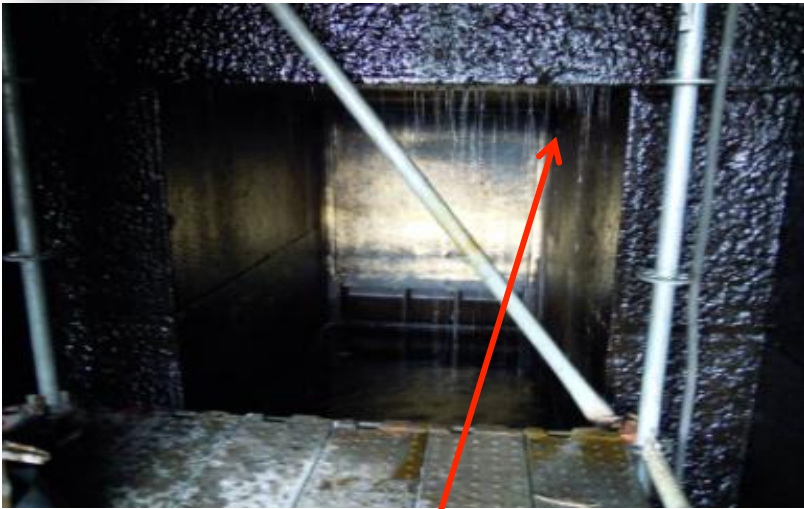
Leakage through stone joints

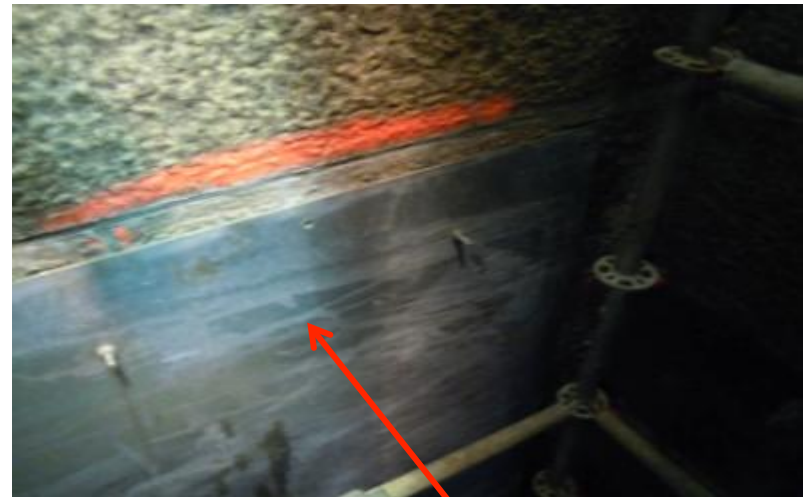
Steel plate for protection against erosion of mortar

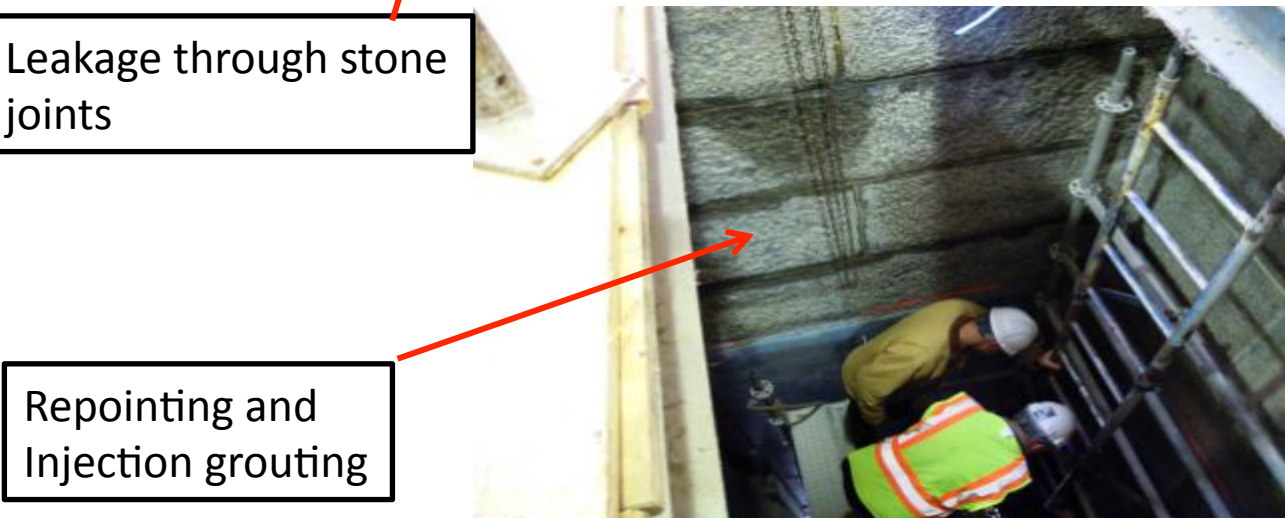
Repointing and Injection grouting

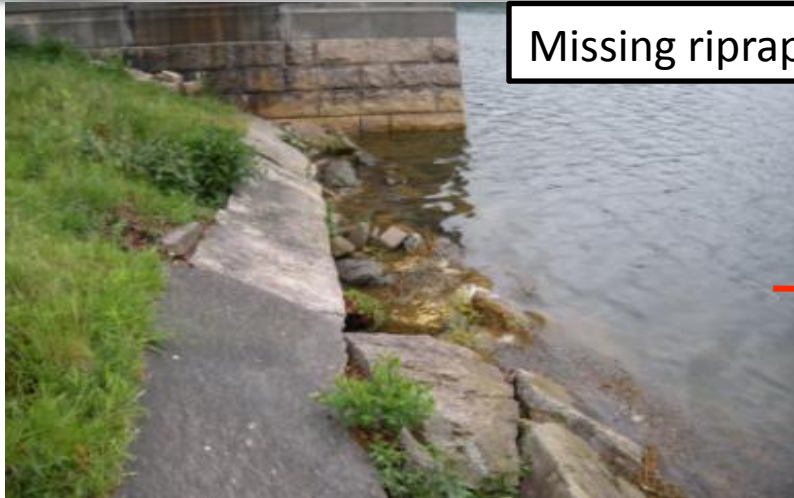
Missing riprap

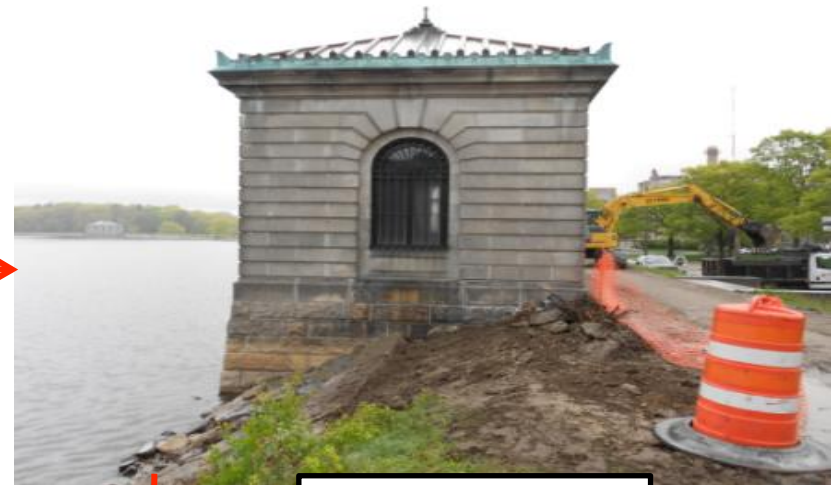
Resetting riprap

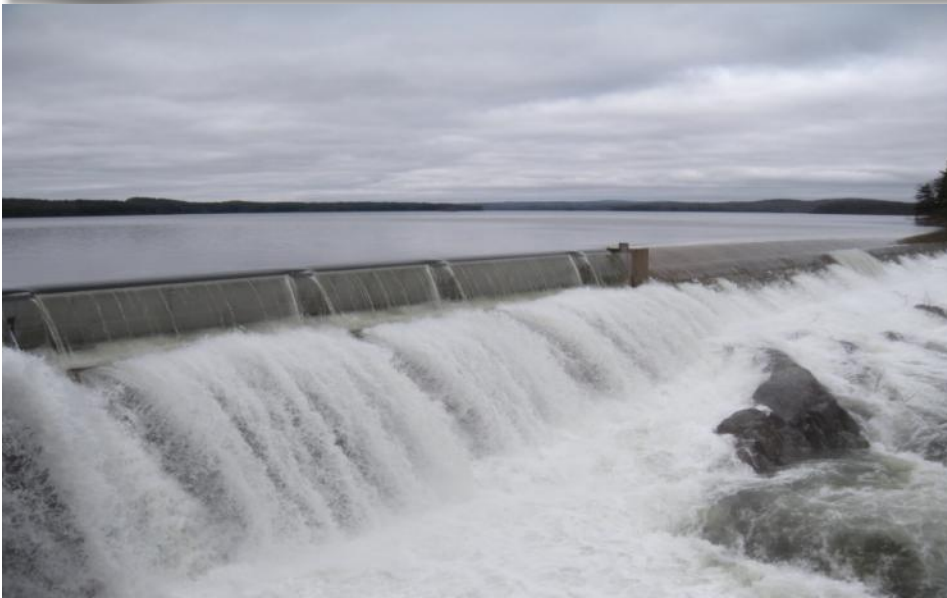
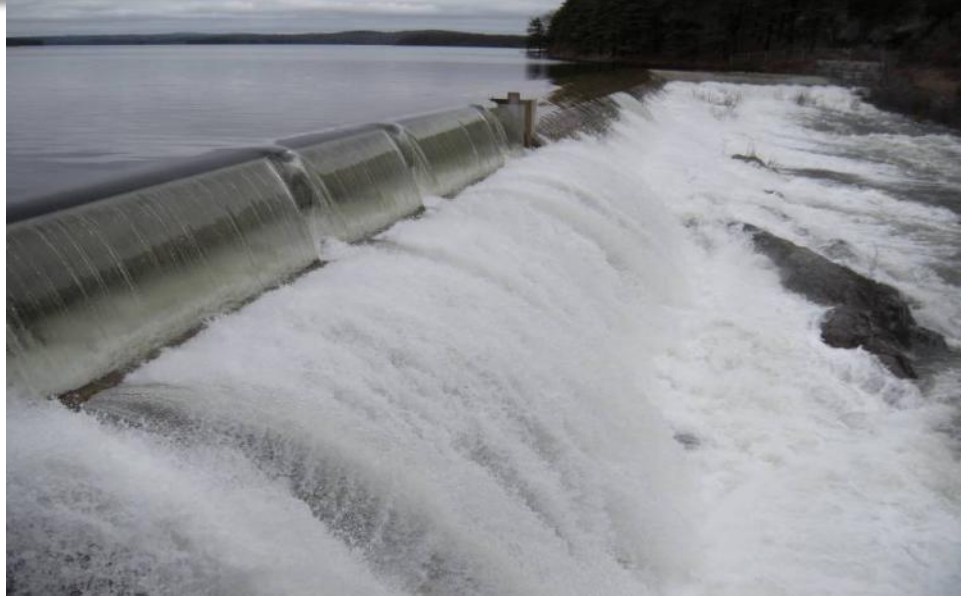
Wachusett el. 396.07' on 04.01.10 @1.6 BGD

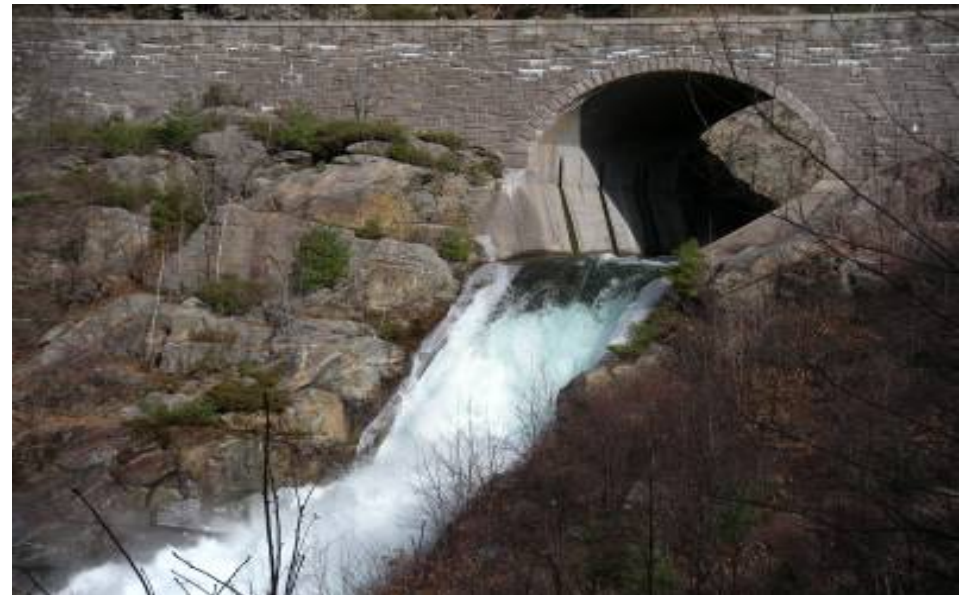
Quabbin Spilling @ 0.6 BGD on 04.05.10
