***MWRA's Outfall Monitoring Overview
2016 Results***

***Update on Invasive Aquatic Plant Management
at MWRA Reservoirs***

***CSO Post-Construction Monitoring and
Performance Assessment
Contract 7572***

***Southern Extra High and Northern Intermediate
High Pipeline Redundancy Projects***

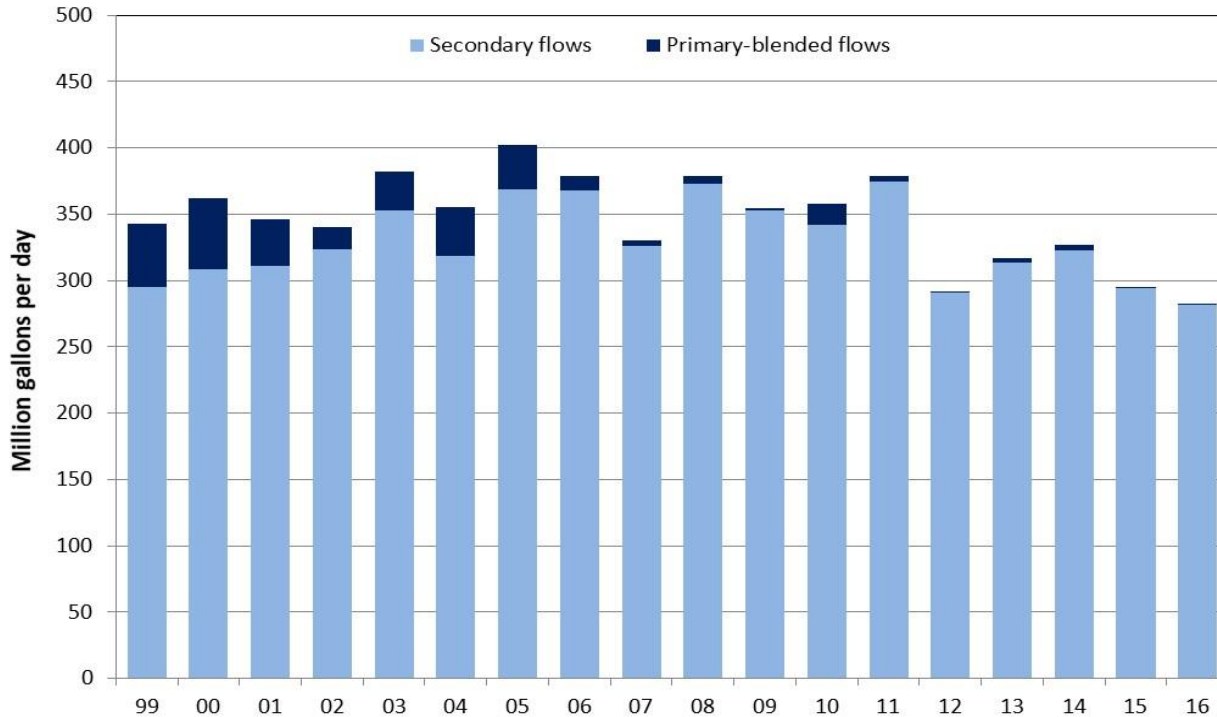
2016 Was A Very Dry Year With Almost No Blending

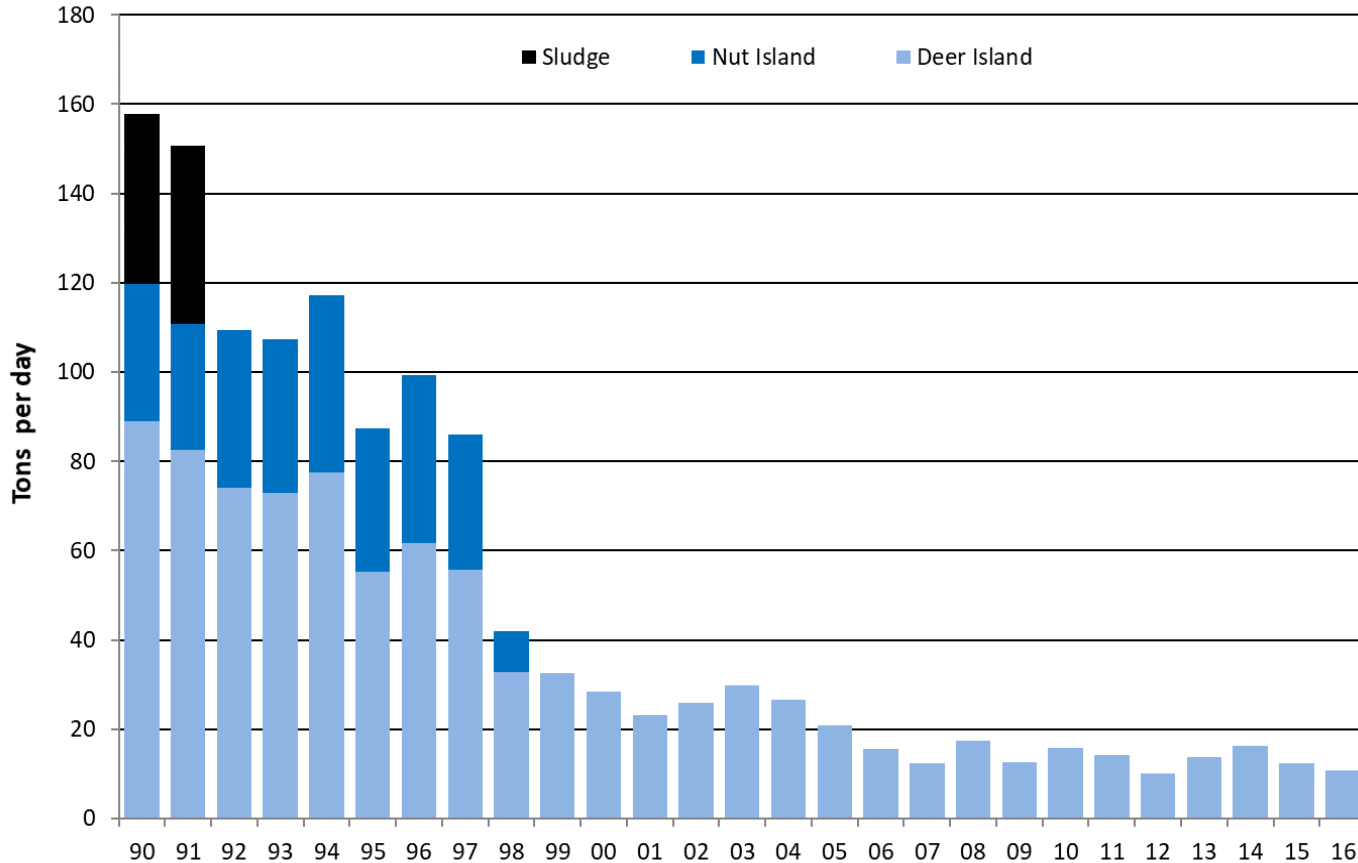
Total Solids Discharged (Tons/Day), 1990-2016

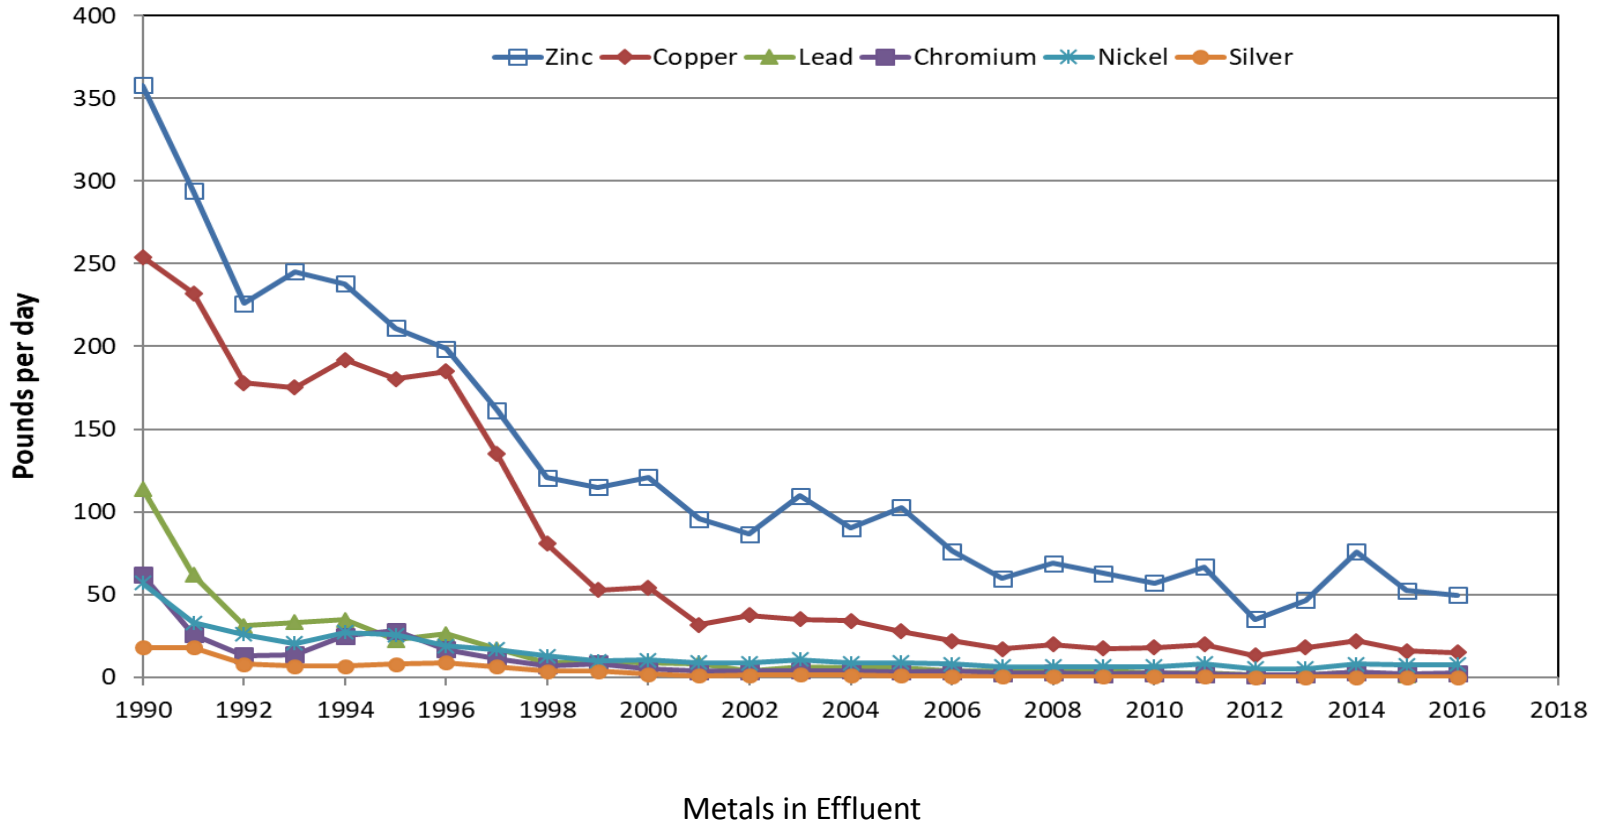
Contaminants In Deer Island Effluent

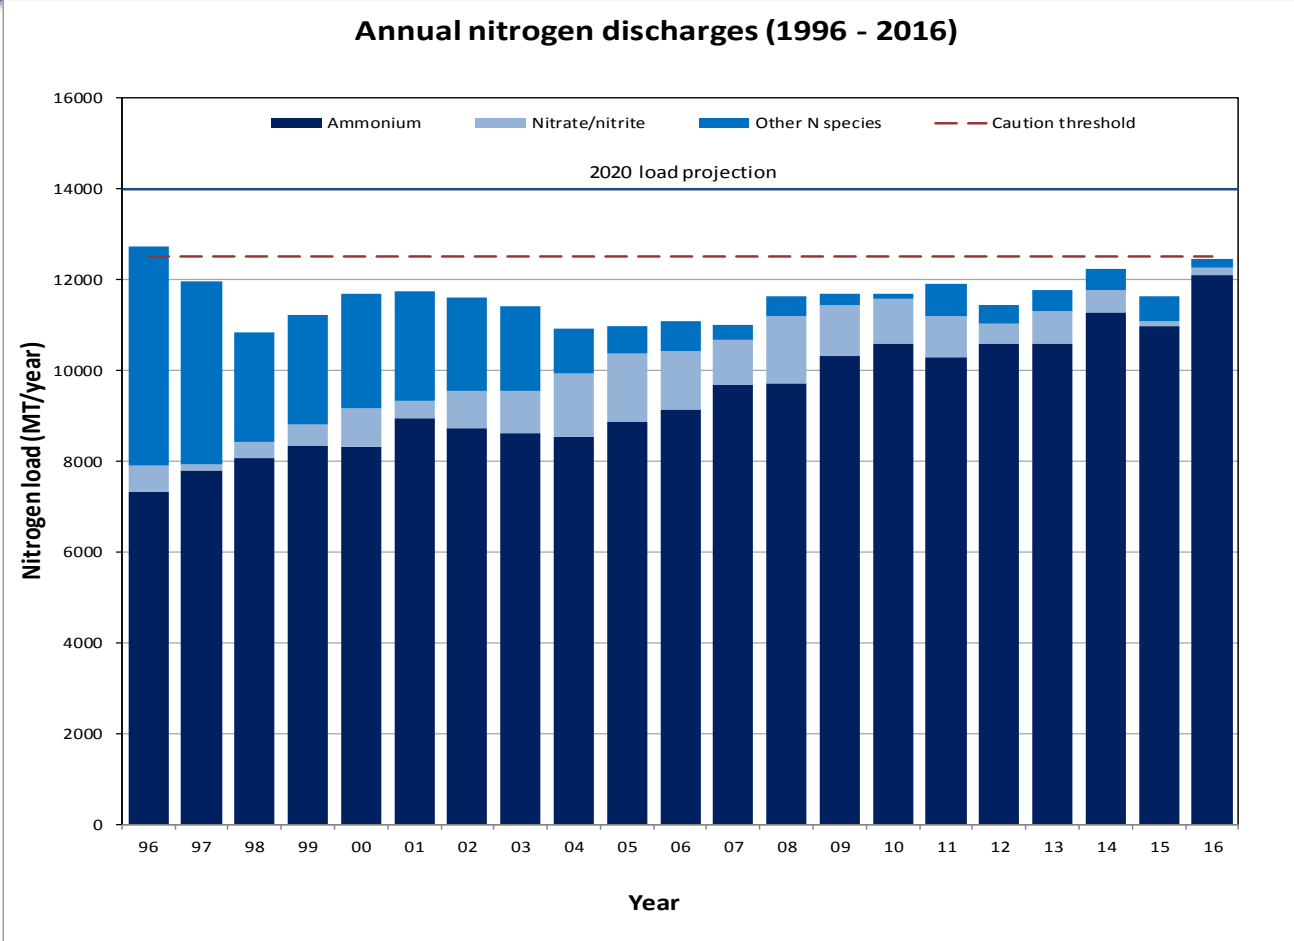
Effluent Nitrogen Was High In 2016

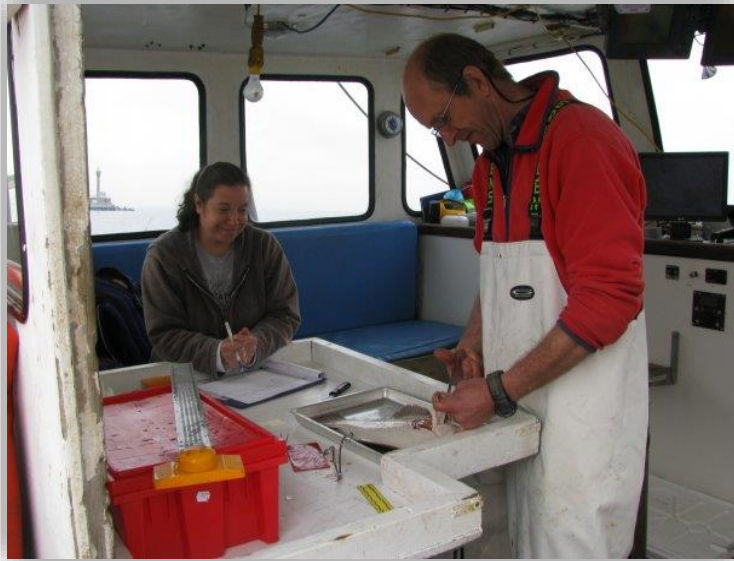
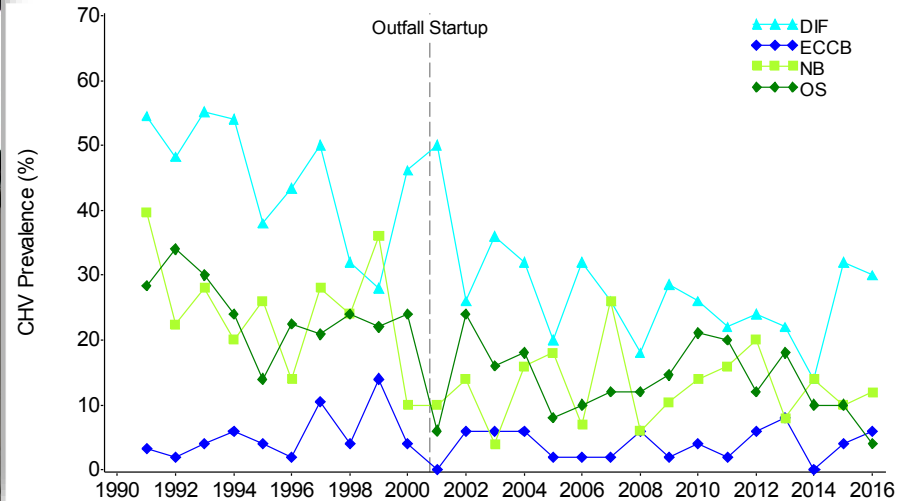
Flounder Health In Boston Harbor And Near Outfall

- Diseased flounder were one cause of Boston Harbor being termed “Dirtiest in the Nation”
- Liver tumors were last observed in 2004
- Prevalence of liver tumor precursors has decreased substantially in Boston Harbor
- Tumor precursors are decreasing near outfall as well; 2016 levels were the lowest yet observed

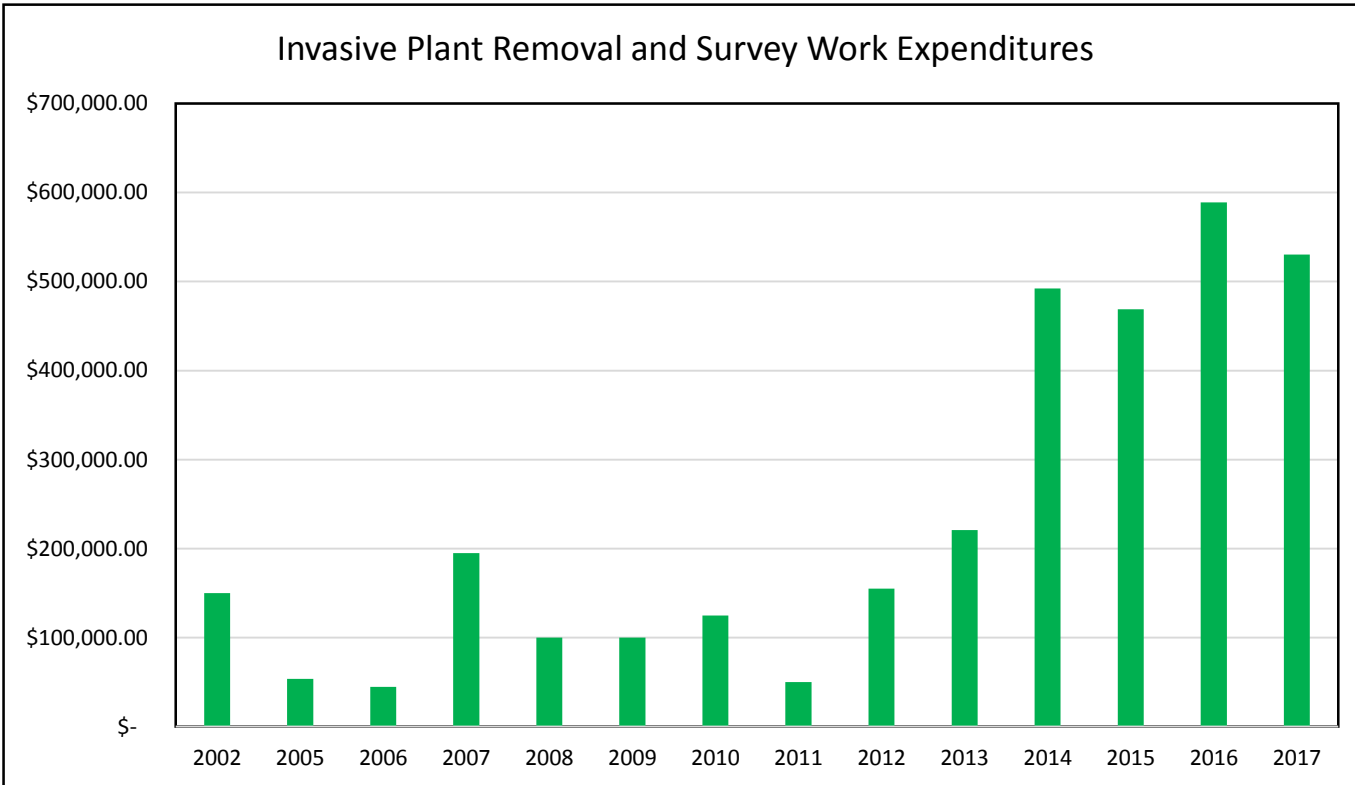
Aquatic Invasive Removal And Plant Survey Spending Since 2002

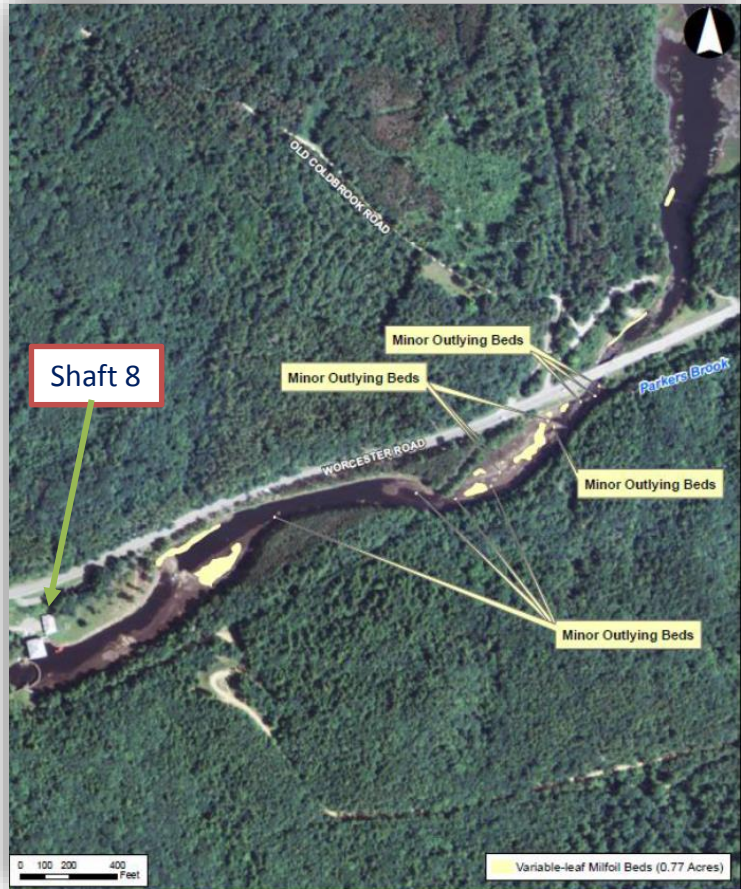
Ware River Shaft 8 Intake Pool

Intake Pool at drawdown with exposed milfoil

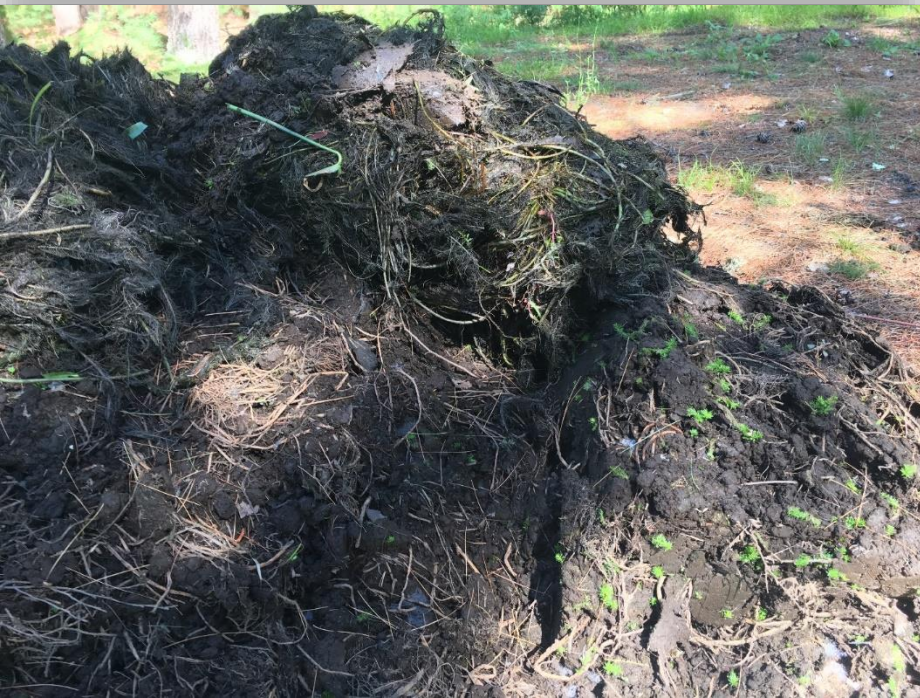
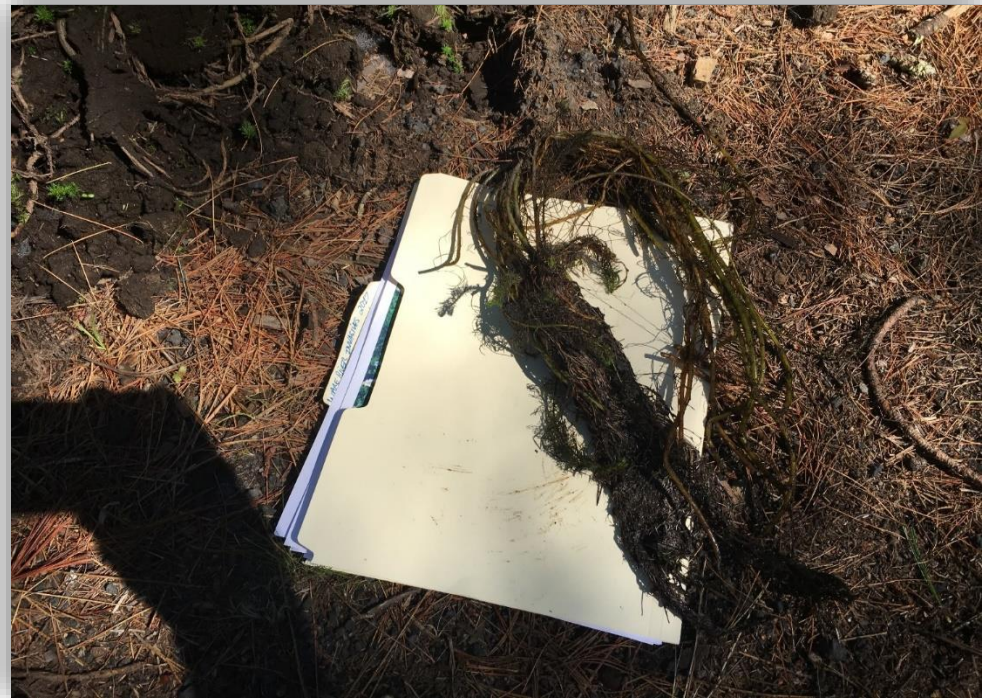
Ware River Variable Leaf Milfoil harvest

In 2016 harvest totaled 4,170 gallons of Variable Leaf Milfoil
In 2017 harvest totaled 2,940 gallons of Variable Leaf Milfoil representing ~30% reduction

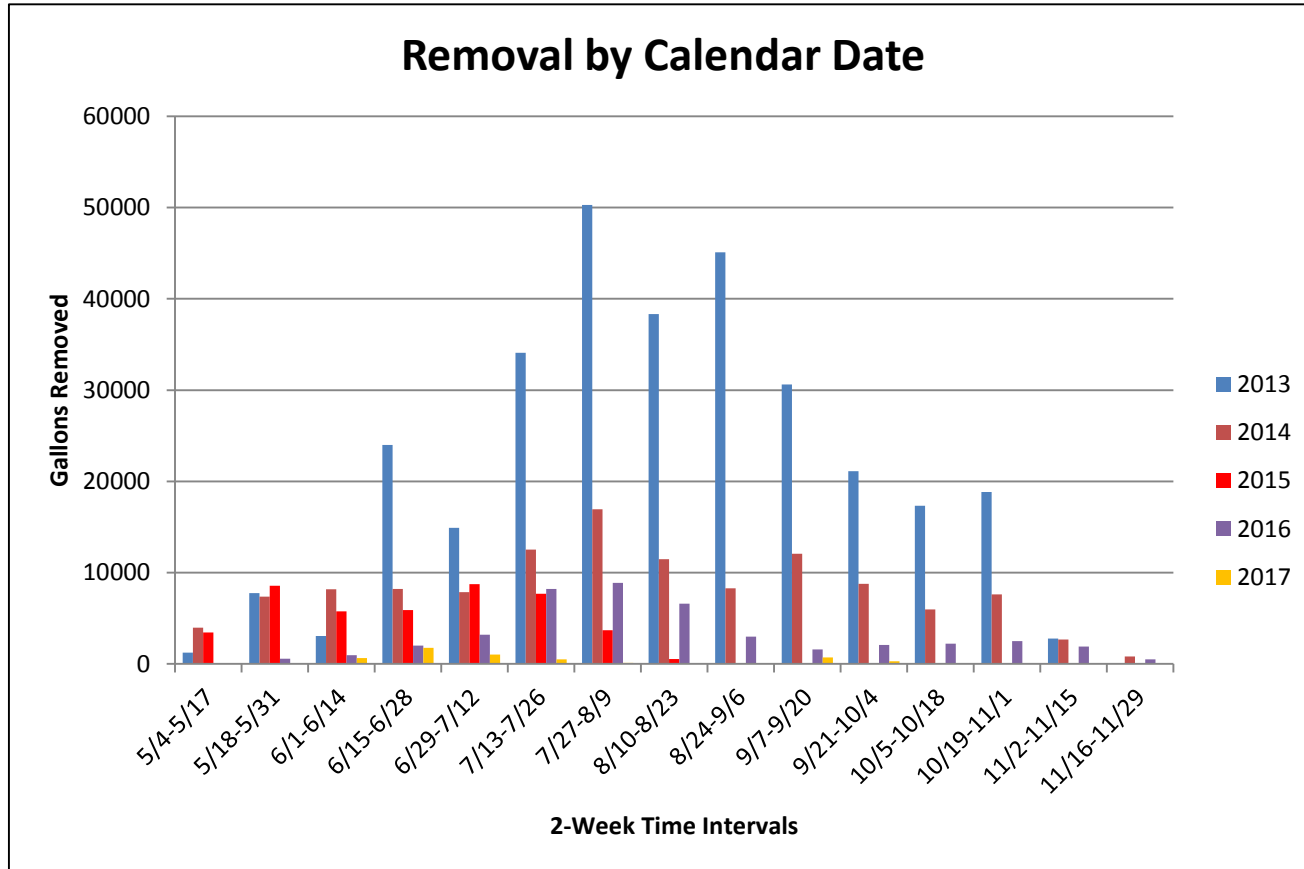
Stillwater Basin DASH: Overall 5-Year Comparison

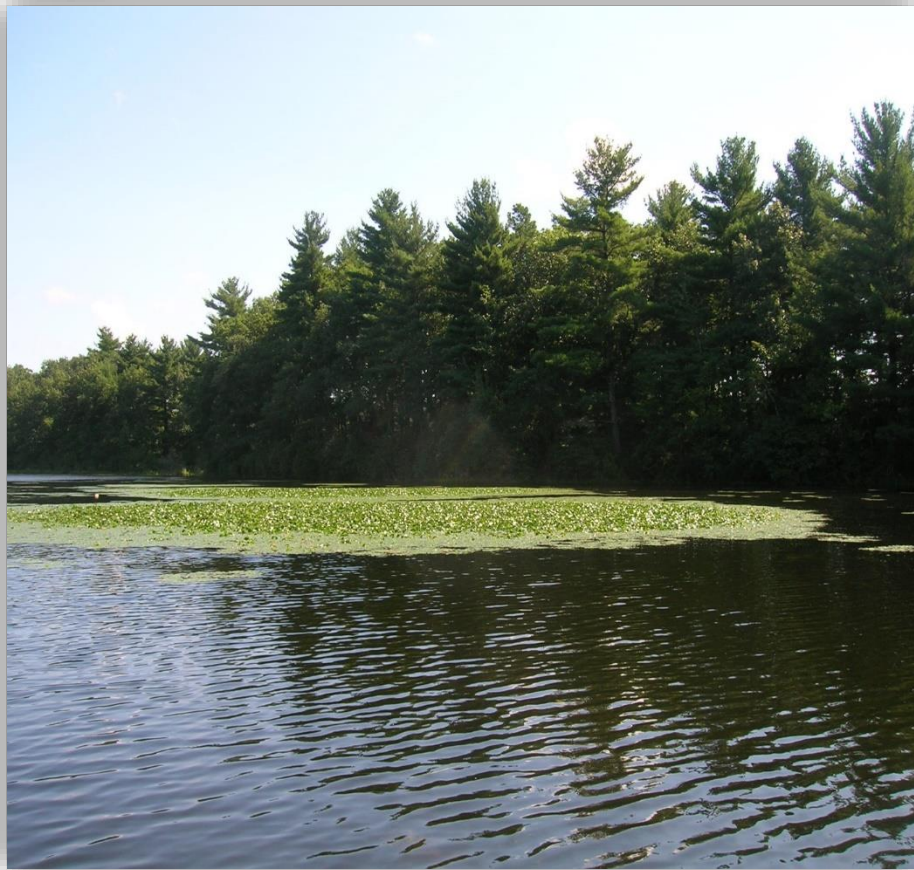
Sudbury Water Chestnut: 2008 To Present

In 2008 dense mats and mature plants with many nuts

2017 – scattered small immature plants

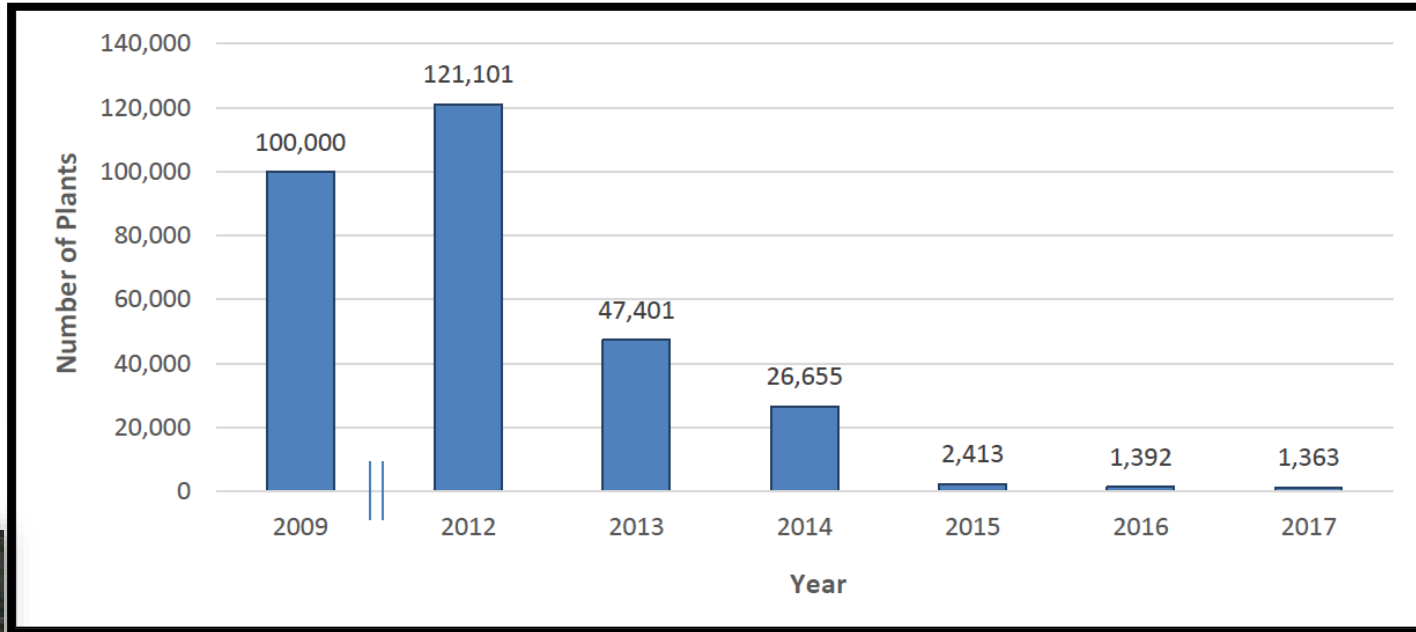
Sudbury Water Chestnut Control History

2011 heavy infestation

Transition from mechanical harvesting to hand harvesting as extent of water chestnut decreases

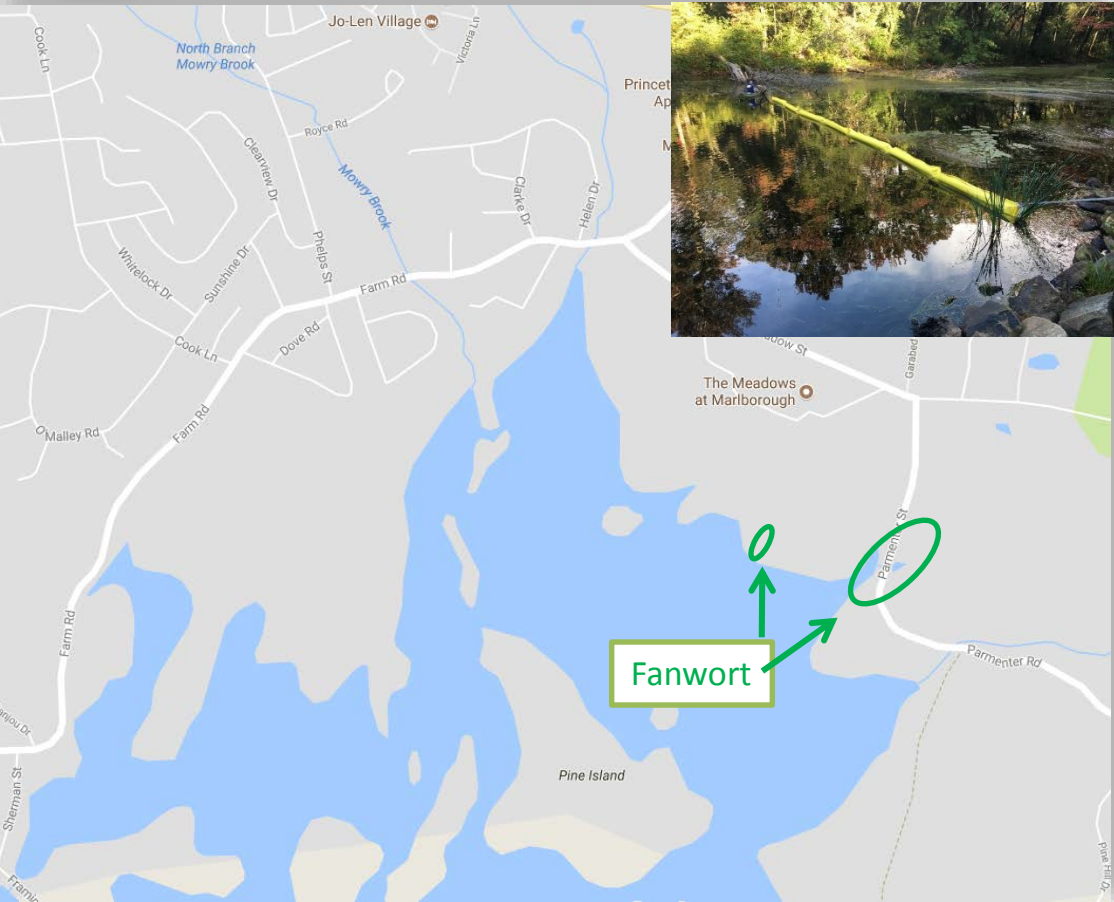
2017 - New 0.5-Acre Fanwort Infestation Discovered At Sudbury Reservoir

½ acre dense infestation discovered early August 2017

Removed ~6,600 gallons of plants by late August

Installed fragment barrier to contain

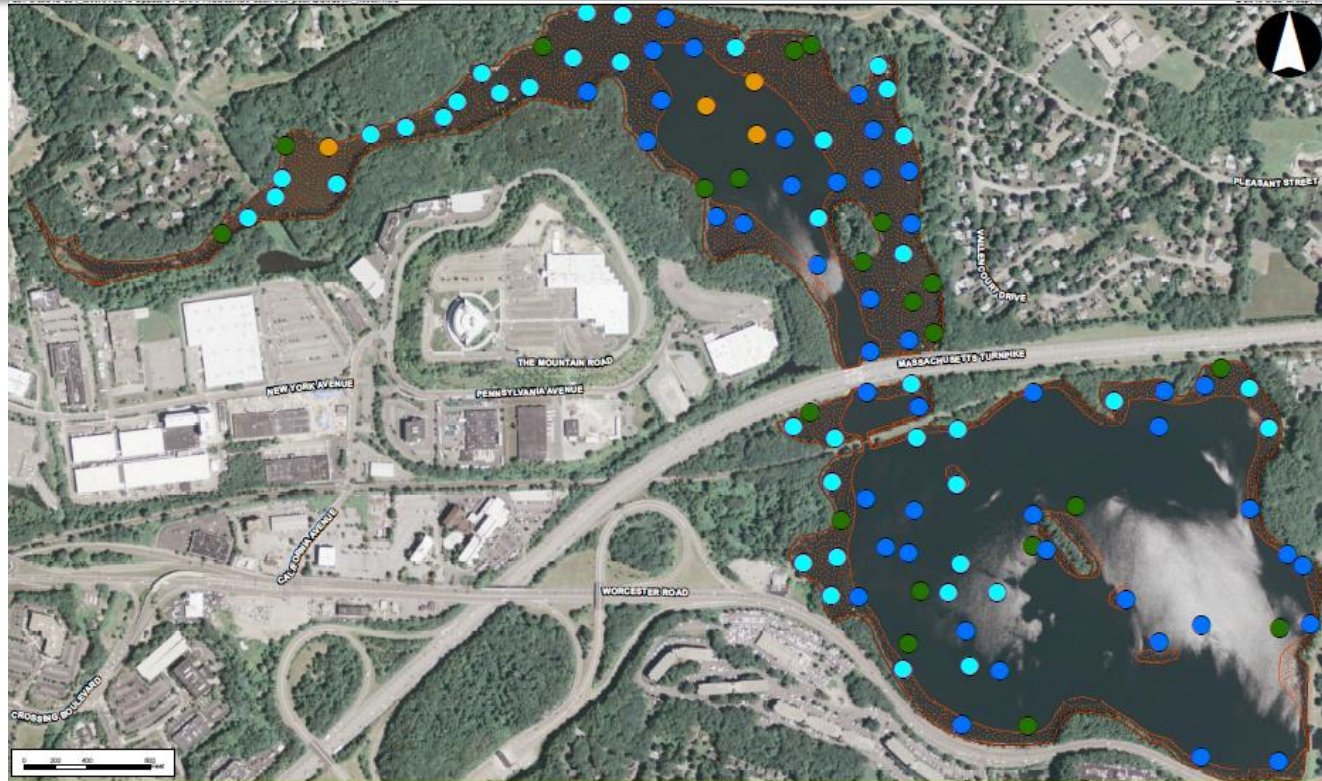
Figure 1

Foss Reservoir 2015/2016 Winter Drawdown Was Effective

Blue tones represent areas where some control of milfoil was achieved. Most of the points are **Blue**.

Green represents no measurable effect in milfoil growth.

Orange represents areas of new milfoil growth (confined mainly to deeper areas of north basin).

- Full Control - 45 points
- Reduced Density - 40 points
- No Change (Milfoil Present) - 21 points
- New Growth - 4 points

Exposed Sediments with 10 foot drawdown (87.1 acres)*
* Anticipated stream flow within the upper basin not shown.

Post-Drawdown
Observed Change in
Variable-leaf Milfoil Growth
(2016)

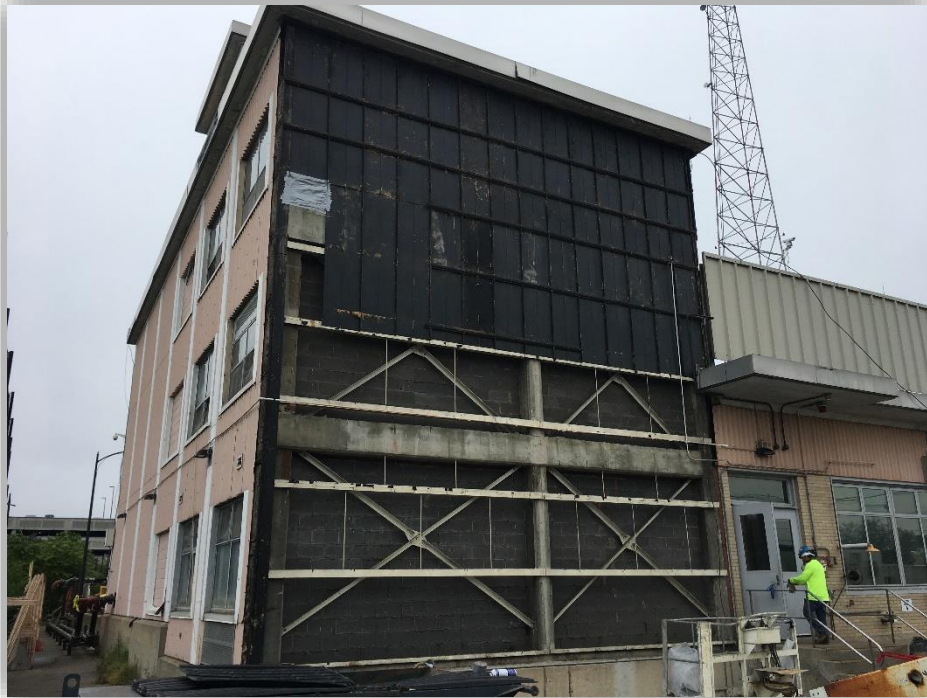
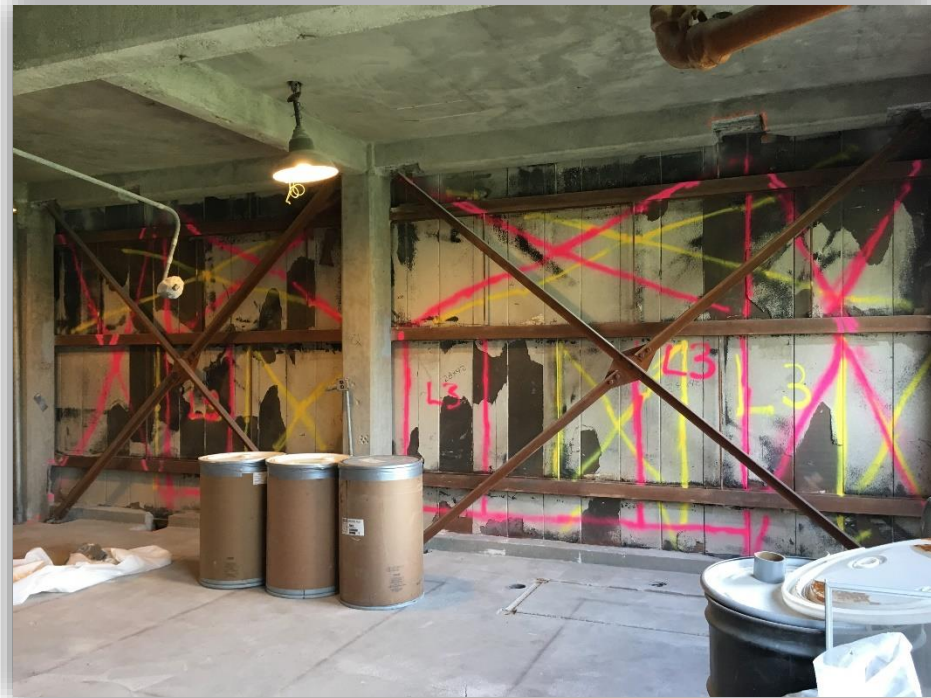
Chelsea Headworks Upgrade: Girt Framing Modifications

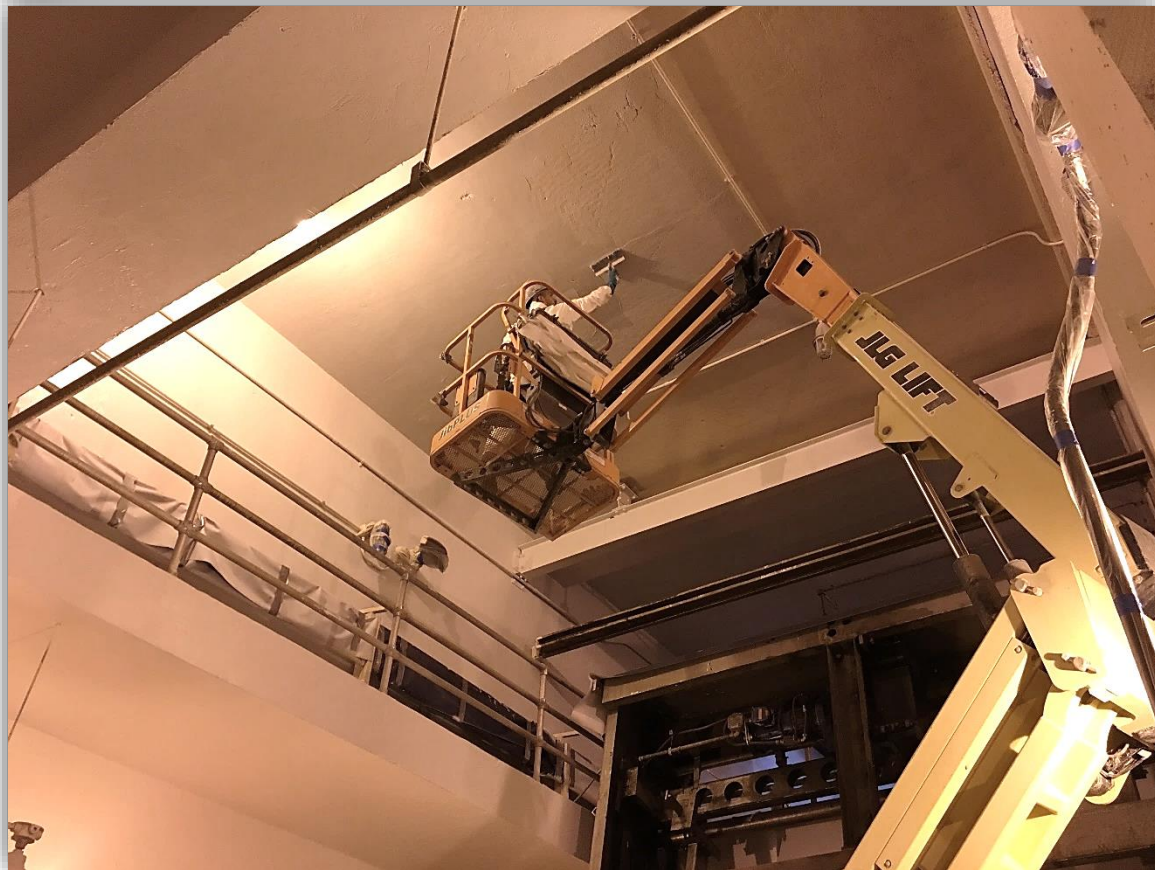
Chelsea Creek Headworks: PCB Encapsulation

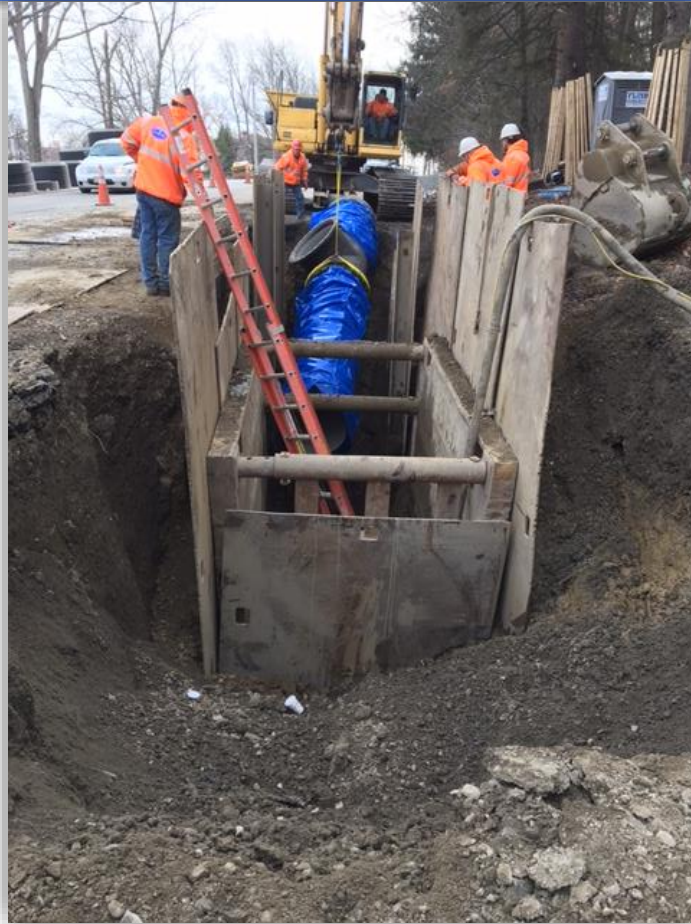
Installing Pipe And Tee On West Roxbury Parkway

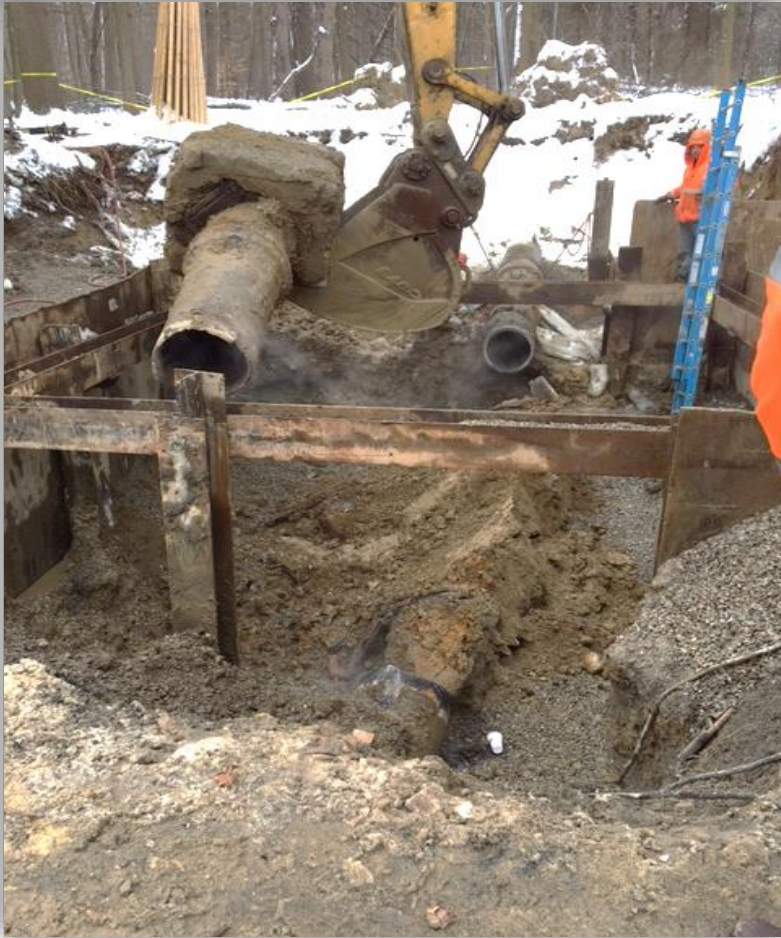
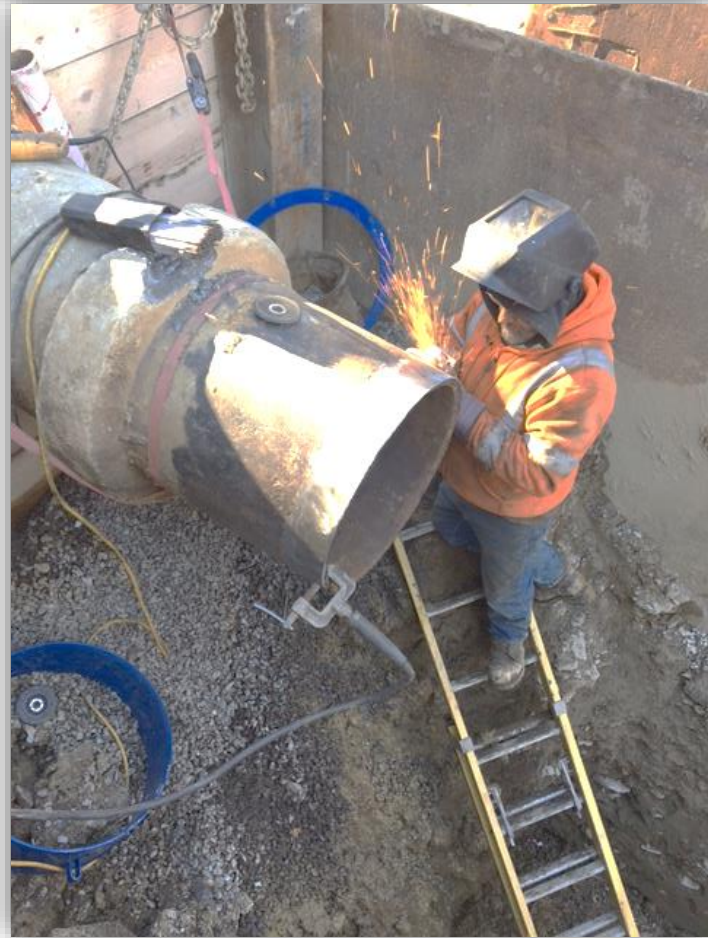
Connection to Section 74

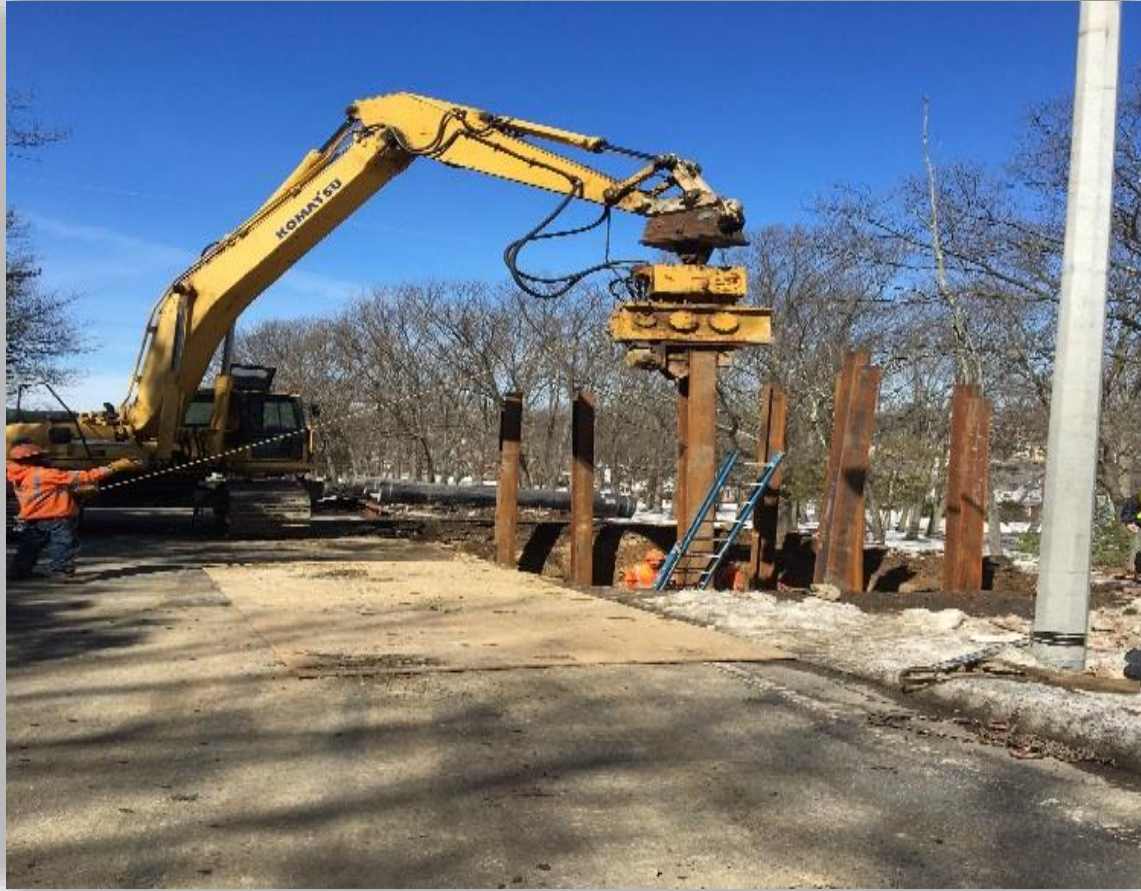
Installing Excavation Support At Section 77 Tapping Location

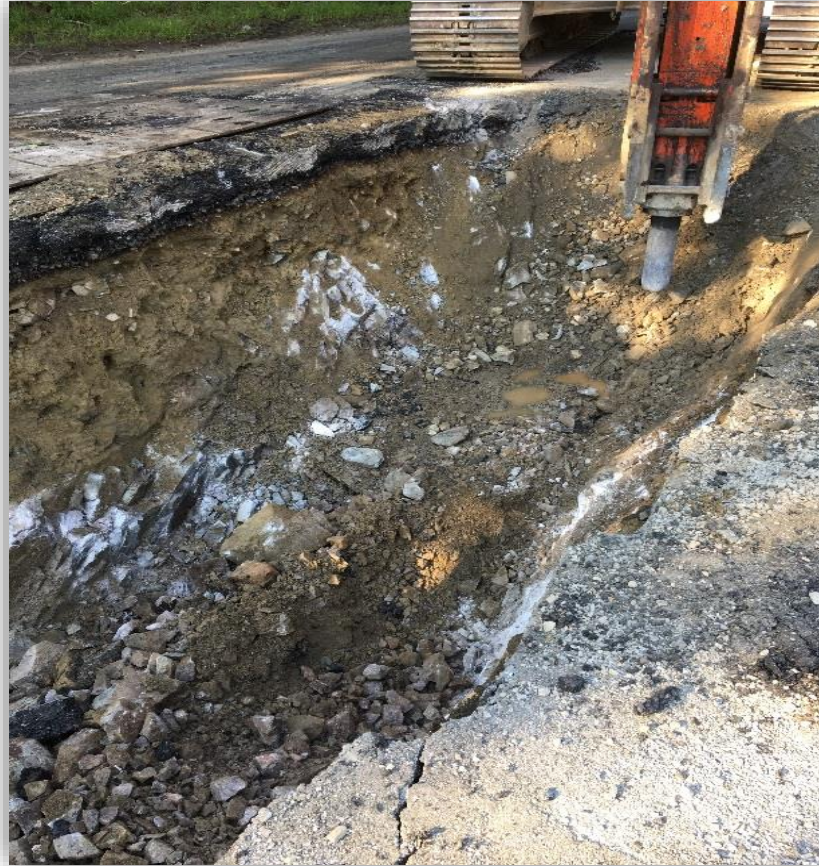
Hydraulic Ramming On Enneking Parkway

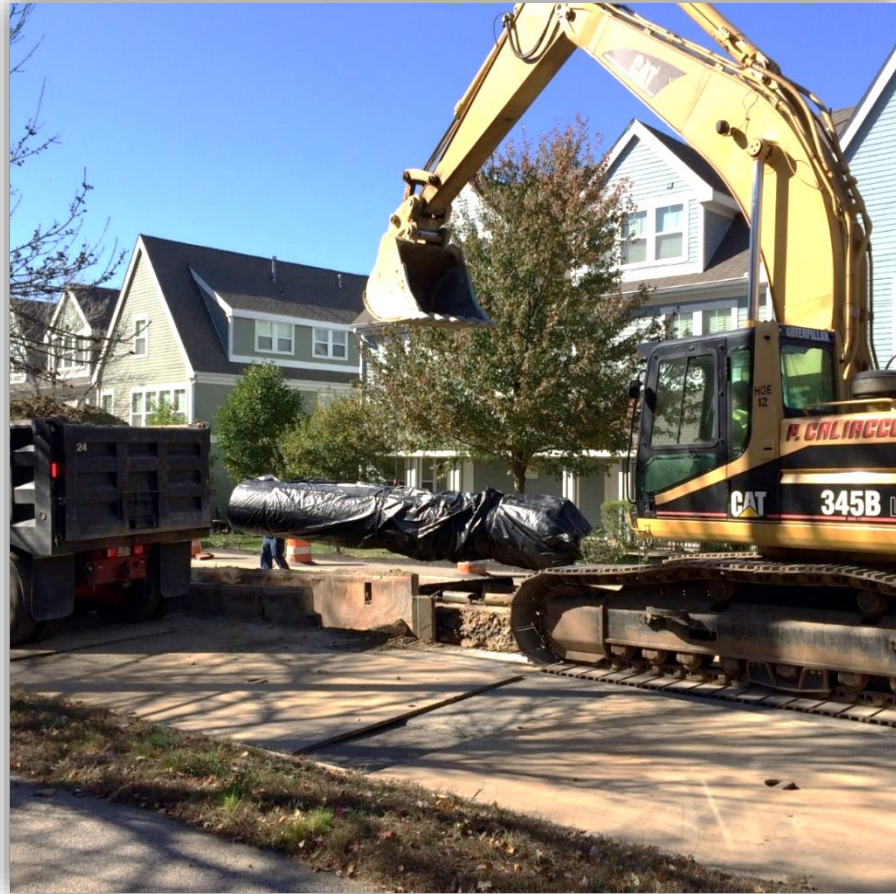
Installation Of 36-Inch Water Main On West Street, Reading

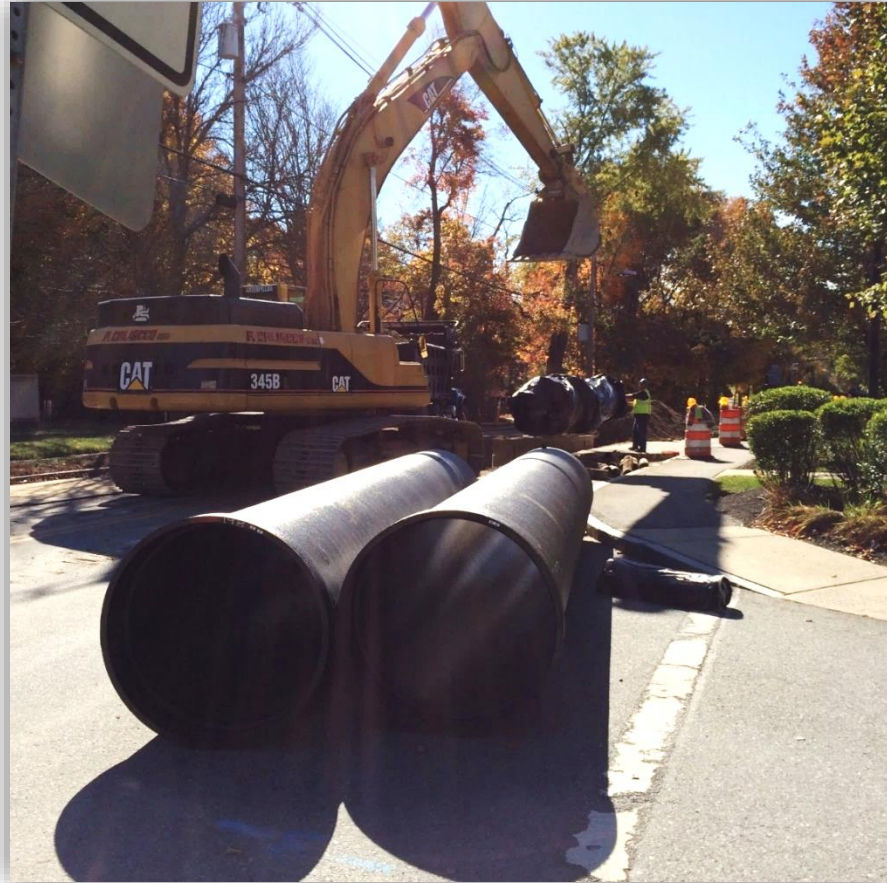
Installation Of 36-Inch Water Main On West Street, Reading

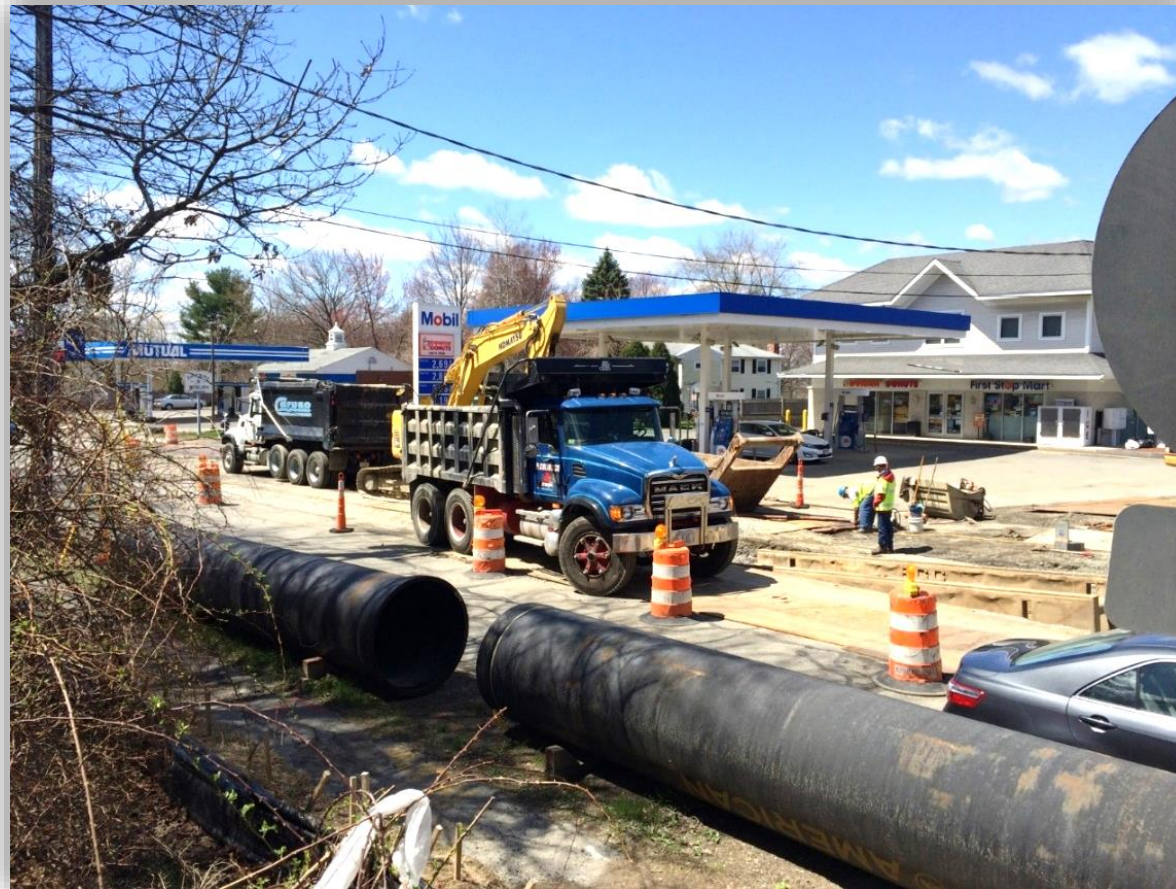
Excavation To Install 36-Inch Water Main On West Street, Reading
