***MWRA's Outfall Monitoring Overview
2016 Results***

***Update on Invasive Aquatic Plant Management
at MWRA Reservoirs***

***CSO Post-Construction Monitoring and
Performance Assessment
Contract 7572***

***Southern Extra High and Northern Intermediate
High Pipeline Redundancy Projects***

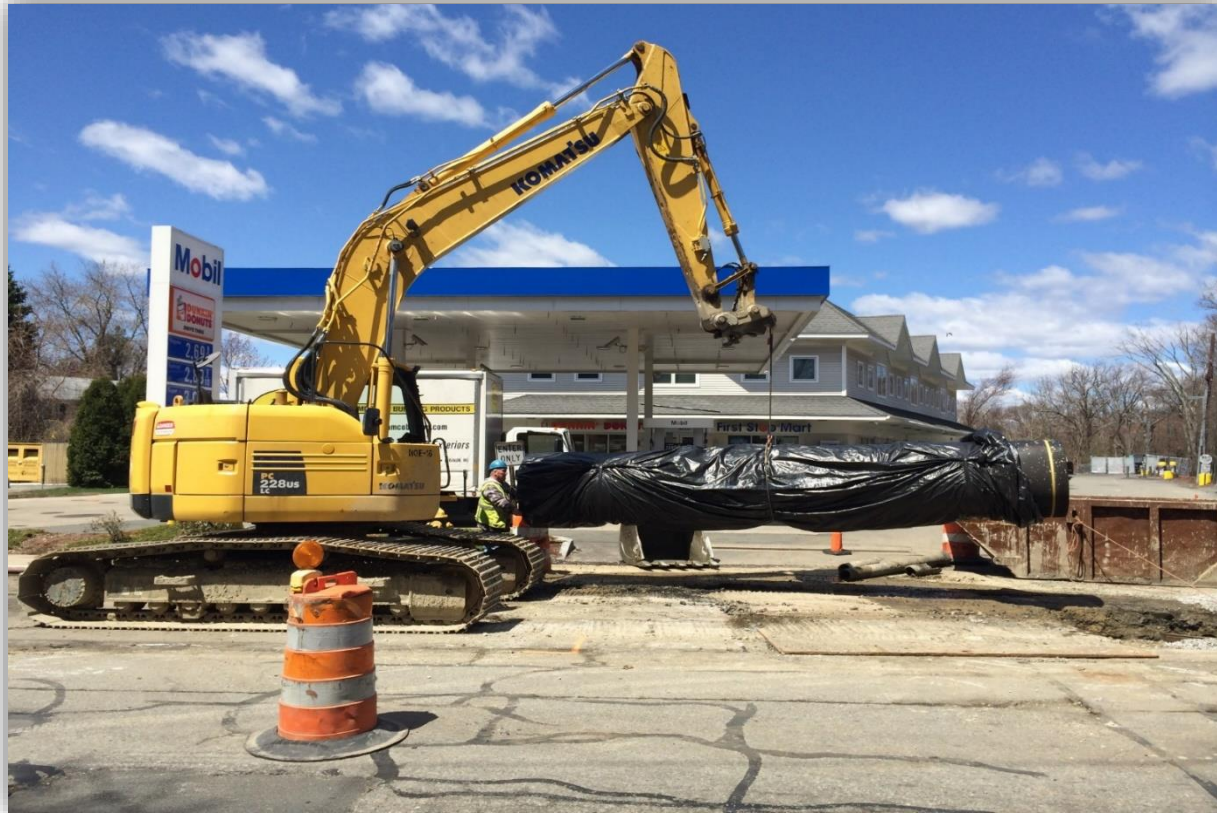
Installing 36-Inch Water Main, West Street, Reading

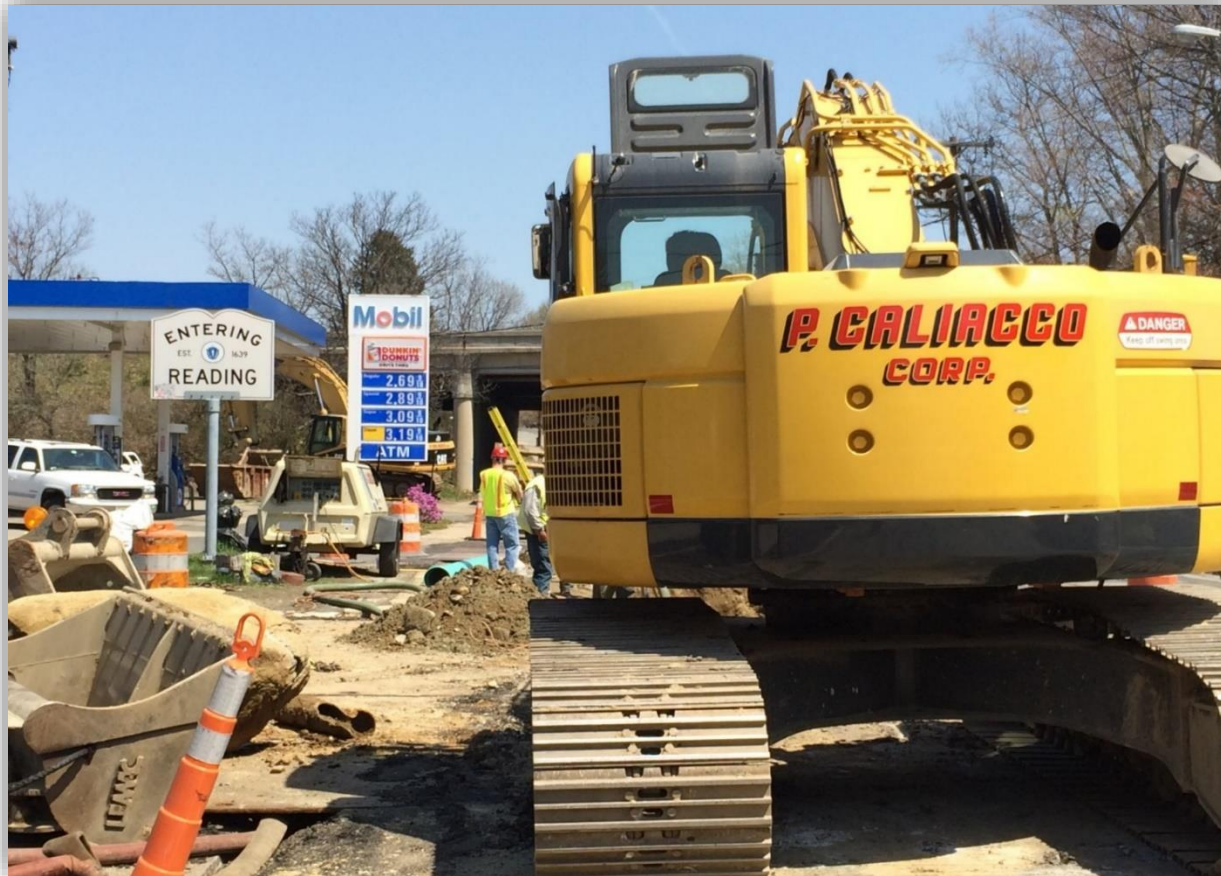
Installing 36-Inch Water Main, Town Line

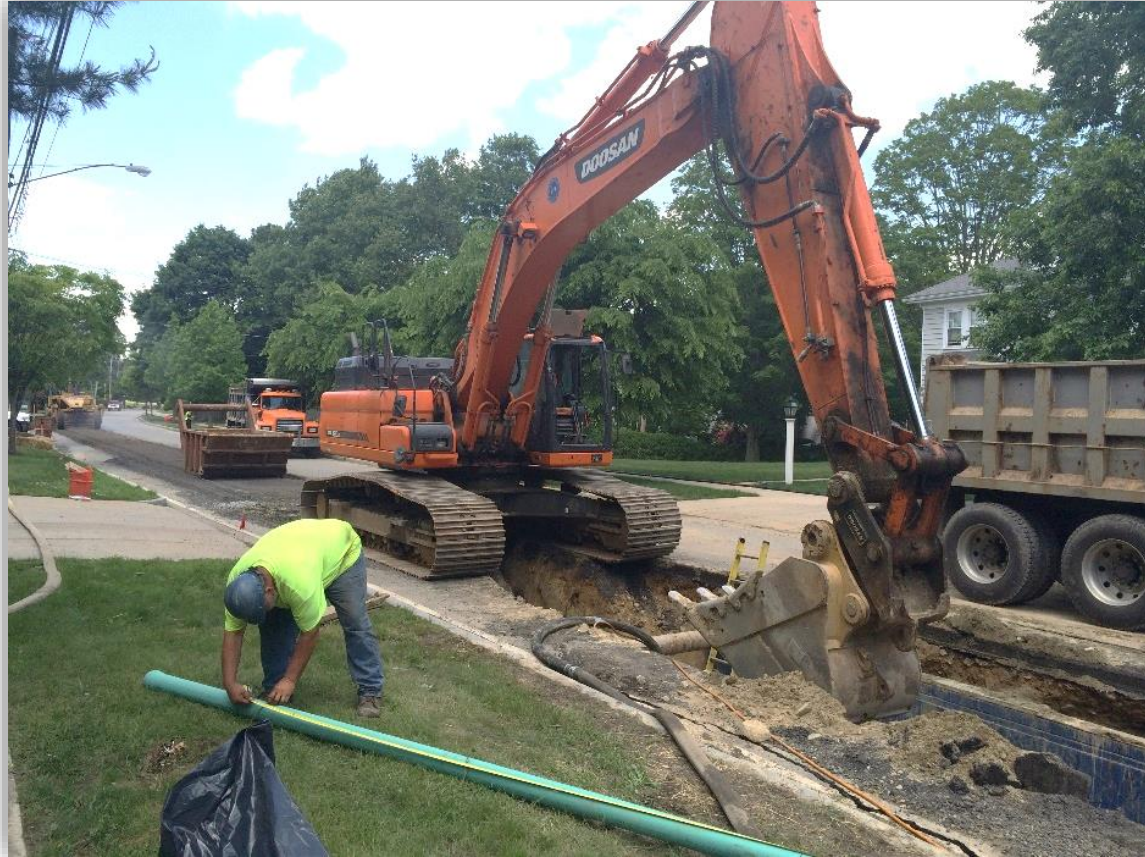
Excavation To Install 36-inch Water Main On Summer Street

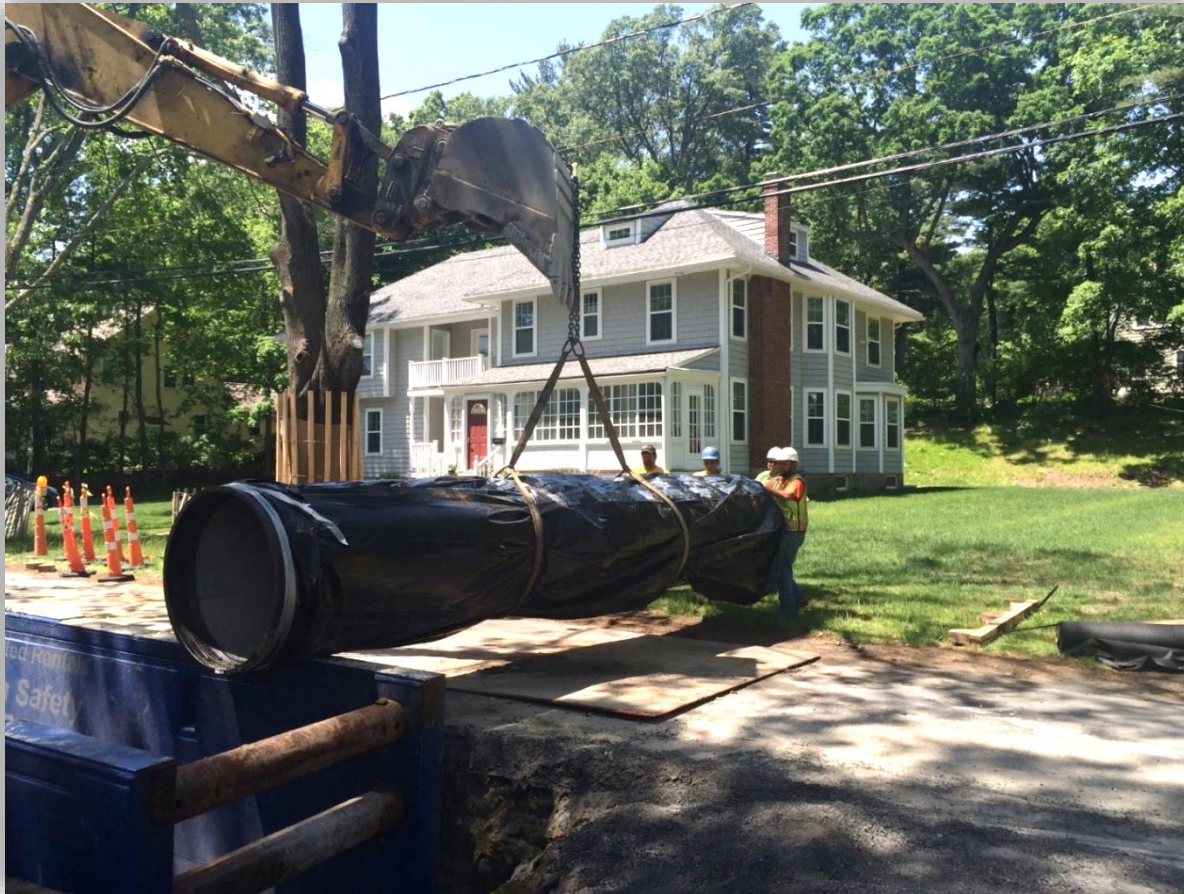
Installation Of 36-Inch Water Main On Oak Street, Reading

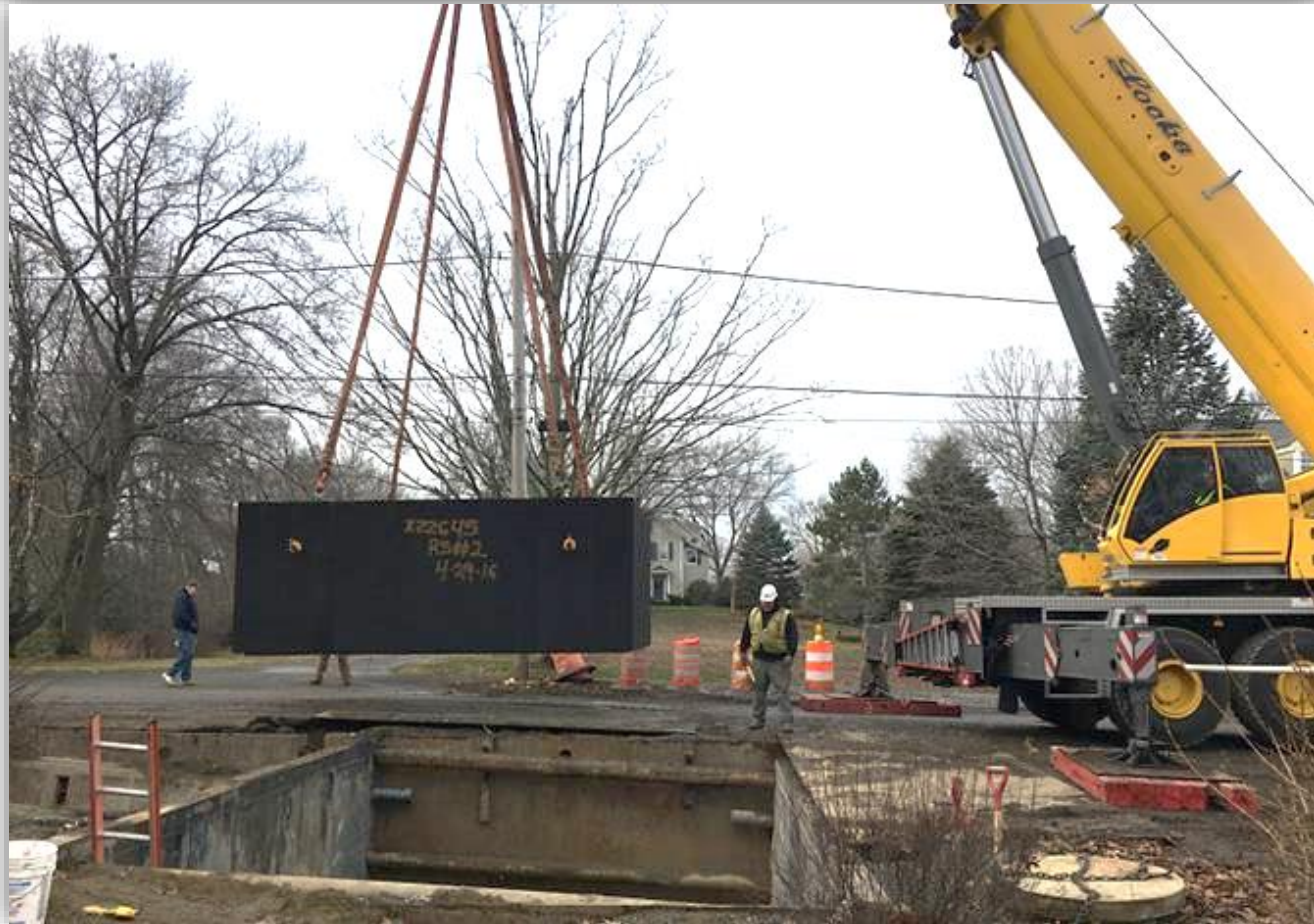
Installation Of Large Concrete Valve Vault At Leach Park

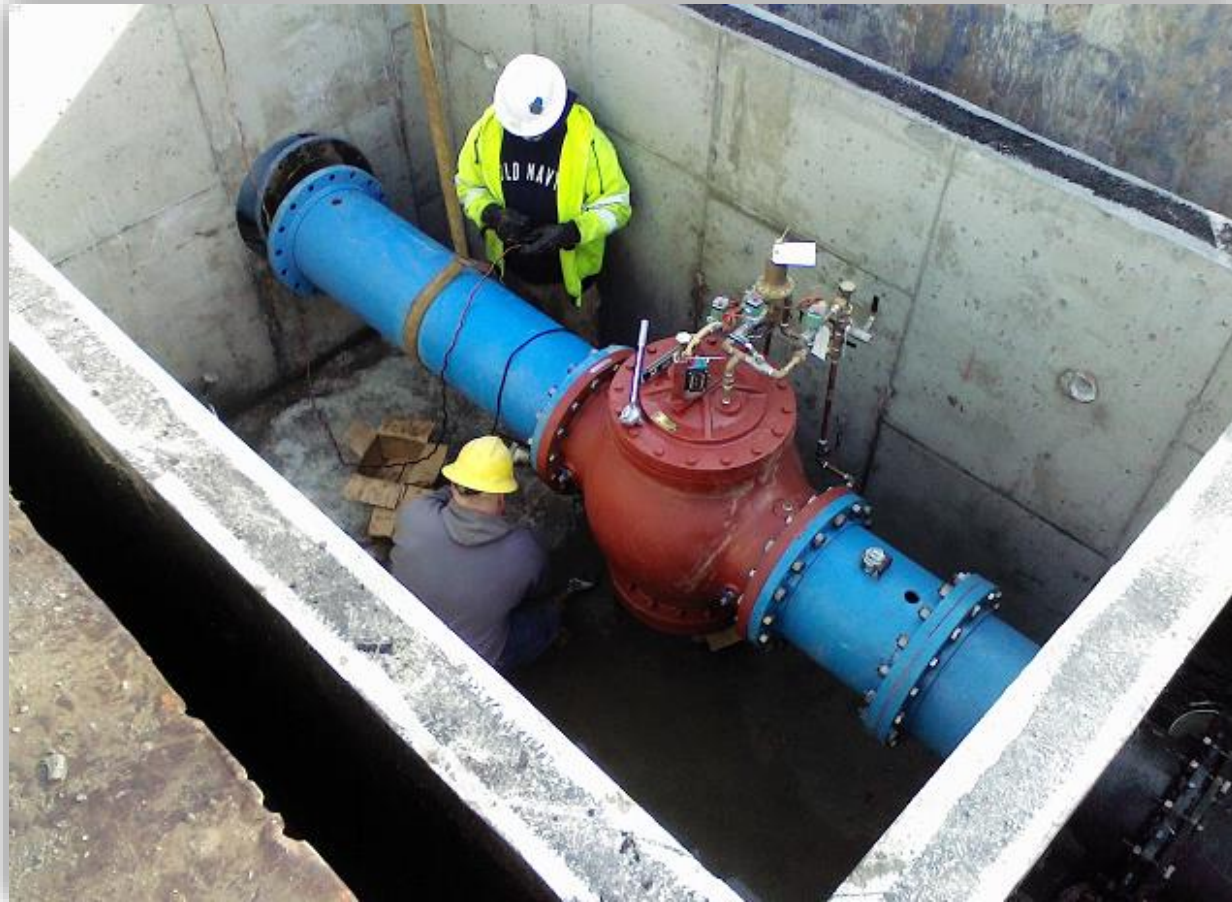
New Town Of Reading Meter Chamber On Louanis Road

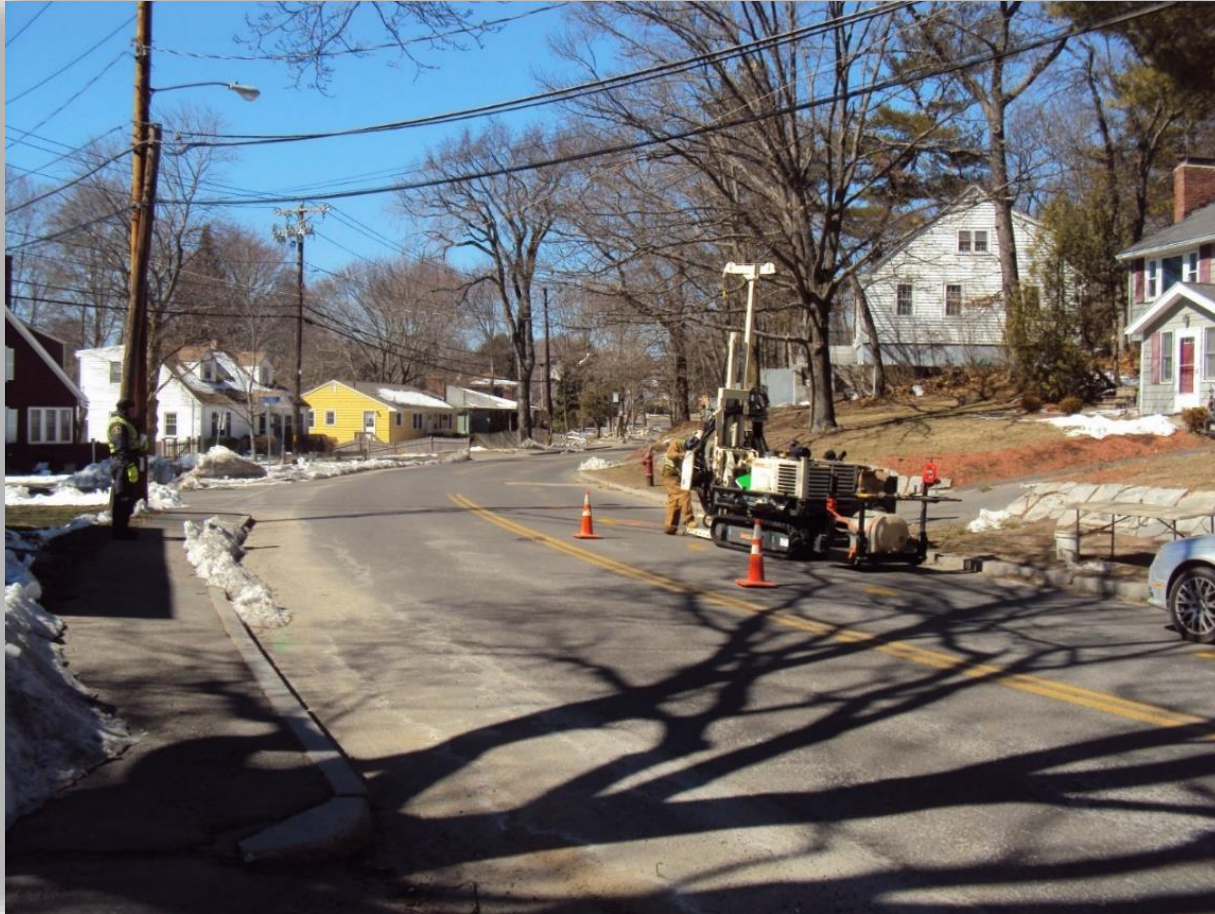
Taking Probes To Precharacterize Soil For Disposal On North Street, Reading

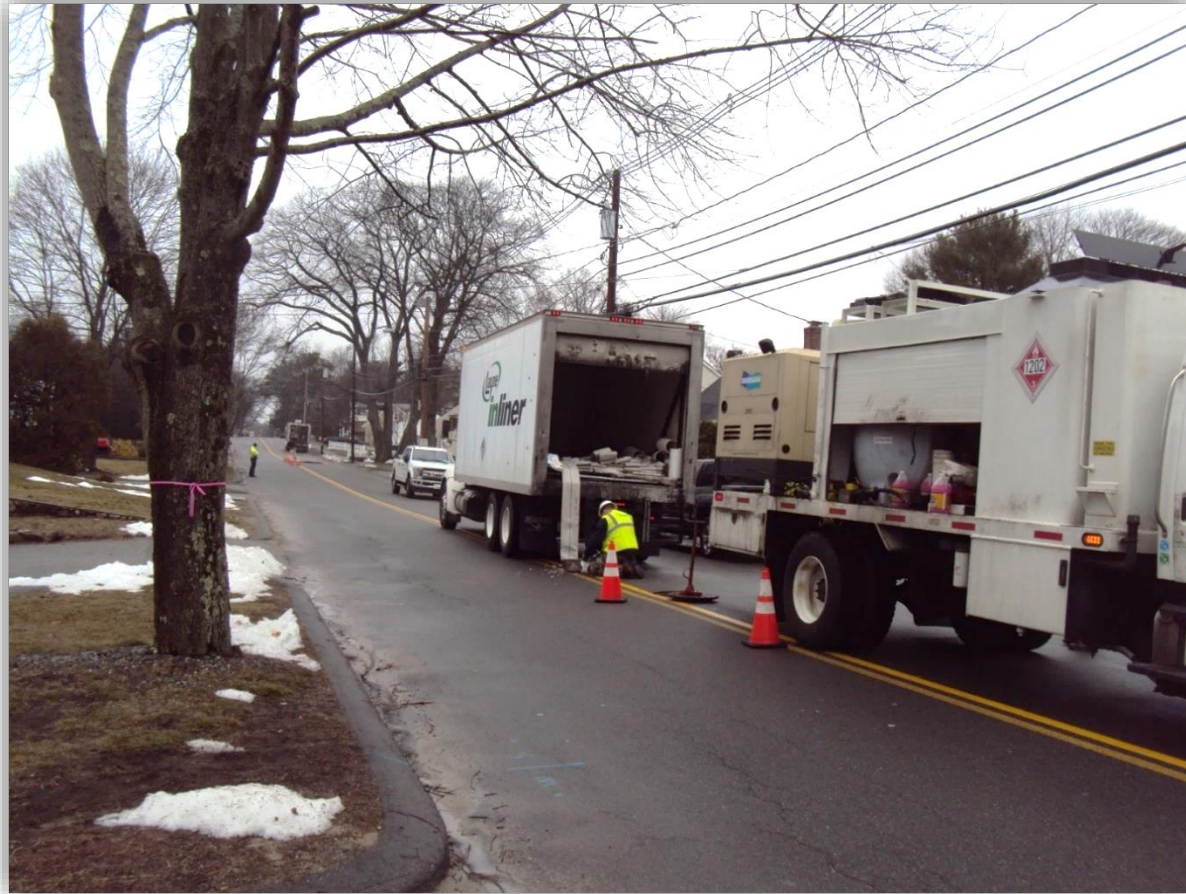
Installation Of Cured In Place Liner In Adjacent Utilities Prior To Construction

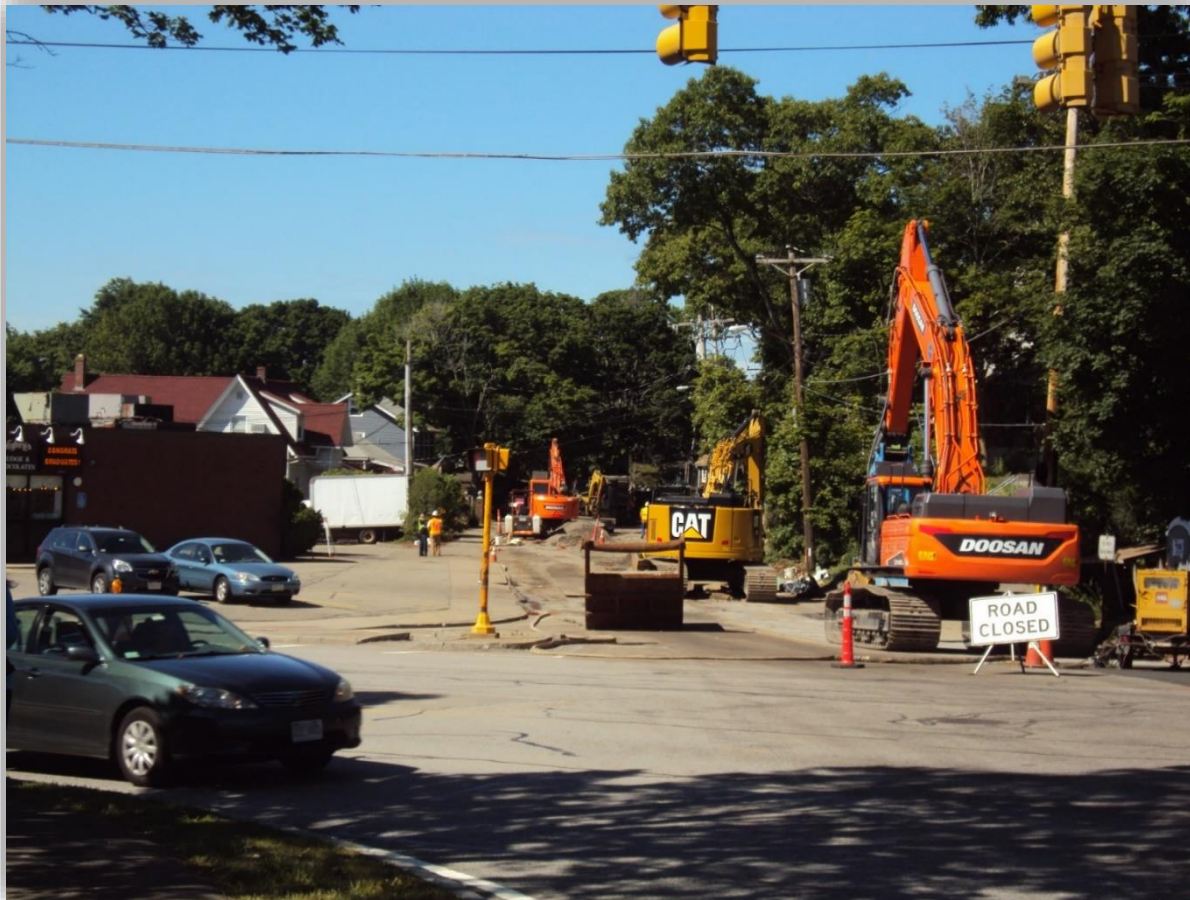
Installation Of 48-Inch Water Main On North Street, Stoneham

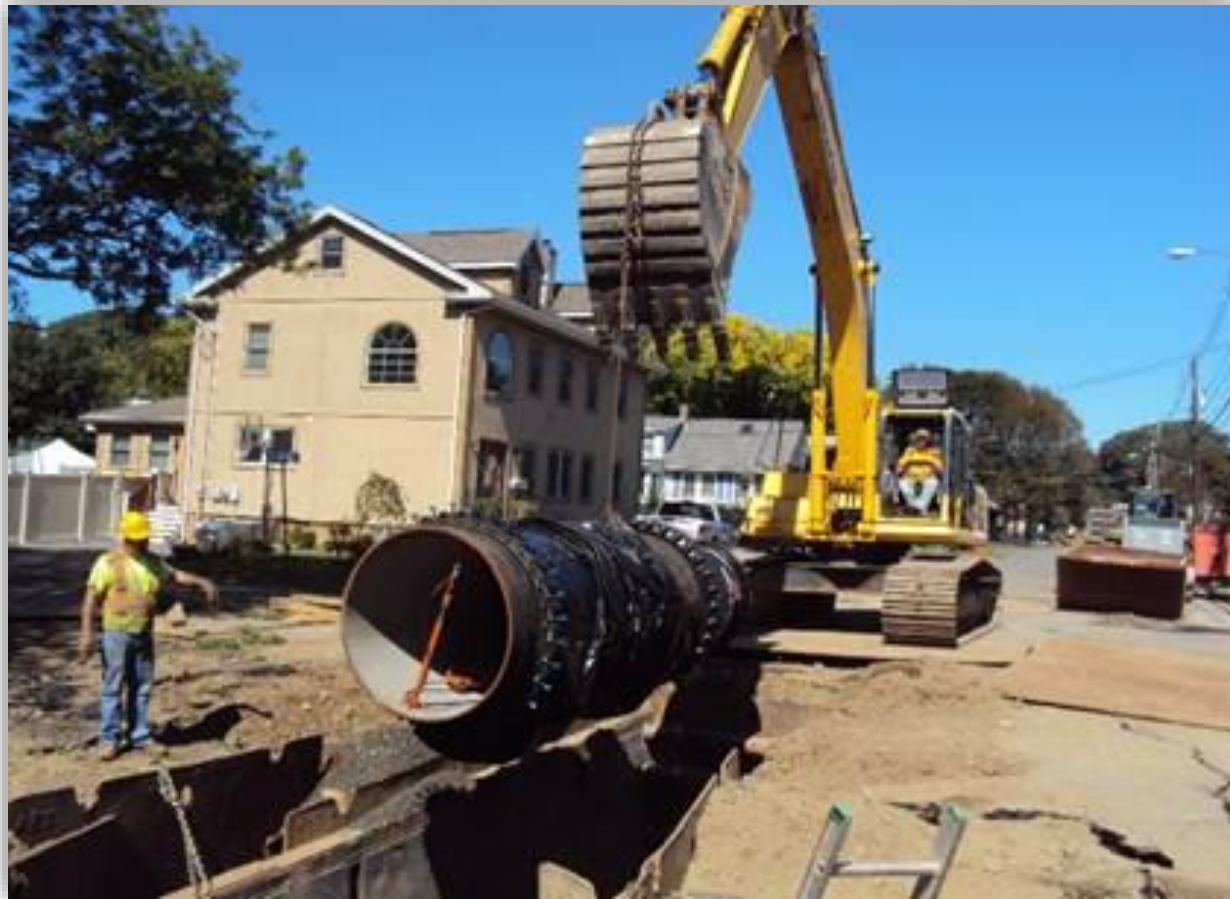
Installation 48" X 36" Reducer On Oak Street

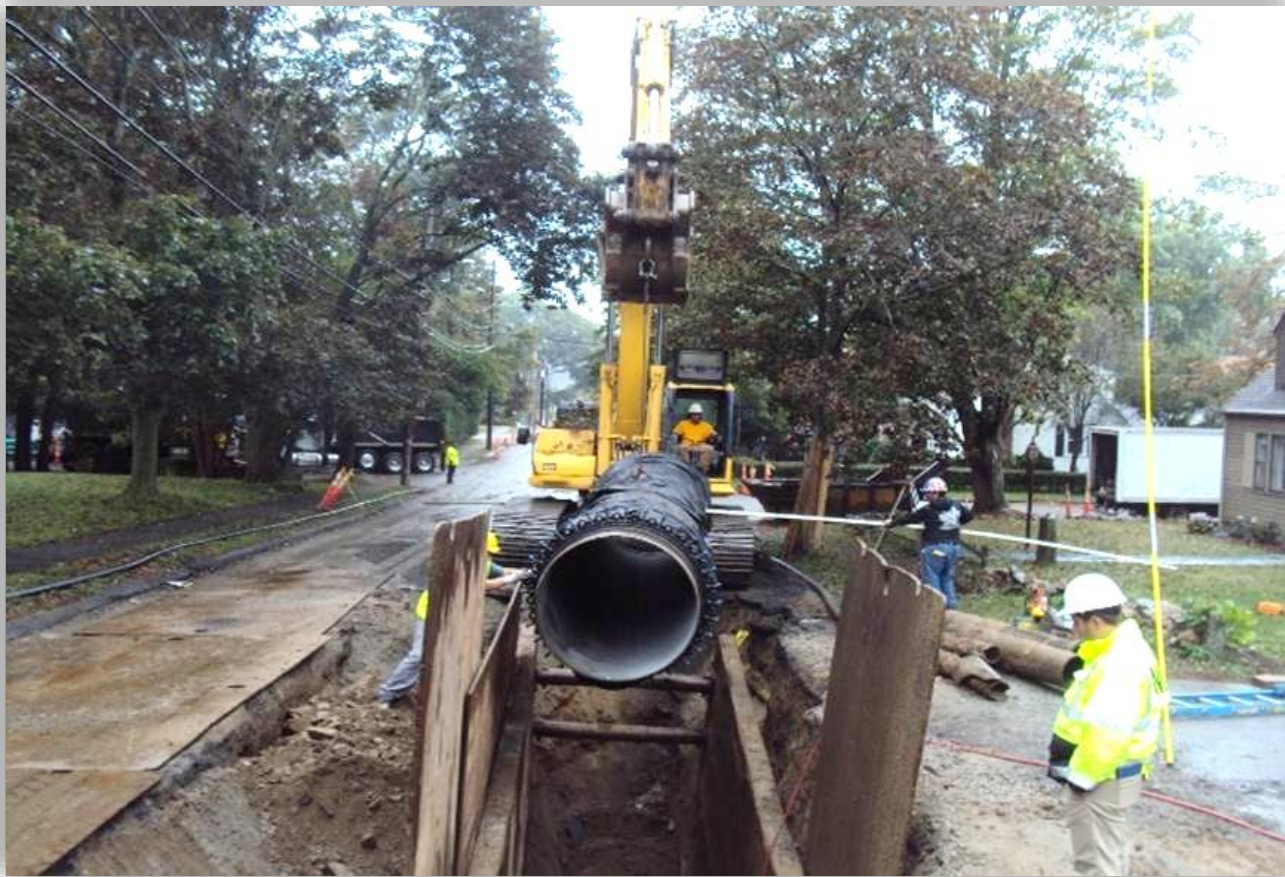
Overseeing Installation Of 48-Inch Pipe On Oak Street

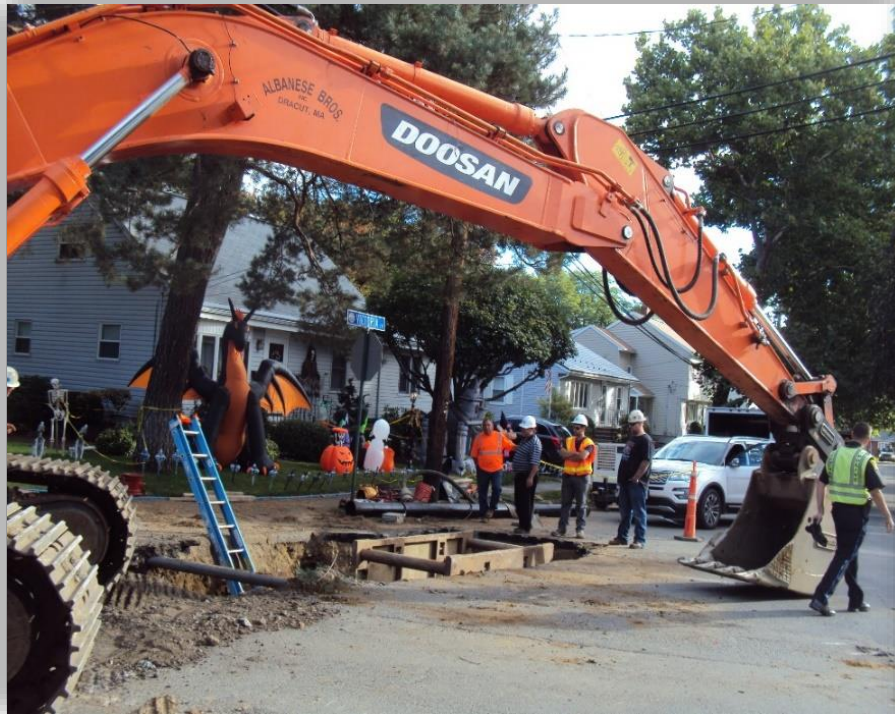
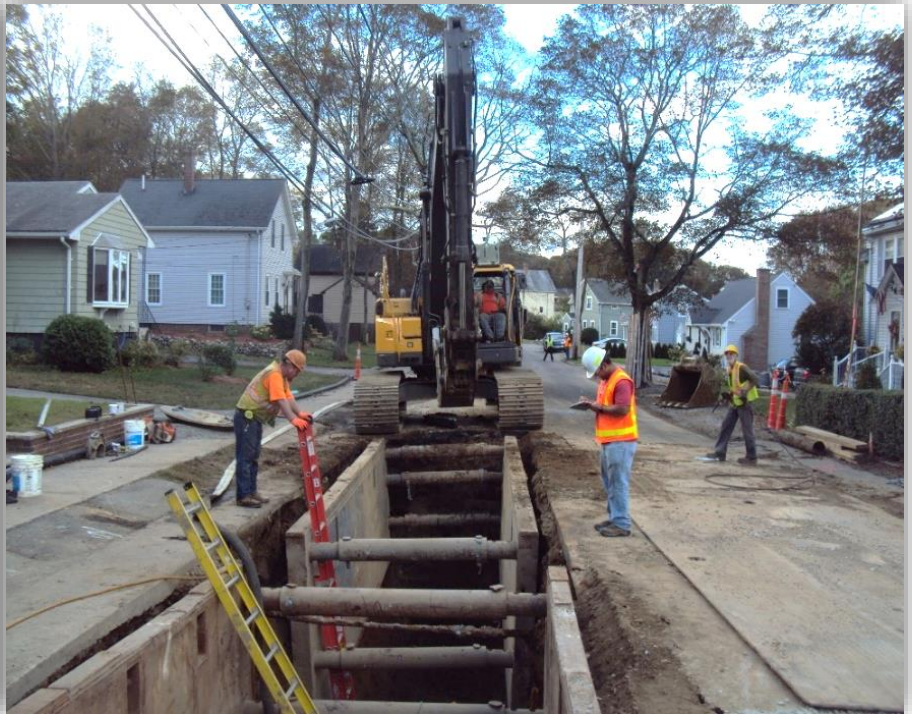
Installation Of 48" Pipe On Oak Street, Stoneham

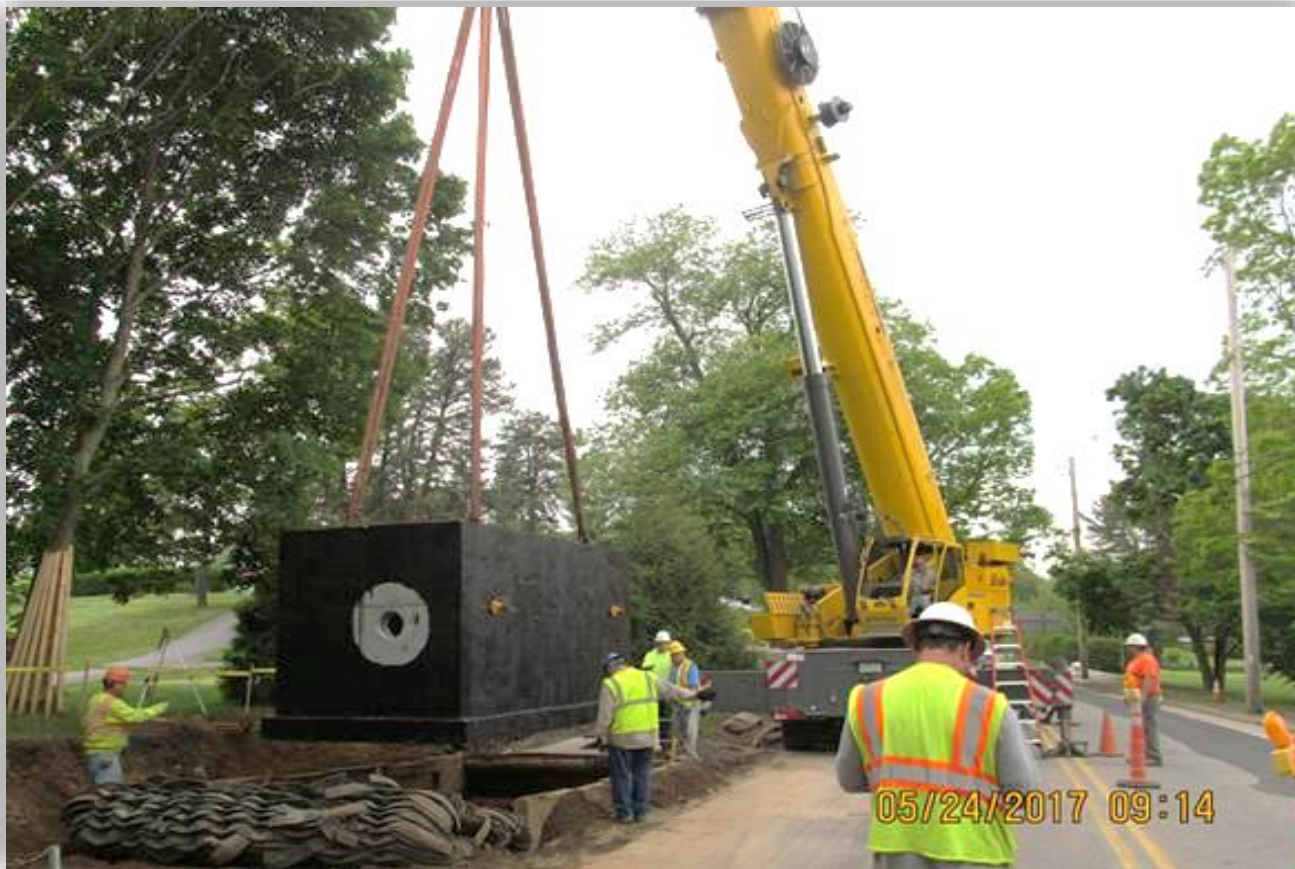
Installation Of MWRA Meter At Wakefield/Stoneham Town Line

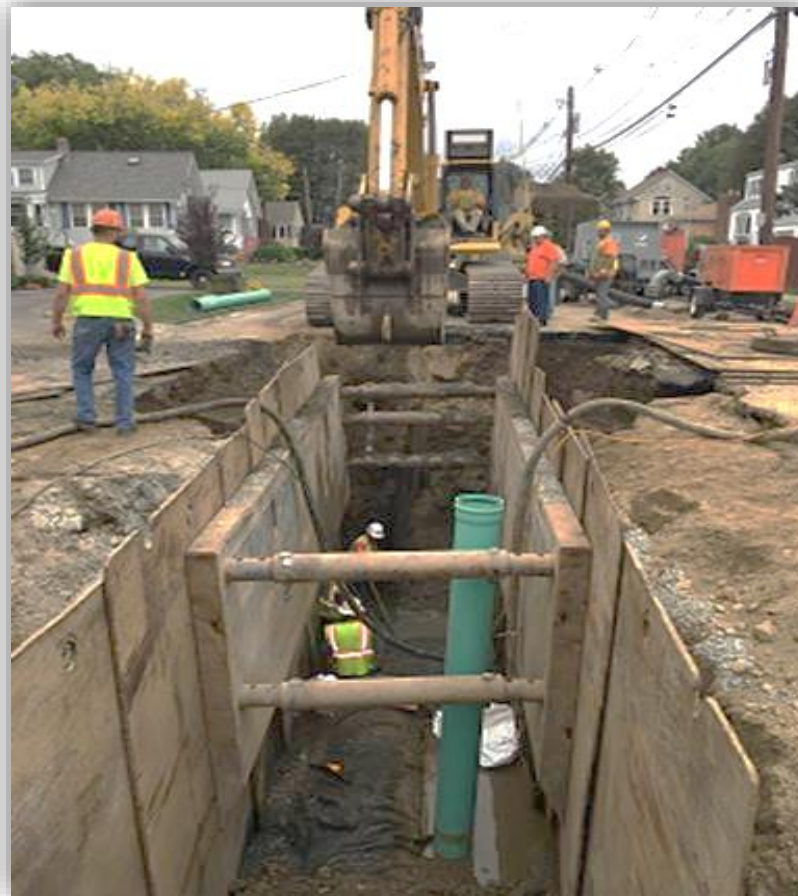
Culvert Crossing On Oak Street, Stoneham

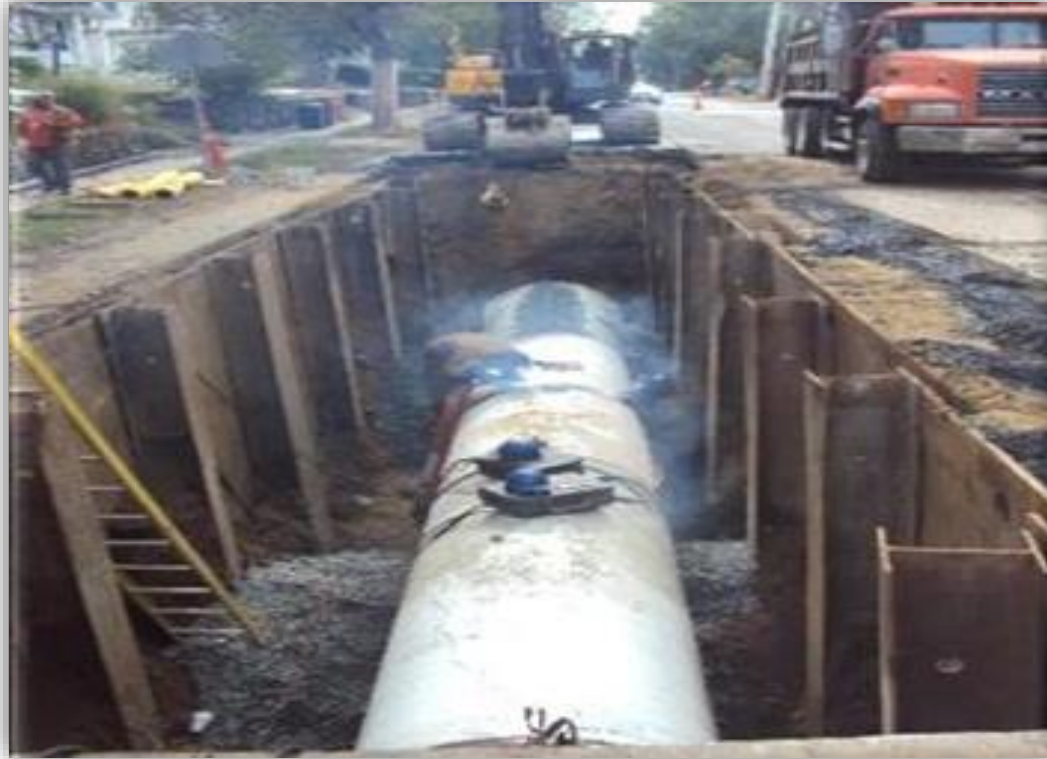
Installation Of 48-inch Steel Water Pipe On Williams Street

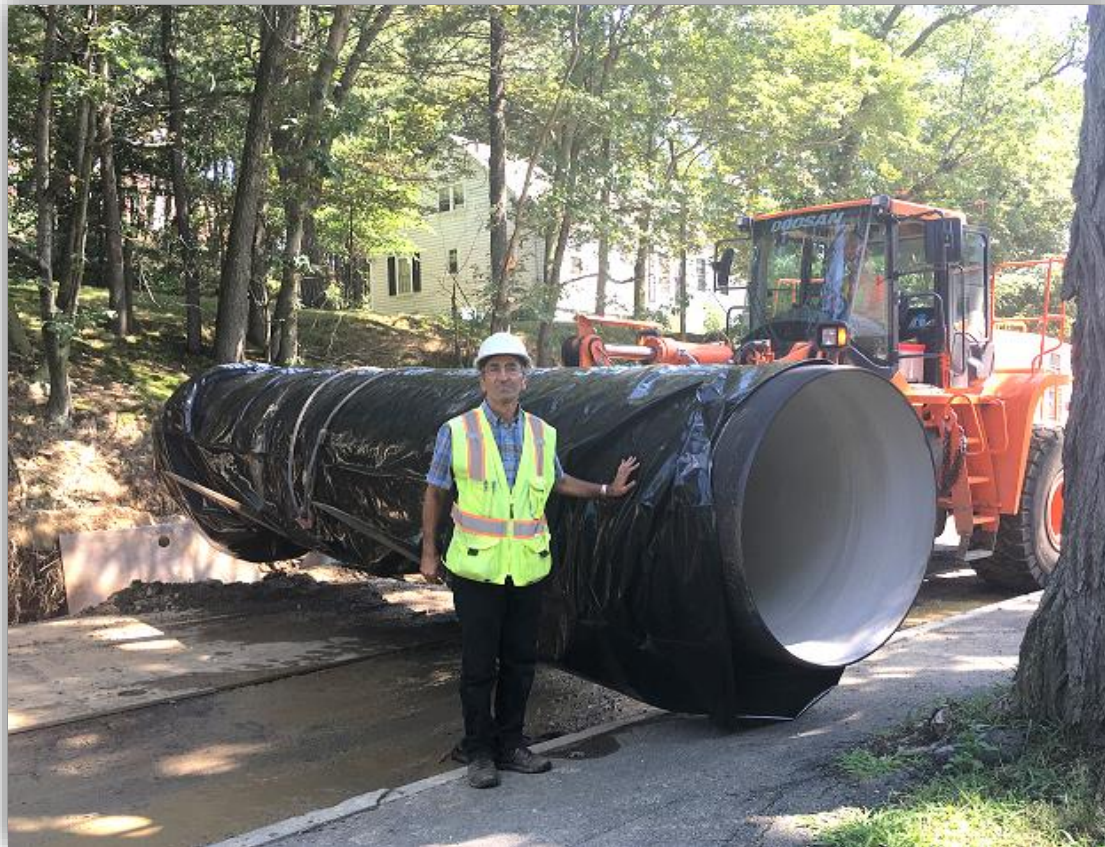
48-Inch Pipe Before Installation
