Presentation to

MWRA Board of Directors

*Deer Island Treatment Plant
Combined Heat and Power System*

*Overview of Water Pipeline Maintenance
Leak Repairs*

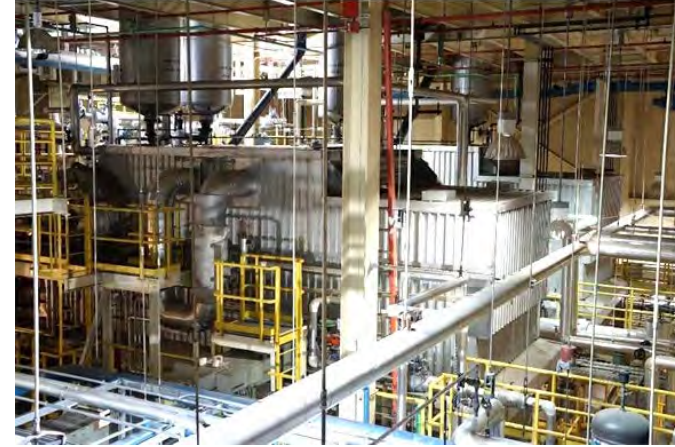
Existing Combined Heat and Power System

- Placed into operation in mid 1990's
- Steam boiler based system
- Heat generated first then electricity

Percent electricity from CHP	CHP Efficiency	Percent energy from onsite sources
Key Metrics	21%	52%	~60%

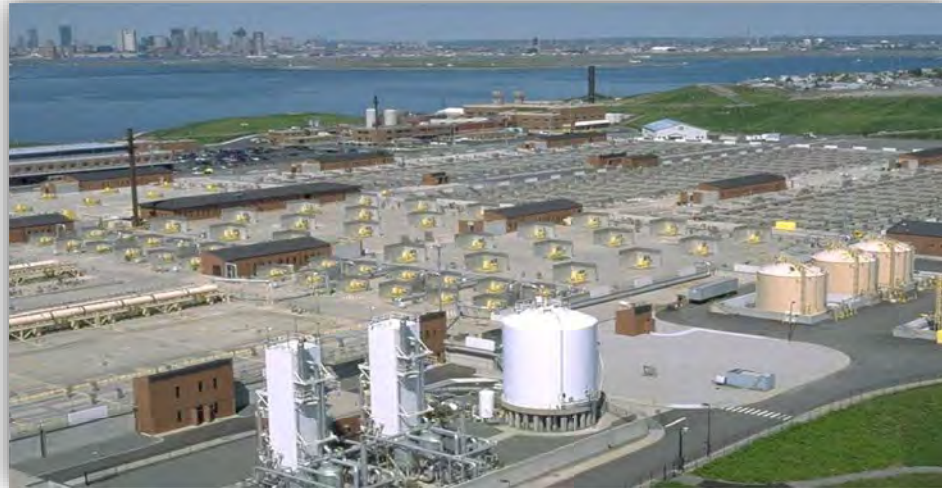
DITP – Cryogenic Oxygen Generation Facility

- Provides oxygen to microorganisms in secondary treatment (97% Purity)
- Critical to core mission of NPDES permit compliance
- Specialized knowledge required for maintenance
- Hundreds of instruments requiring calibration for efficient operation

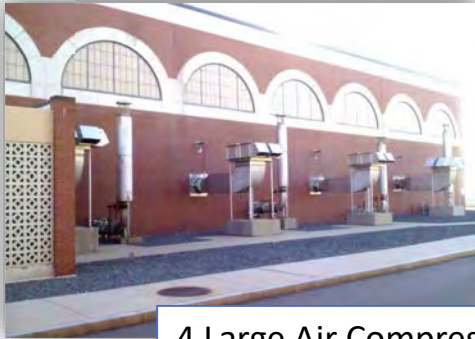
4 Large Air Compressors (2 @ 2,000hp, 2 @ 2500 hp)

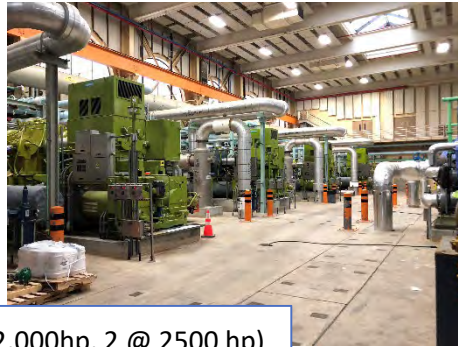
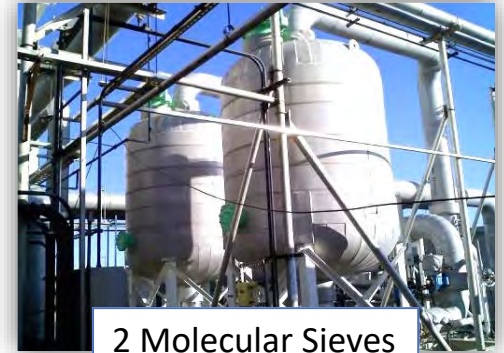
2 Molecular Sieves

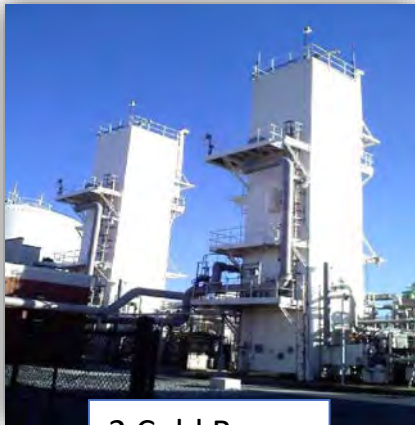
2 Cold Boxes

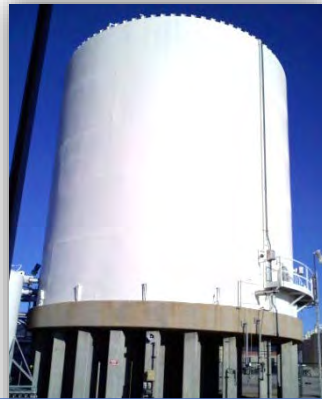
1,000 Ton Liquid Oxygen Storage

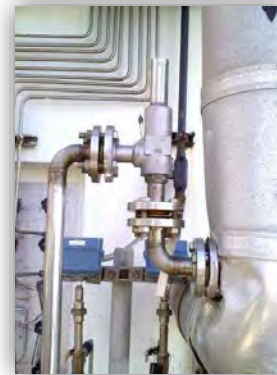
Instrumentation & Controls

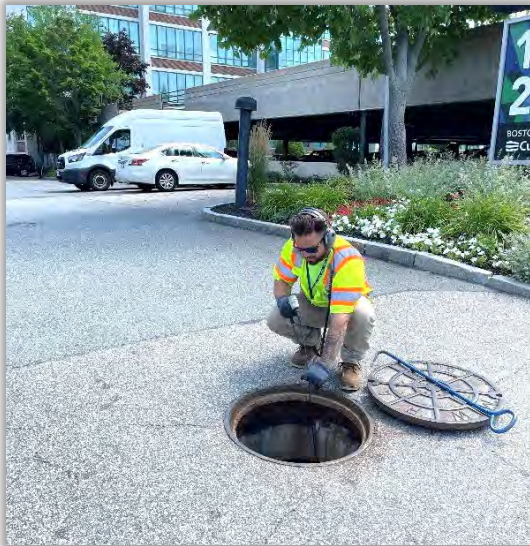
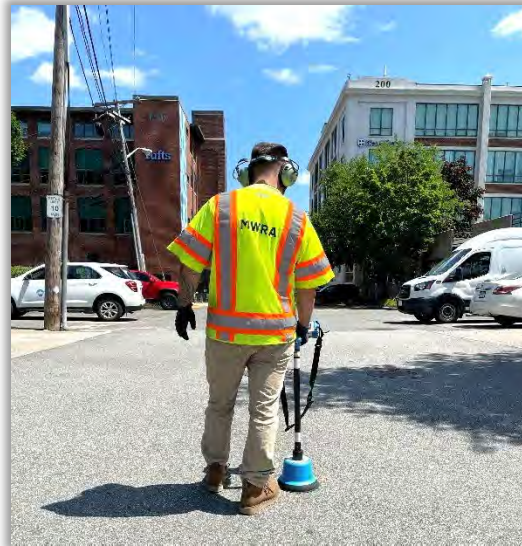
Massachusetts Water
Resources Authority
Leakage Control Report
Inspection Branch

Leak No.: FY24-07
Date: 2/28/2024
Leak Indication Classification:
I II III (Circle One)
Service Area: Watertown Section

Technician: Fishlin, Mosca Town/City: Waltham
Street Address: River Street Cross Street: Bright Street
Section #: WS Detail Record #: WS-3B Record Plan #: Sheet 3 Date Installed: 12/2020

ESTIMATED LEAKAGE	
2 GPM

INDICATION OF LEAK	
Sonic	
Surfaced Water	X

MATERIAL	
Cast Iron	
Steel	
Ductile Iron	
PCCP	
HDPE	X
Copper/Iron/Lead

PIPE DIAMETER	
24 Inch

LEAK APPEARS TO BE ON:	
Main	
Joint	X
Valve	
Blow Off	
Air Valve	
Service

COVER	
Concrete	X
Asphalt	
Soil

ESTIMATE DEPTH	
3 FT

INDICATES SCALED FROM RECORD DRAWINGS
ACCESS CLOSURE AND COUPLINGS
RIVER ST. NEAR BRIGHT ST.
WALTHAM

Remarks: Leak appears to be on mechanical couplings on Watertown Section WS-3B as shown on the Detail Records. Minimal to no sound is heard through leak detection devices in this area but water did come back chlorinated. The public Waltham water main service to this building is off Bright St.

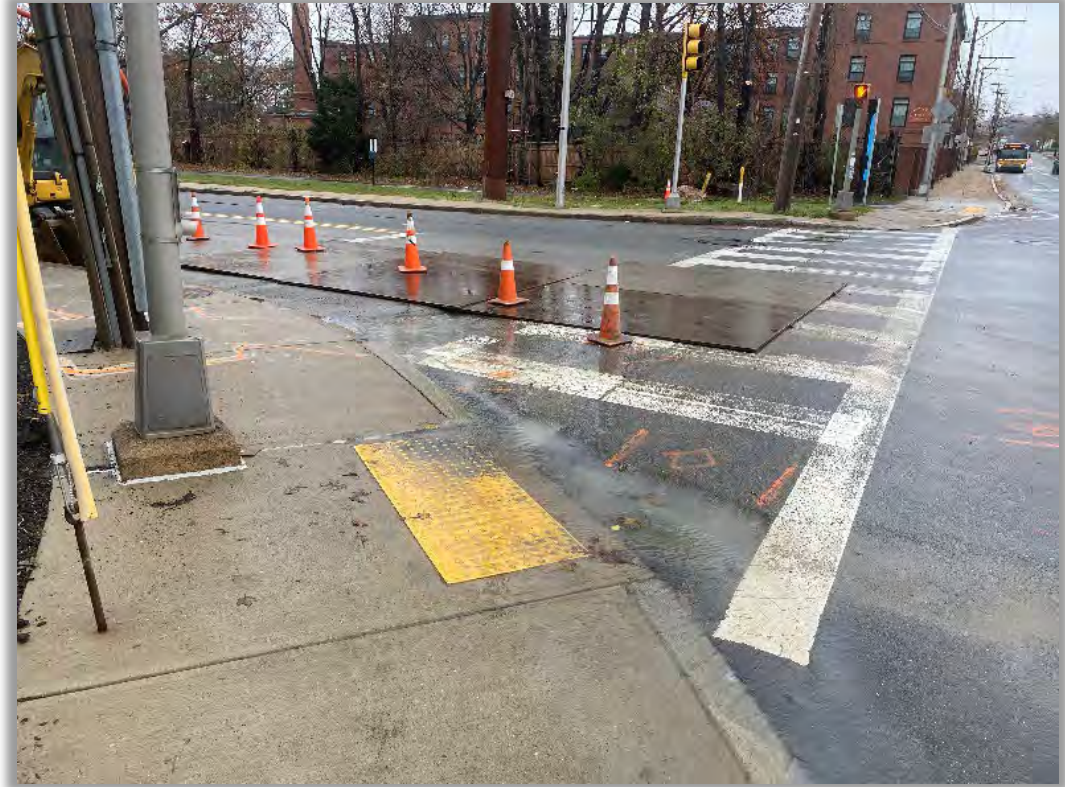
Section 84 Leak

- Reported by City of Malden
- Confirmed by MWRA Leak Detection Crew
- Located on MWRA Section 84 pipeline

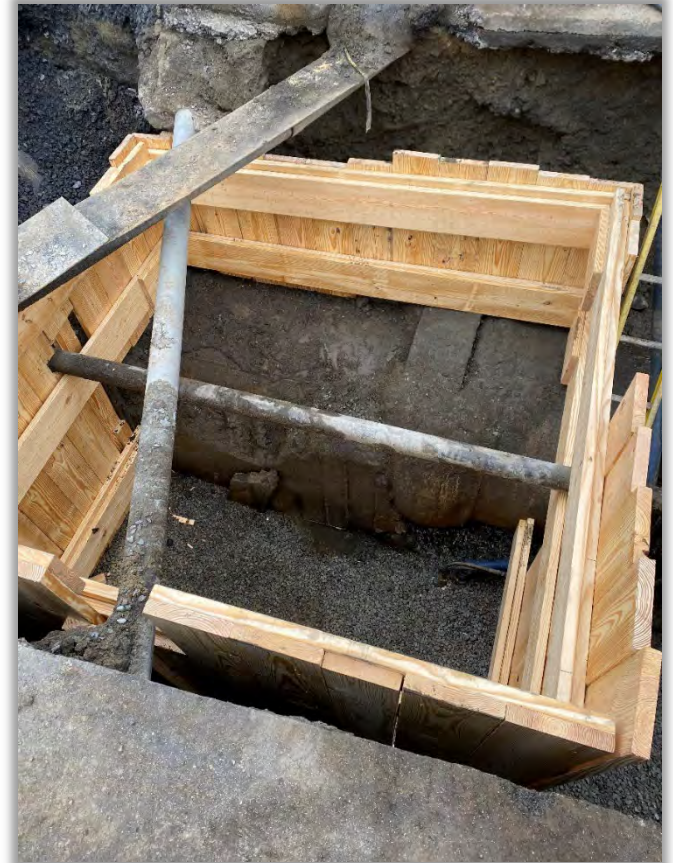
Location of Leak

- Pipe transitions to concrete encased steel at intersection
- Leak suspected in steel section
- Difficult excavation

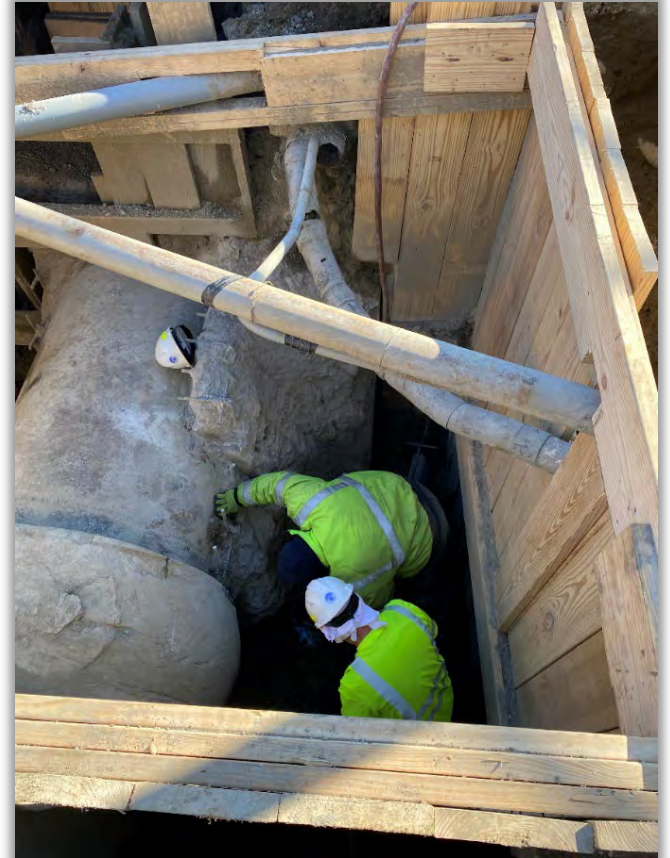
Concrete Encasement

- Concrete encasement concealed leak
- Staff had to remove encasement on one side of pipe
- Very labor intensive

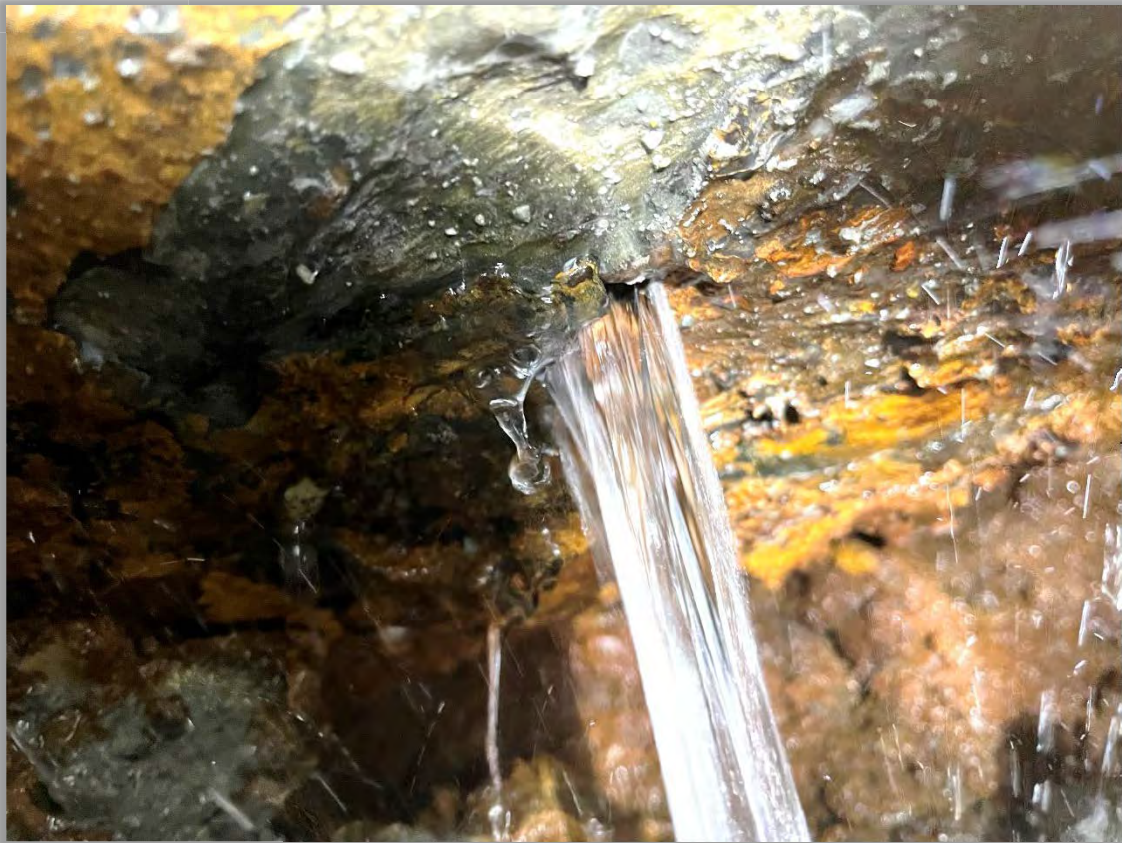
Leak located

- Steel corroded on bottom of pipe
- Pipe severely pitted

- Thickness testing of steel pipe
- Recommended rolled steel welded repair
- Remove entire concrete encasement

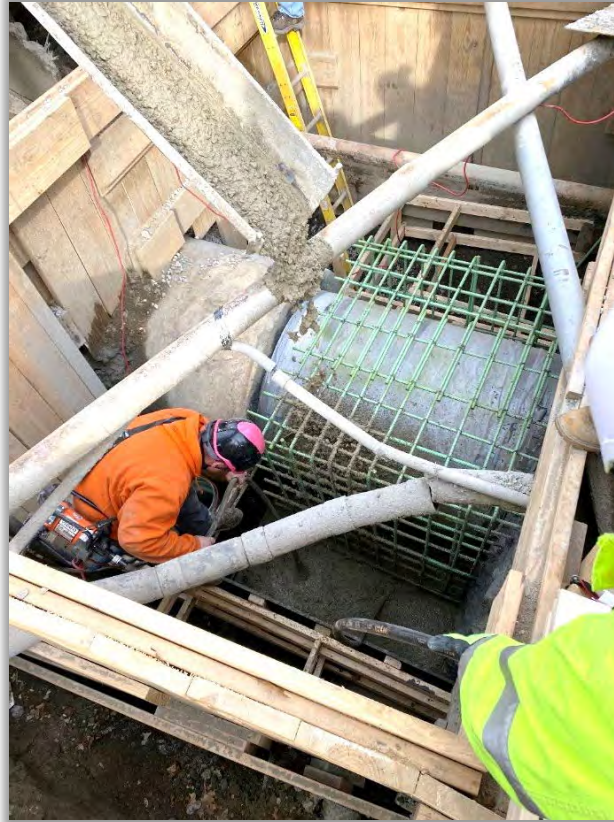
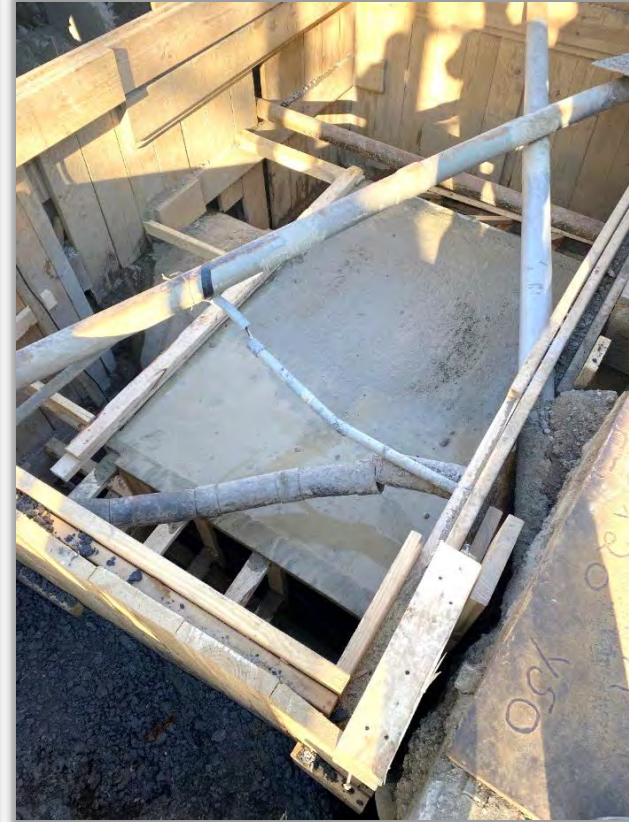
Concrete Encasement Installation

- In-house design
- Two separate pours due to the dimensions

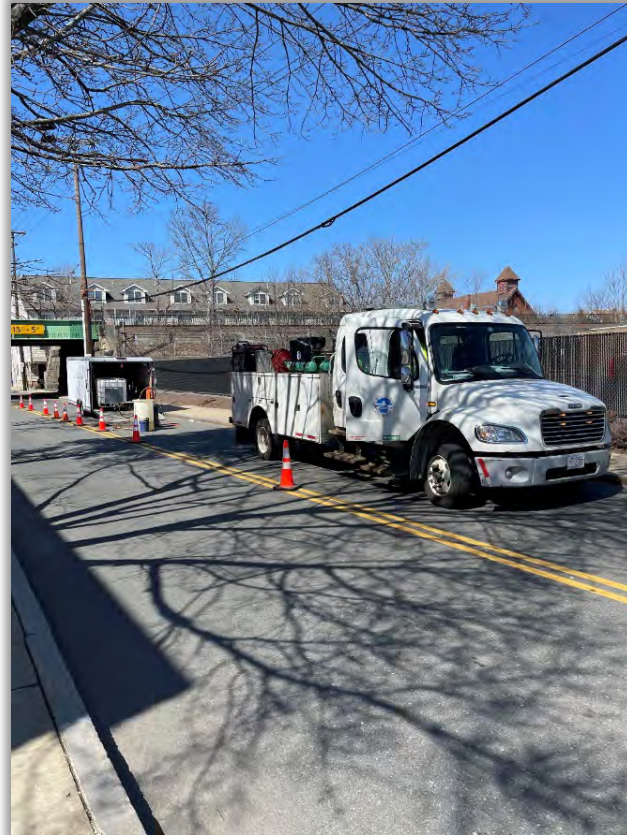
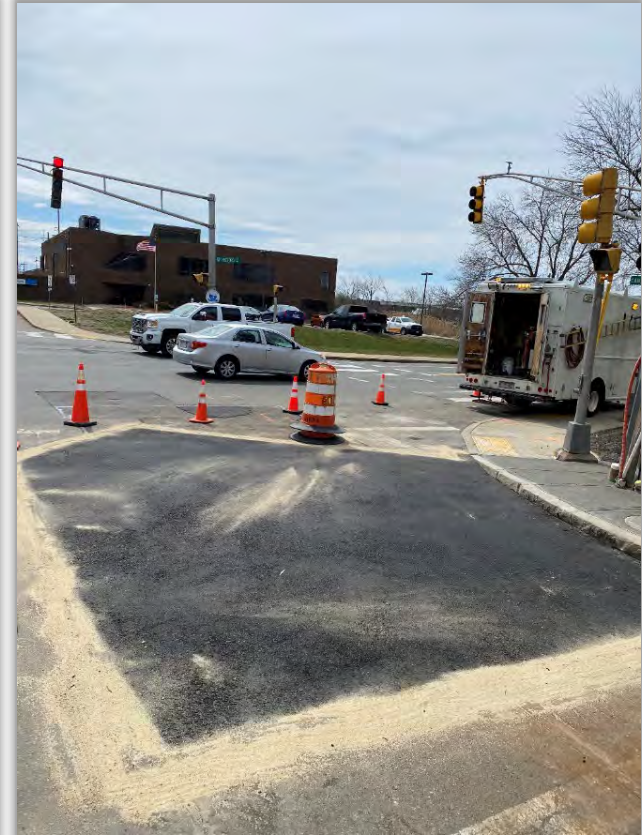
Pipeline Disinfection and Activation

- Disinfected and back in service before warm weather/high demand
- Final pavement completed and road reopened
