Quinapoxet Dam:

Dam Removal Investigation

Water Supply Citizens Advisory Committee
Meeting

October 13, 2015

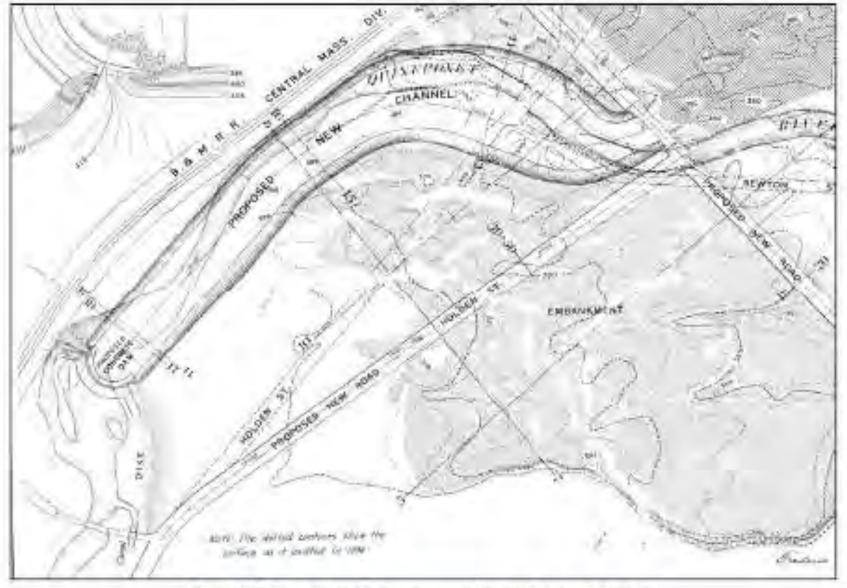
Figure 2-6: Historic plan for dam construction and channel dredging

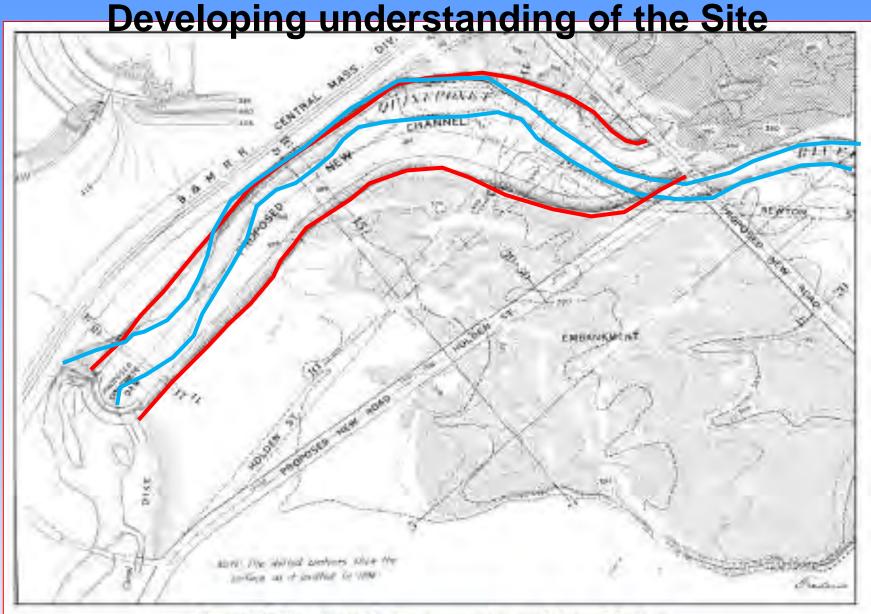
Figure 2-6: Historic plan for dam construction and channel dredging
