Massachusetts Water Resources Authority

***Update on Invasive Aquatic Plant Management at
MWRA Reservoirs***

John Gregoire, Program Manager, Reservoir Operations

March 12, 2019

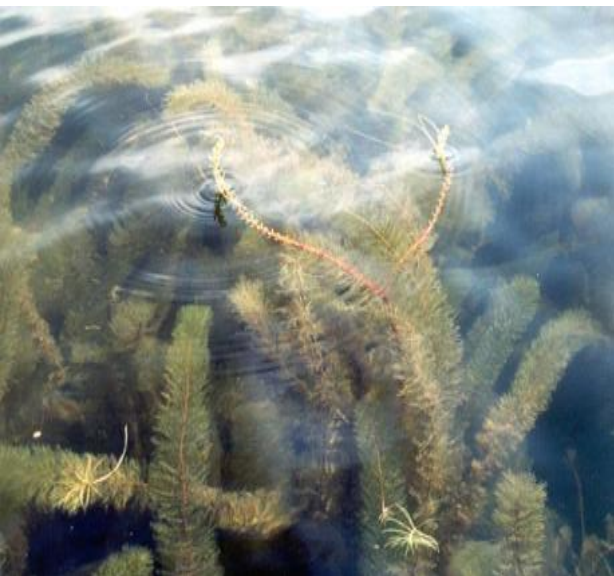
Eurasian Watermilfoil

Spread by roots, seed and fragments

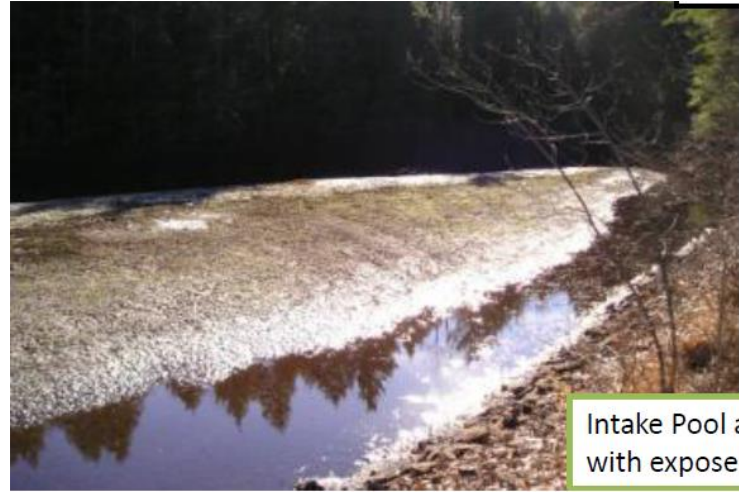
Intake Pool at drawdown with exposed milfoil

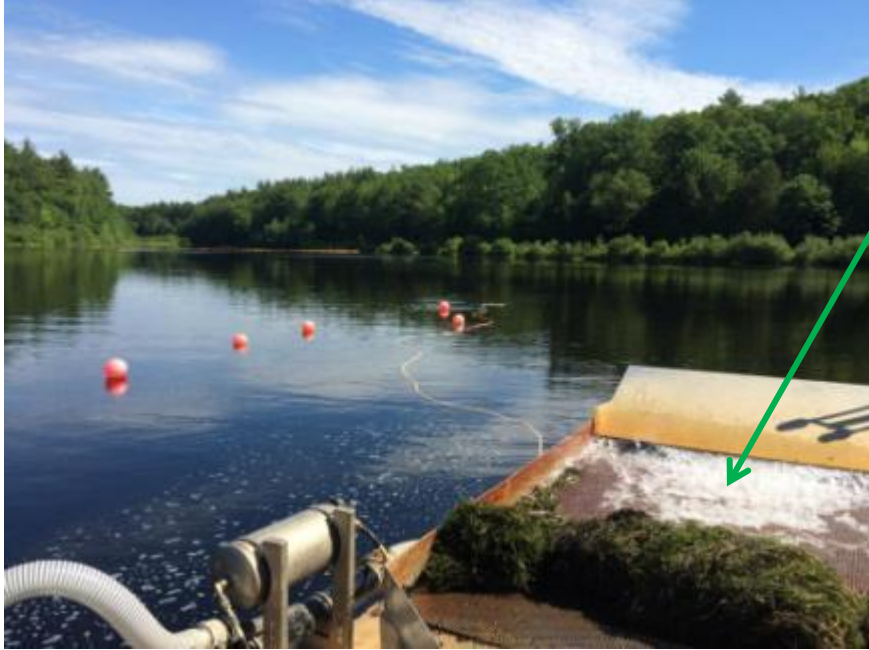
Control efforts by Diver Assisted Suction Harvesting (DASH)

Suctioned plants emerge on screen

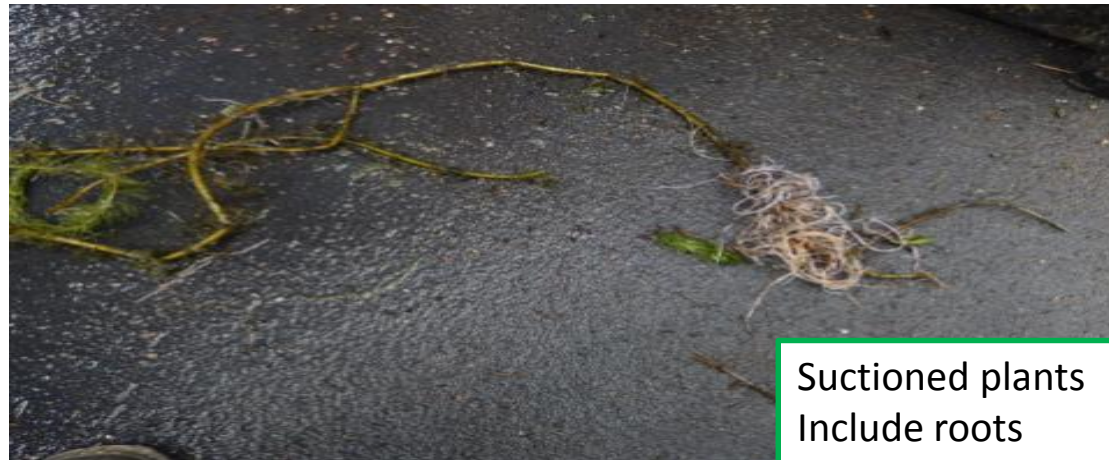
Suctioned plants include roots

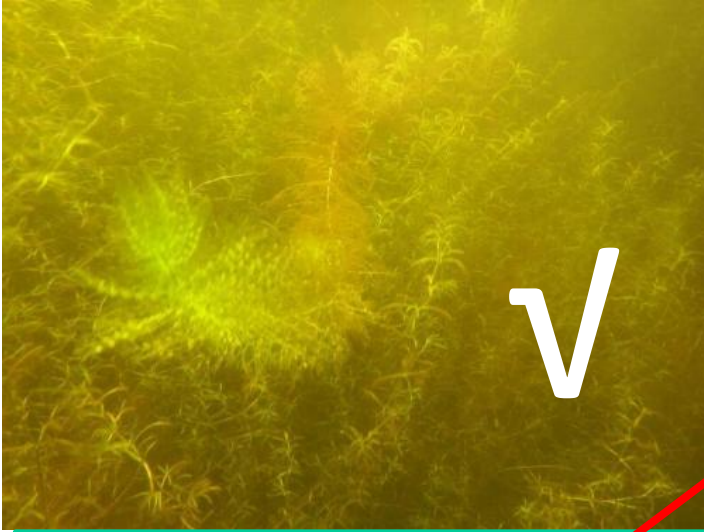
Native plants are returning to Stillwater Basin in the DASH-cleared areas

Native Urticularia (bladderwort) and native naiad

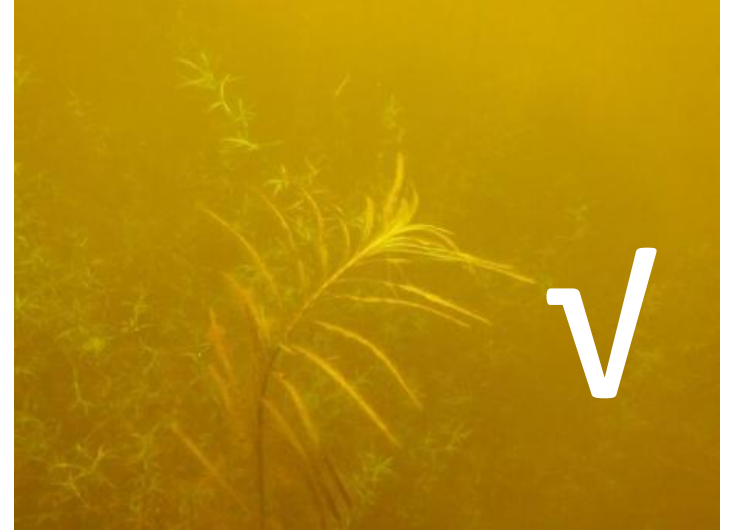
Native P. robbinsii (front), native Naiad (back)

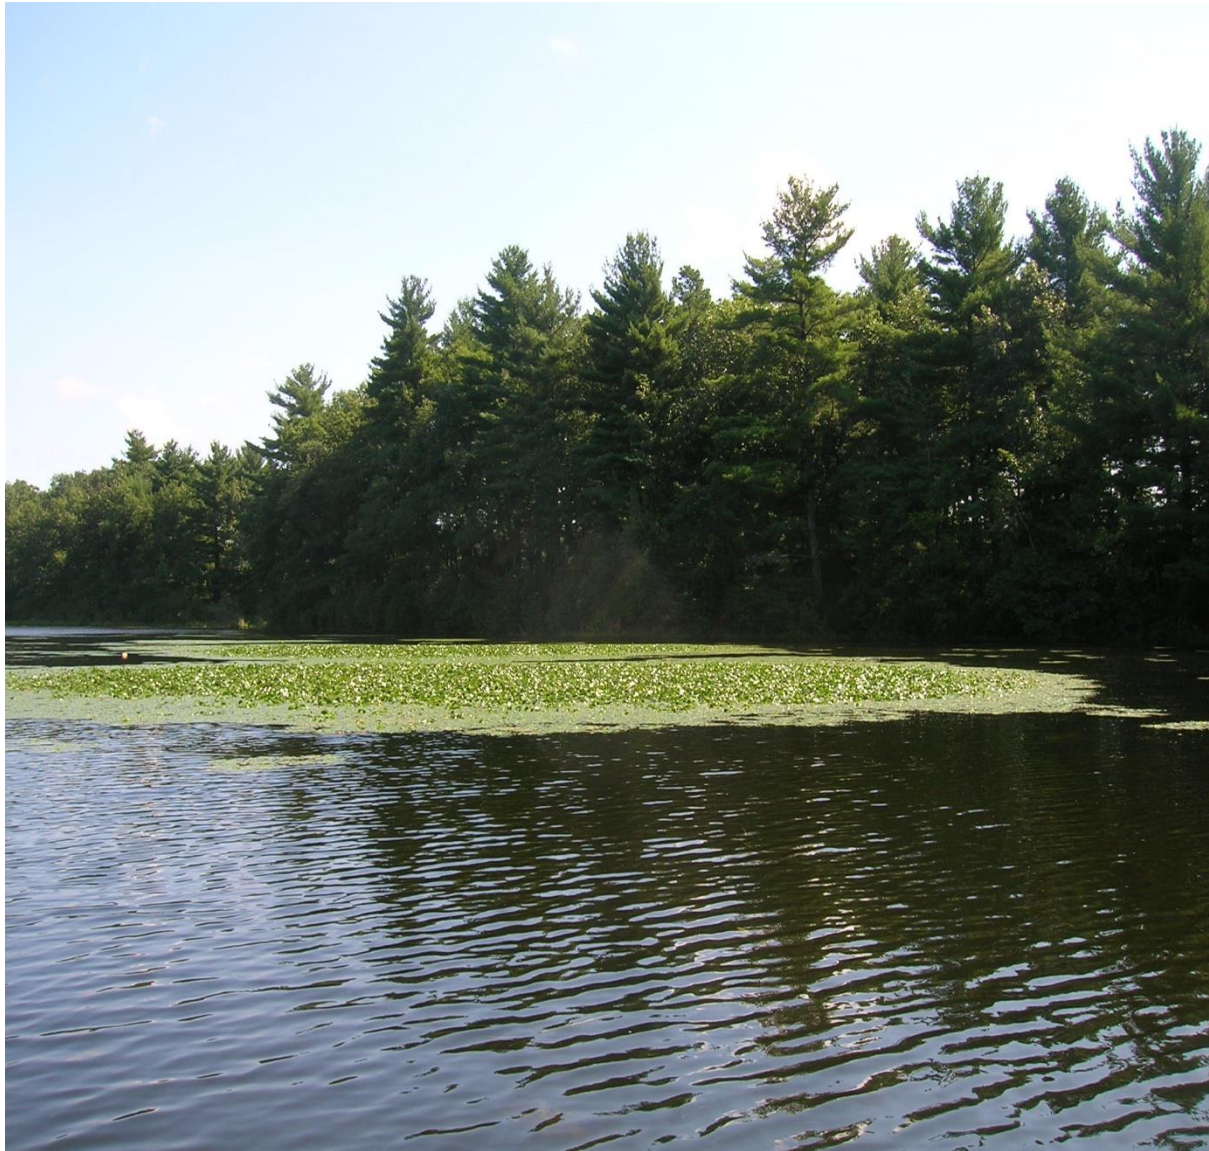
In 2008 dense mats and mature plants with many nuts

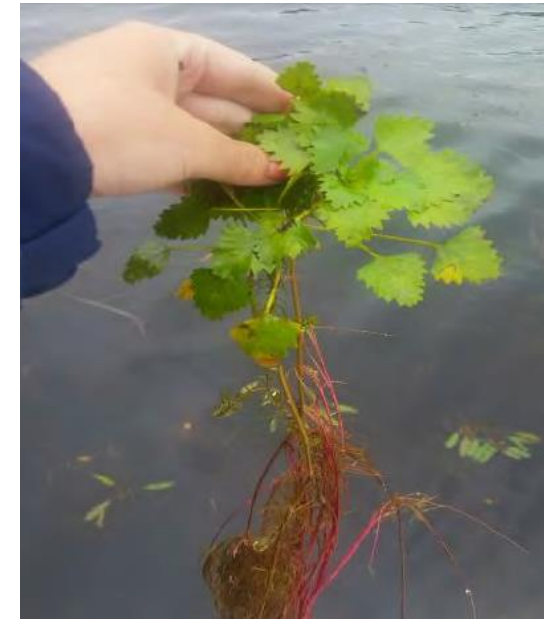
2019 – scattered small immature plants

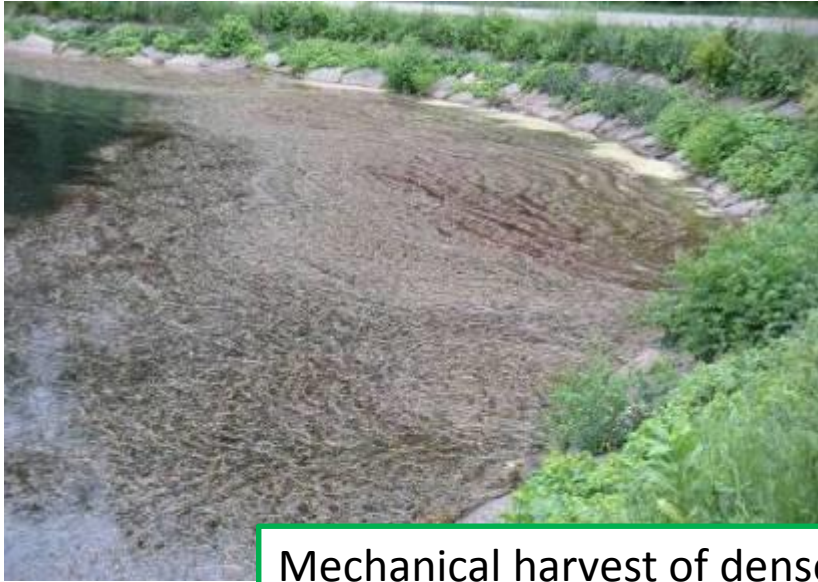
Mechanical harvest of dense EWM

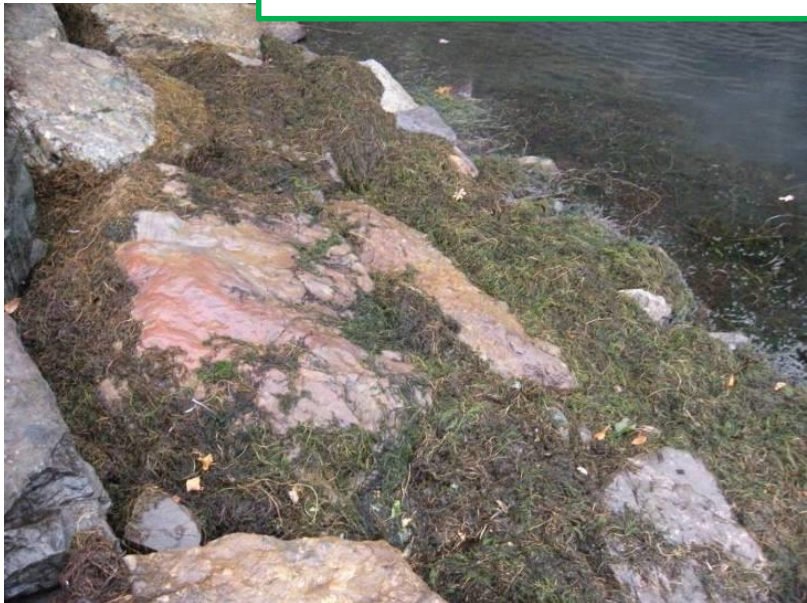
Winter drawdown to freeze and desiccate plants and roots. Suspended in 2016/2017 due to drought
