Water Supply Citizens Advisory Group
MWRA Reservoir Operations Update

Topics for today

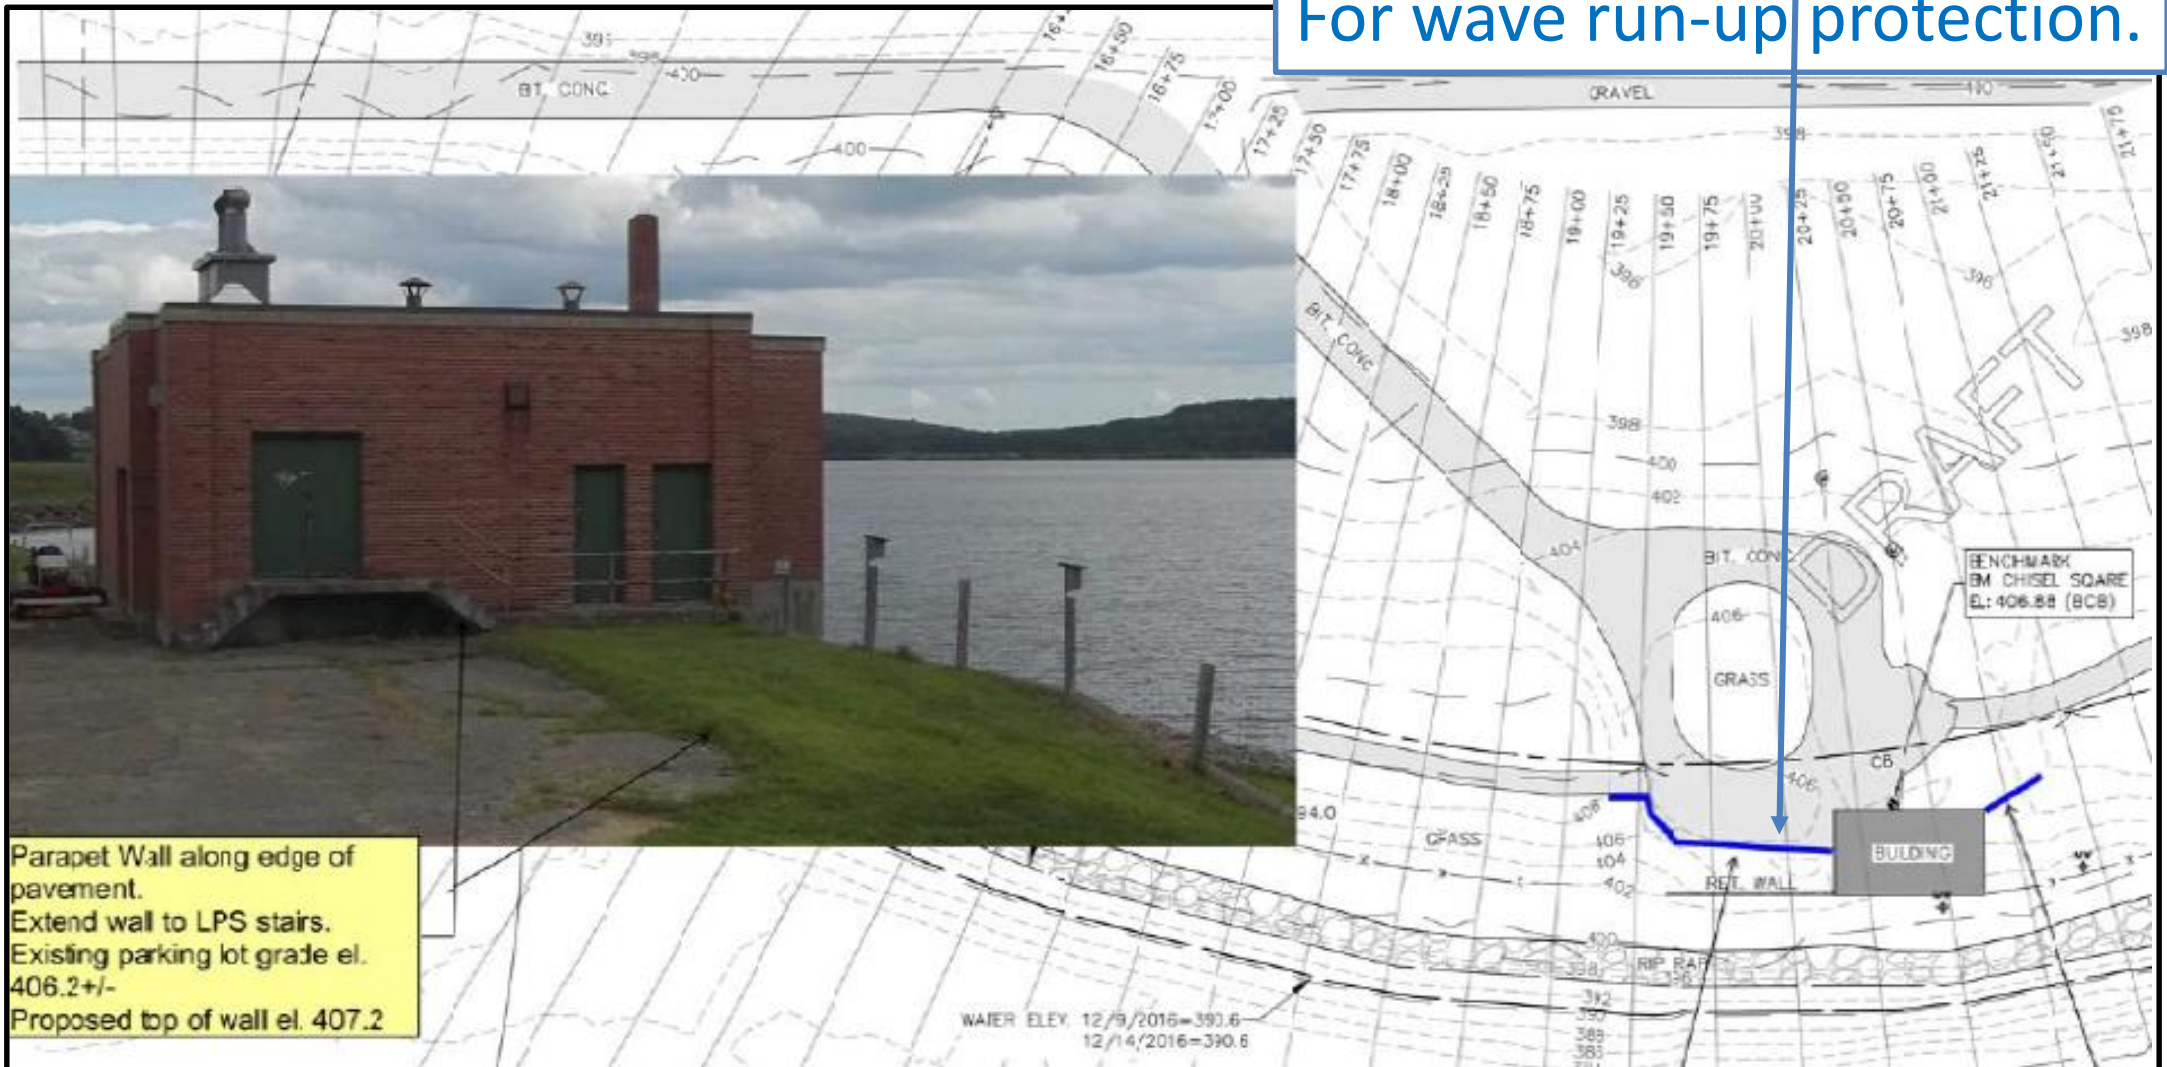
#7614 Task 2 – North Dike Revised Overtopping Protection

Install 18" high parapet wall
For wave run-up protection.

Parapet Wall along edge of pavement.
Extend wall to LPS stairs.
Existing parking lot grade el. 406.2+/-
Proposed top of wall el. 407.2

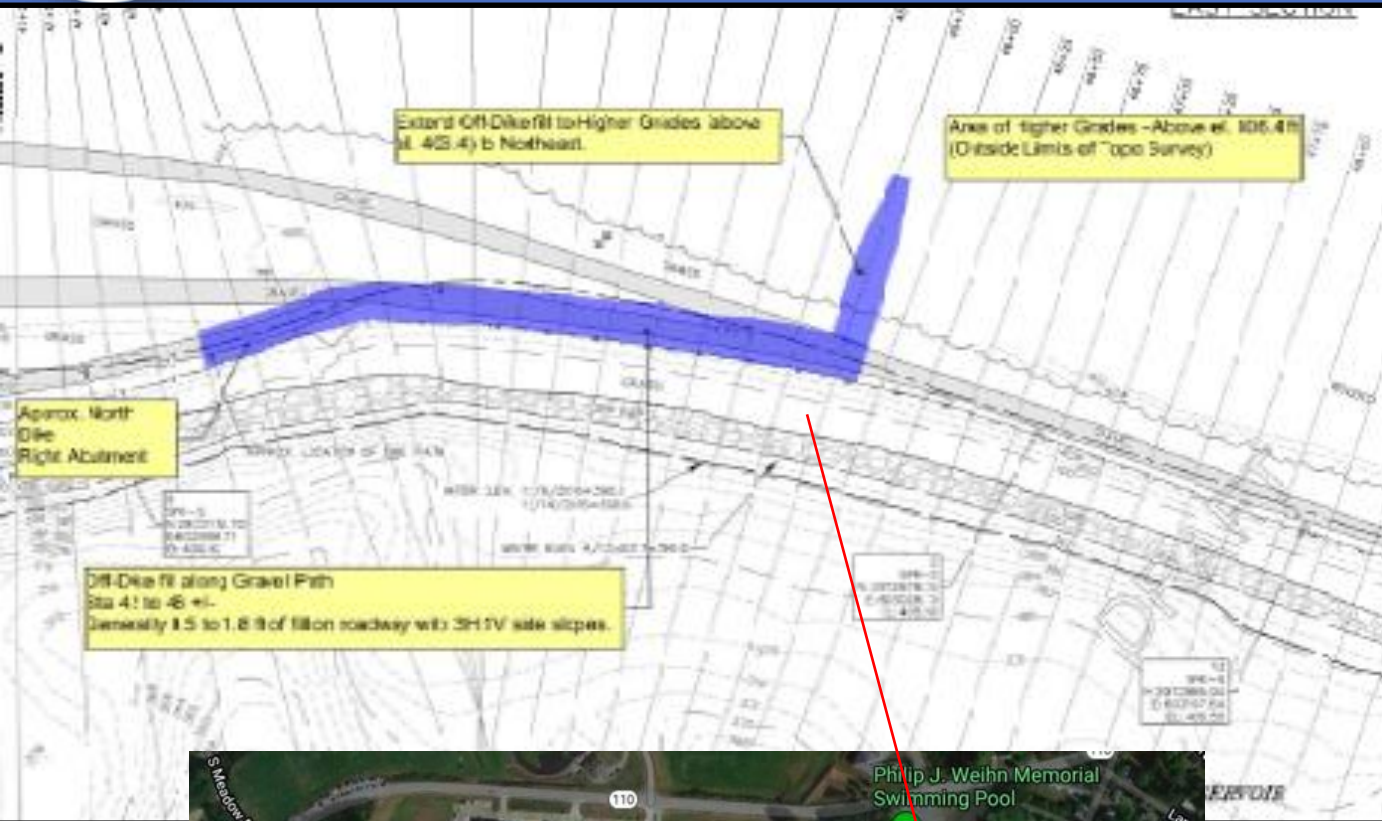
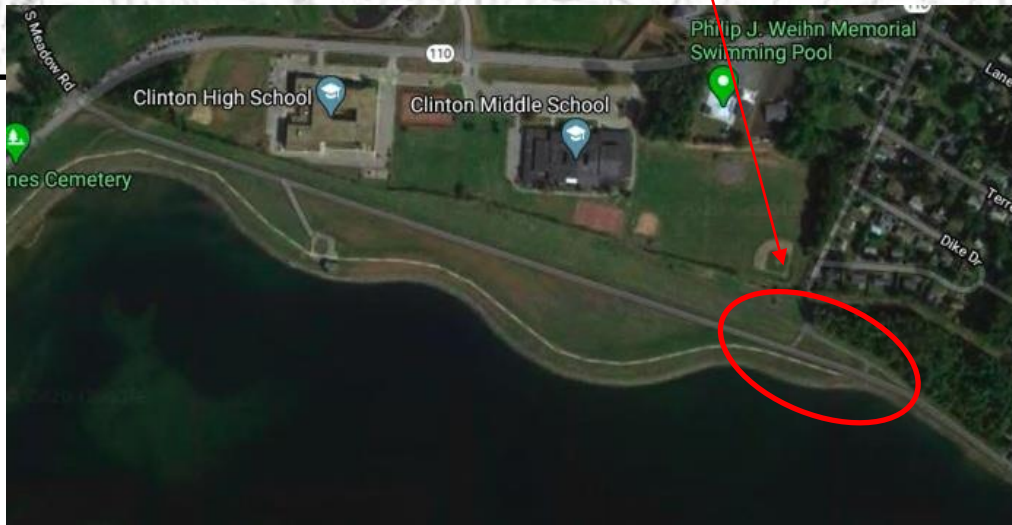
#7614 Task 2 – North Dike Overtopping Protection

New repair approach: Install 0.5' – 1.8' fill to prevent wave end-around erosion where North Dike abuts natural ground.

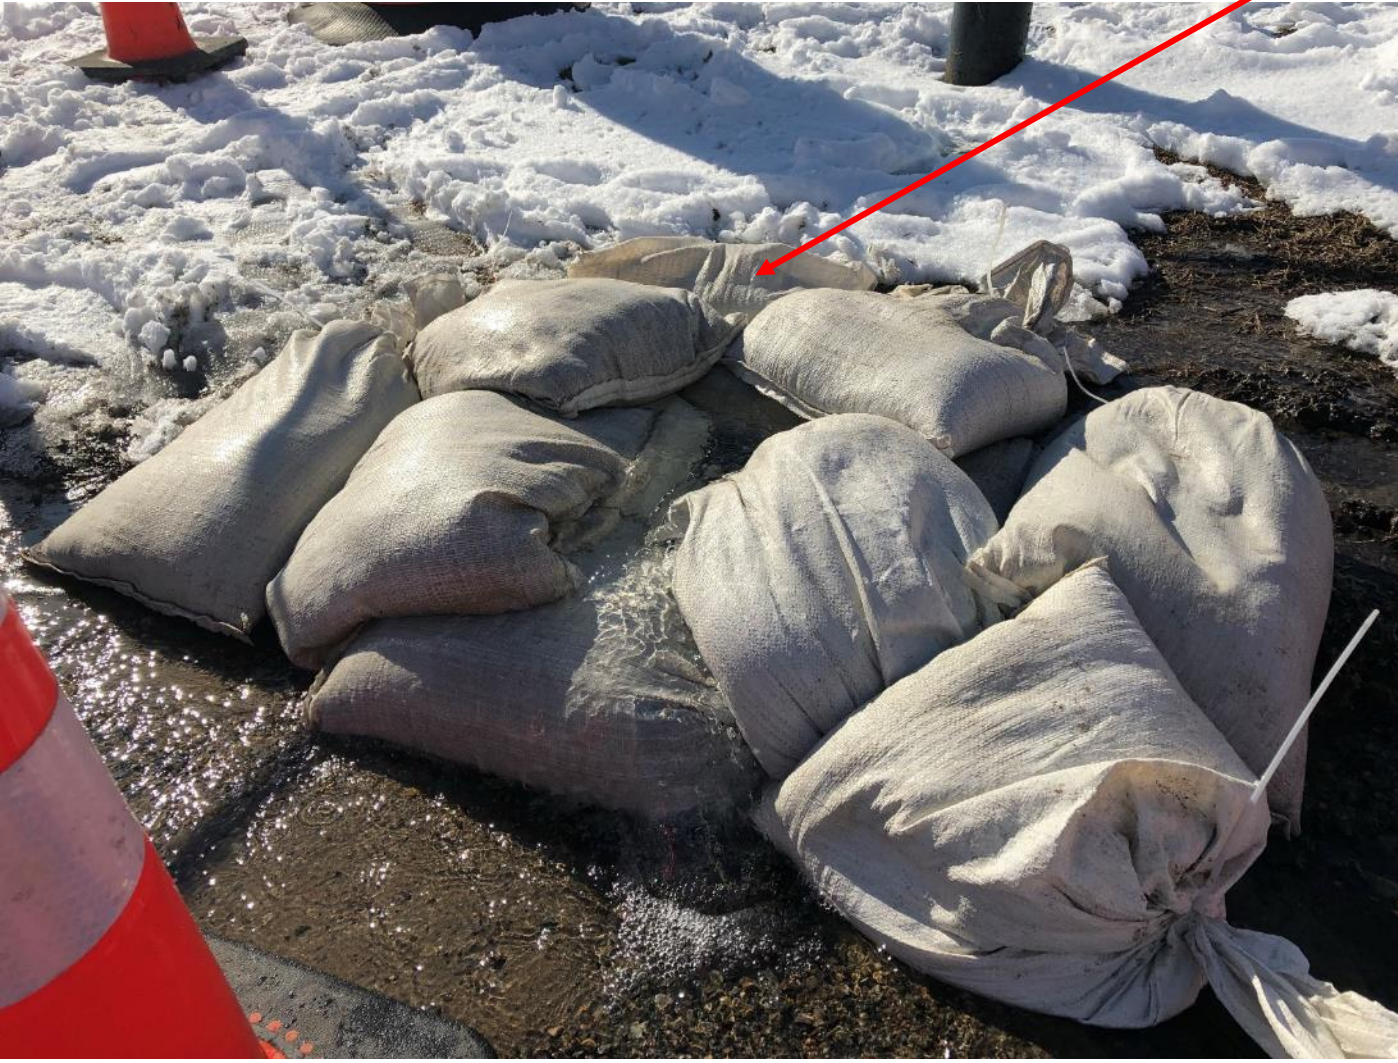
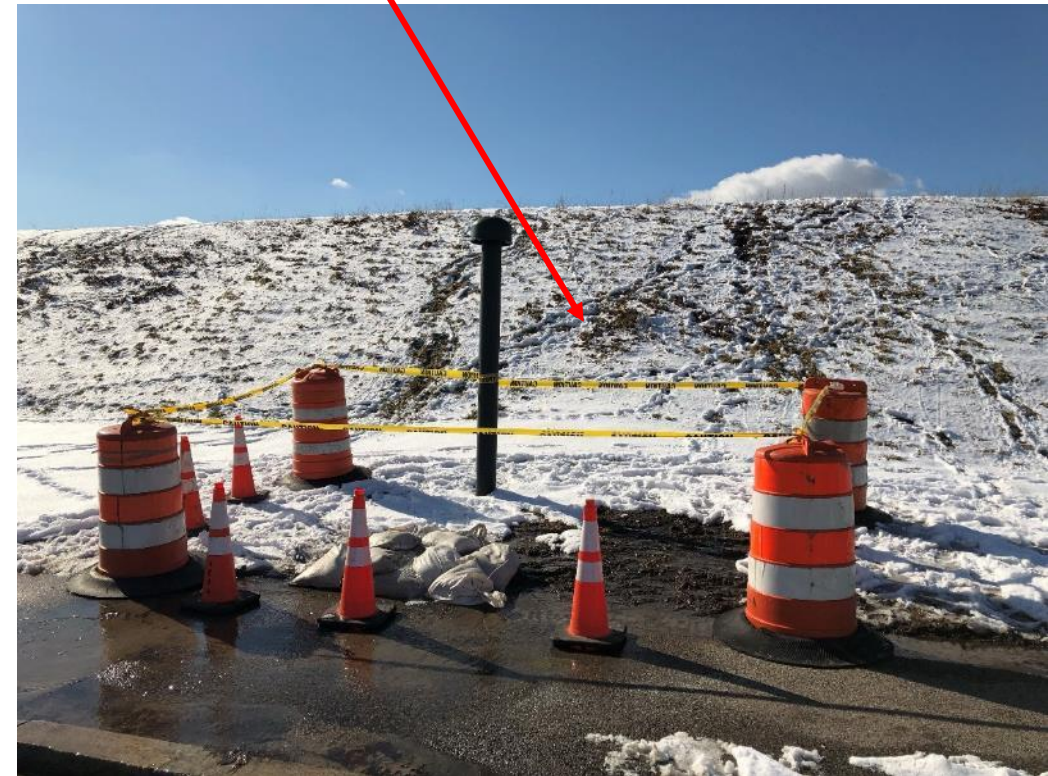
Chestnut Hill Dam Seepage Repair

Seepage surfacing 02.28.19 as defined boil and diffuse flow

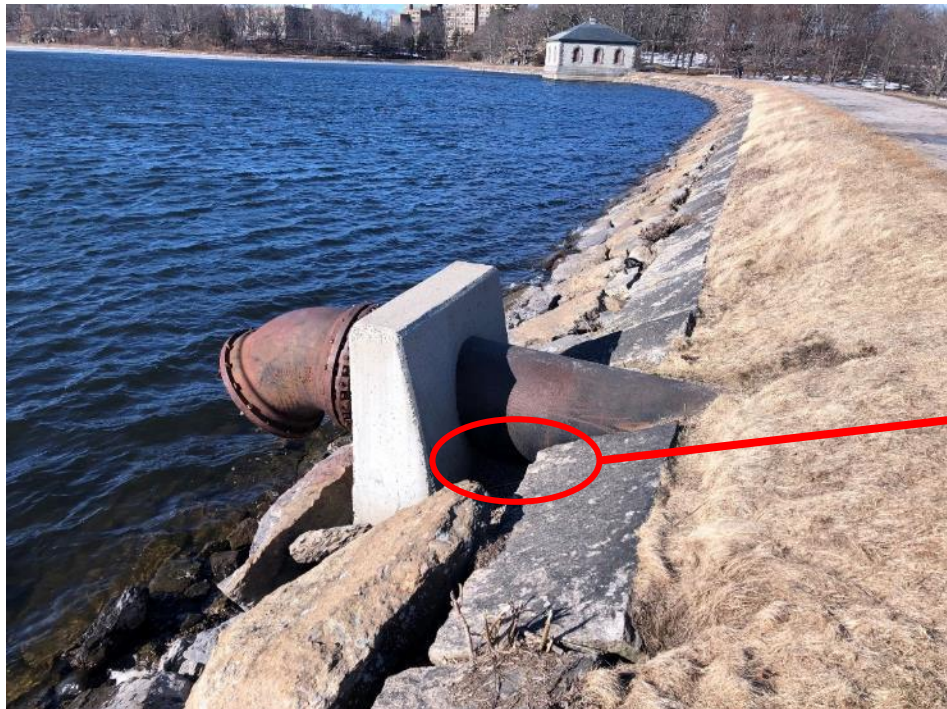
Seepage flow path along crushed stone

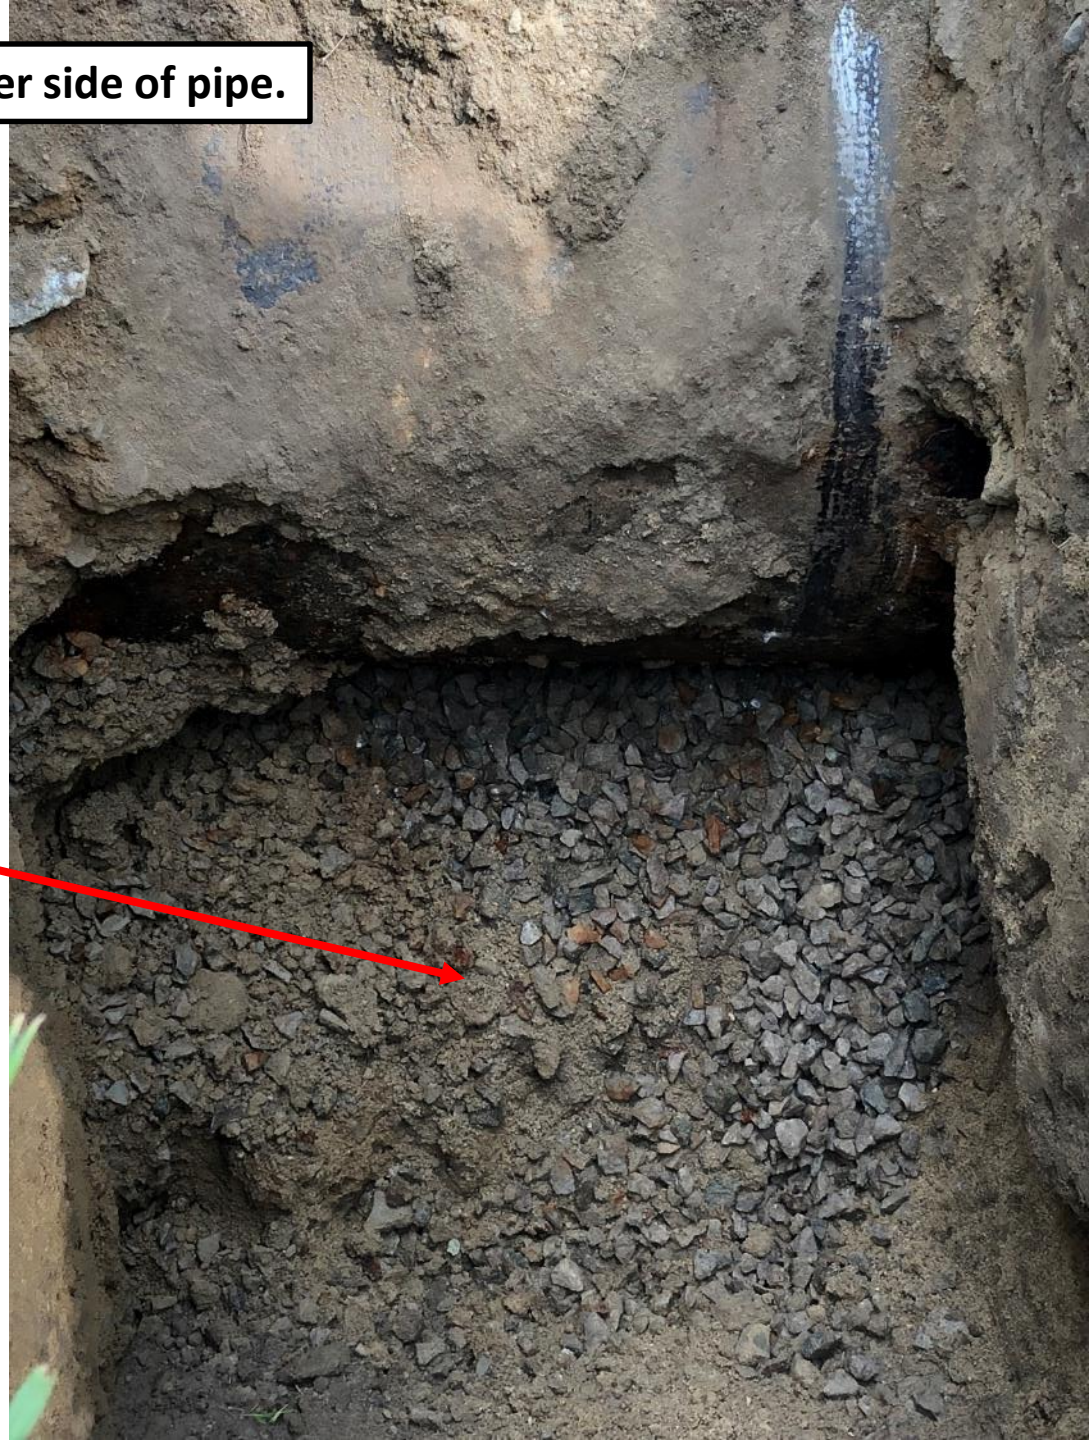
Findings: BO Pipe is bedded with ~13" crushed stone on 4ft. either side of pipe.

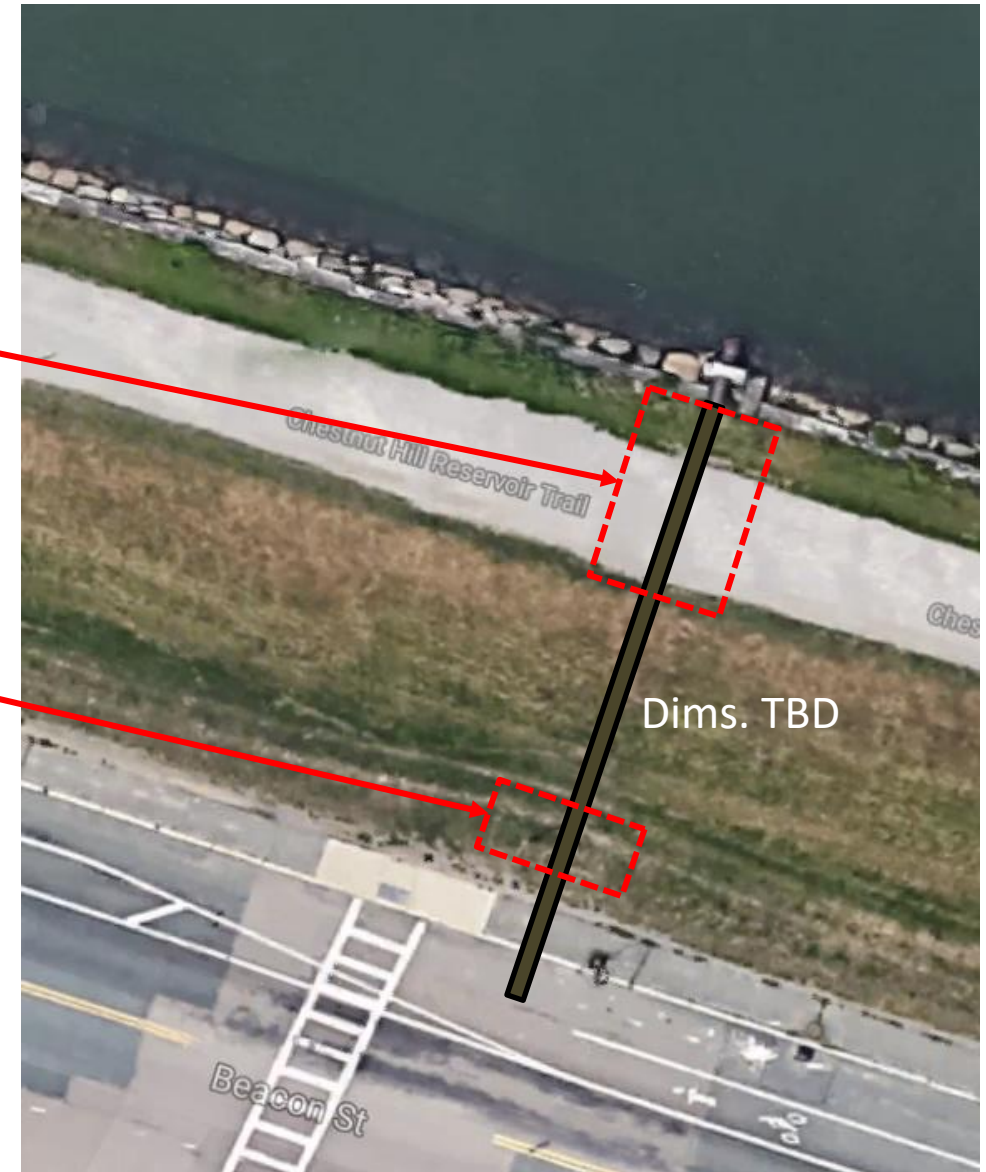
Repair design selected

1. Reestablish upper core zone at crest:
Excavate material under pipe, support
pipe, and replace with l/w concrete, flowfill,
foamed concrete or low perm. soil.
- +
2. Establish a filter blanket (at pipe
alignment near toe) of 2-3' of free-draining
coarse material.

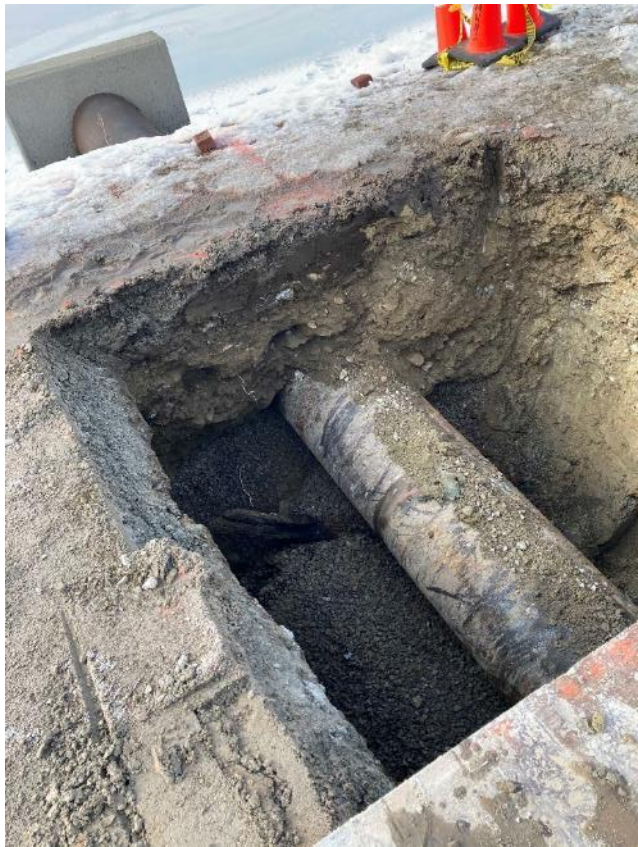
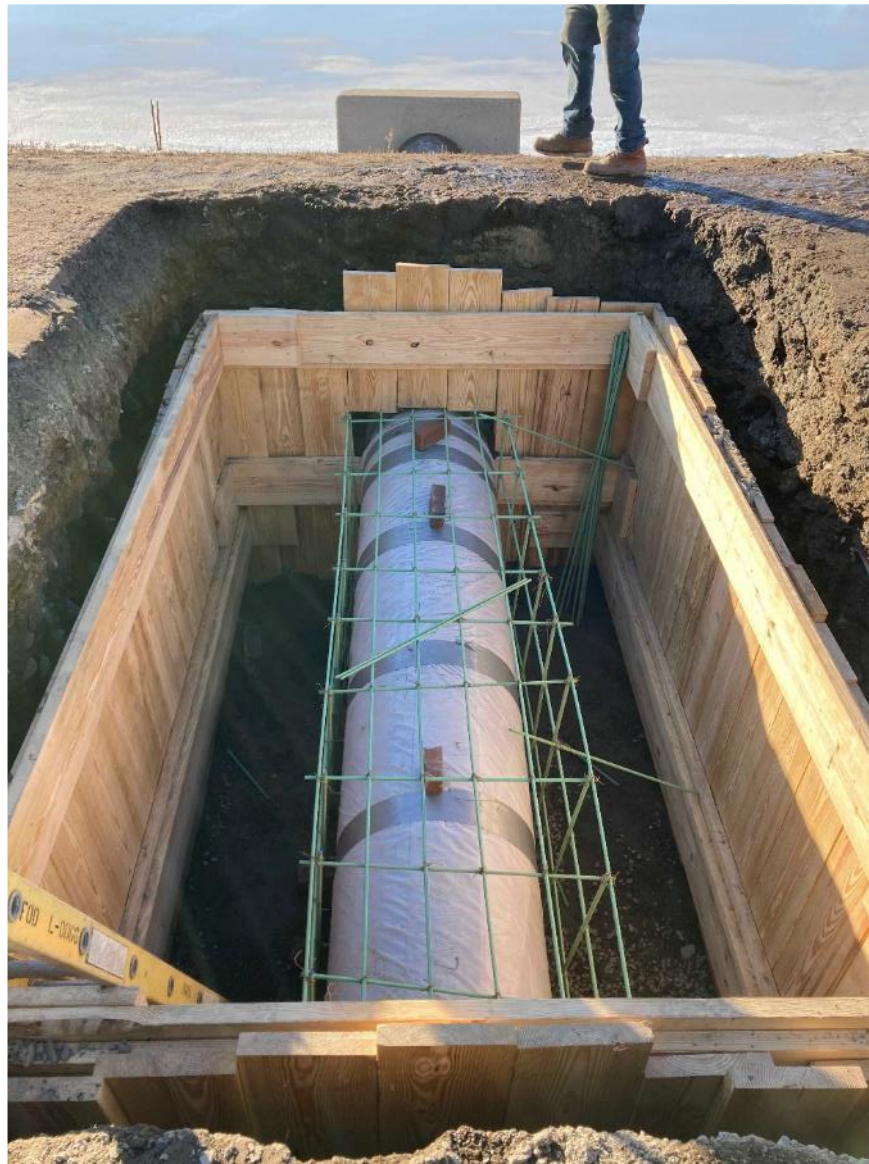
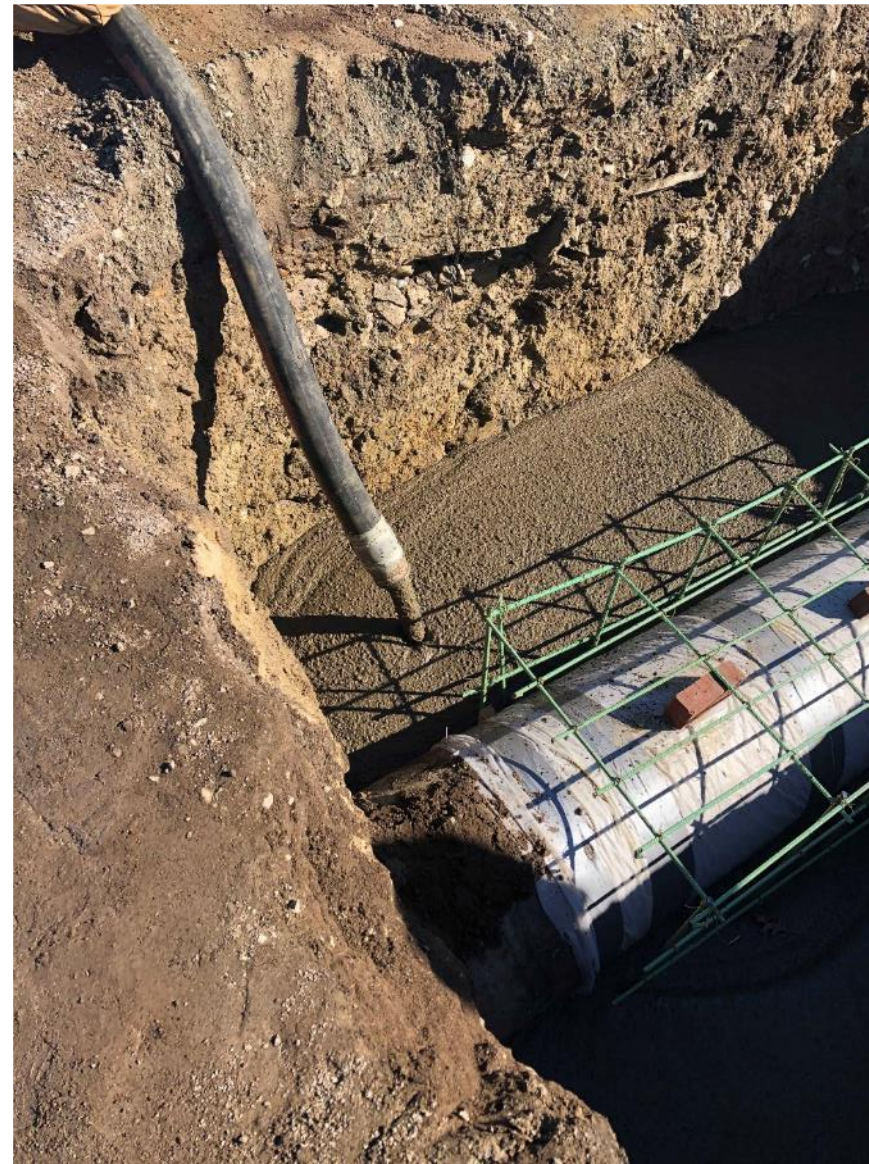
Expose pipe, form, rebar and flow-fill for core restoration

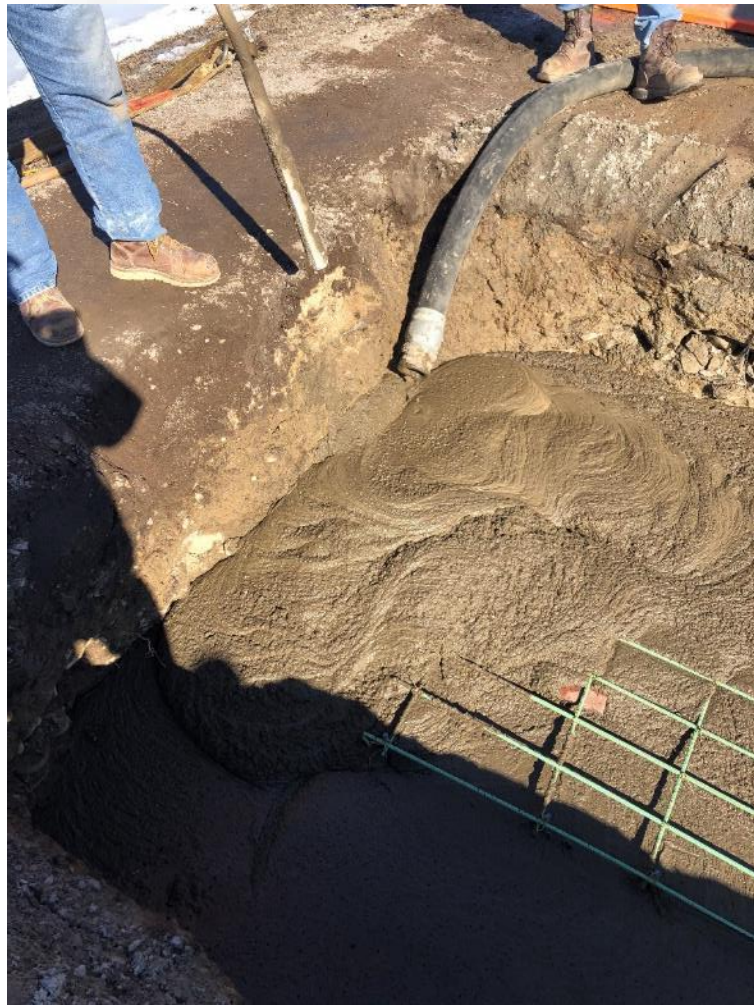
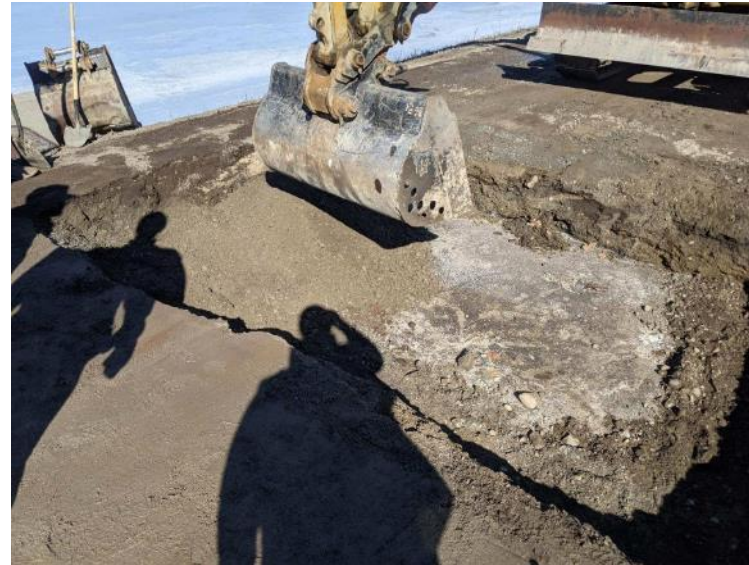
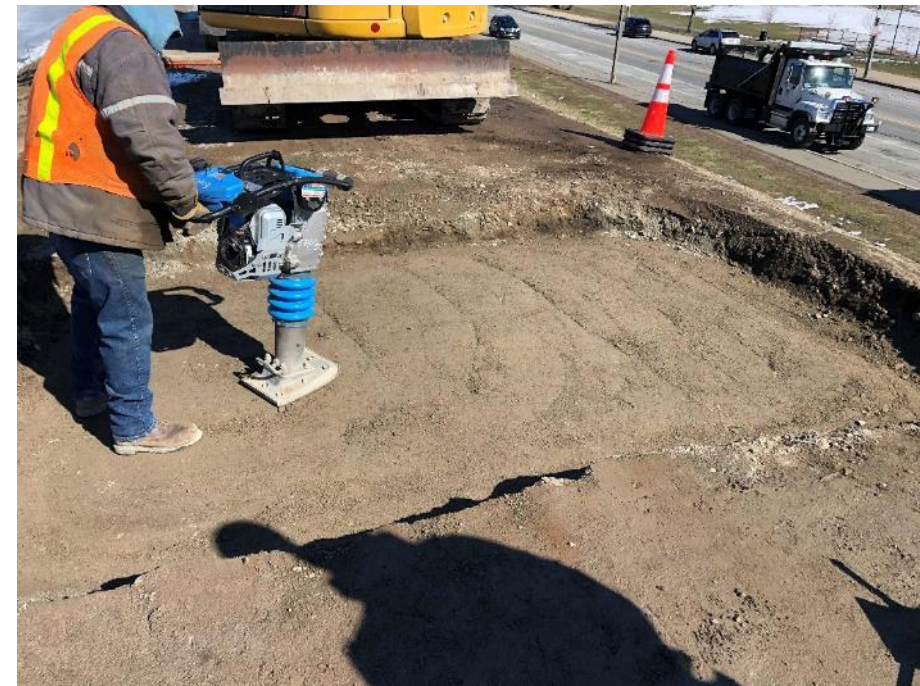
Flowable fill and backfill

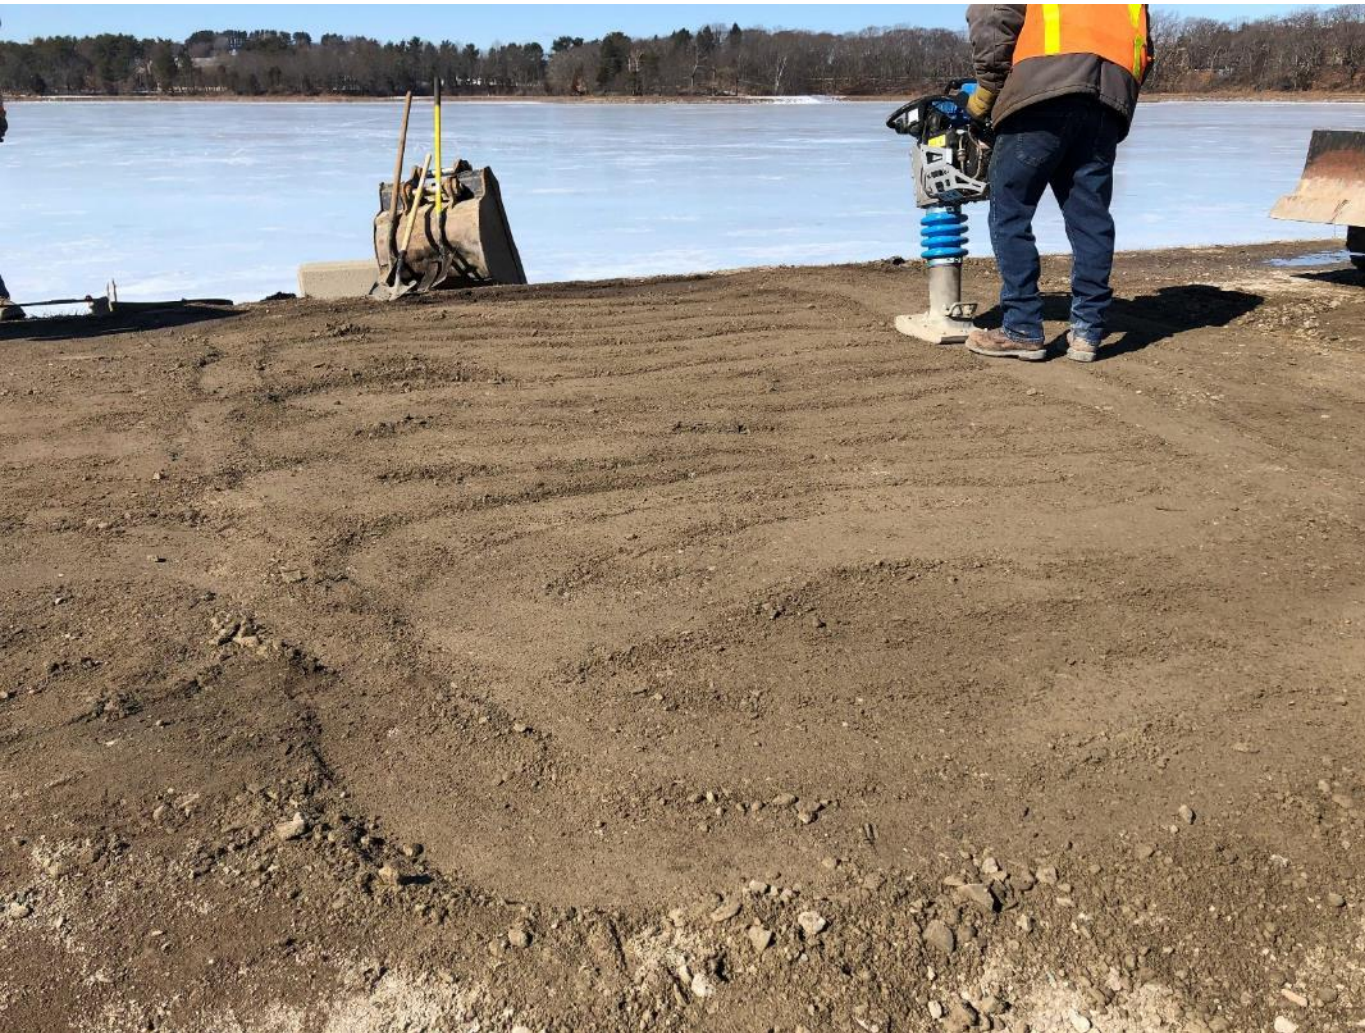
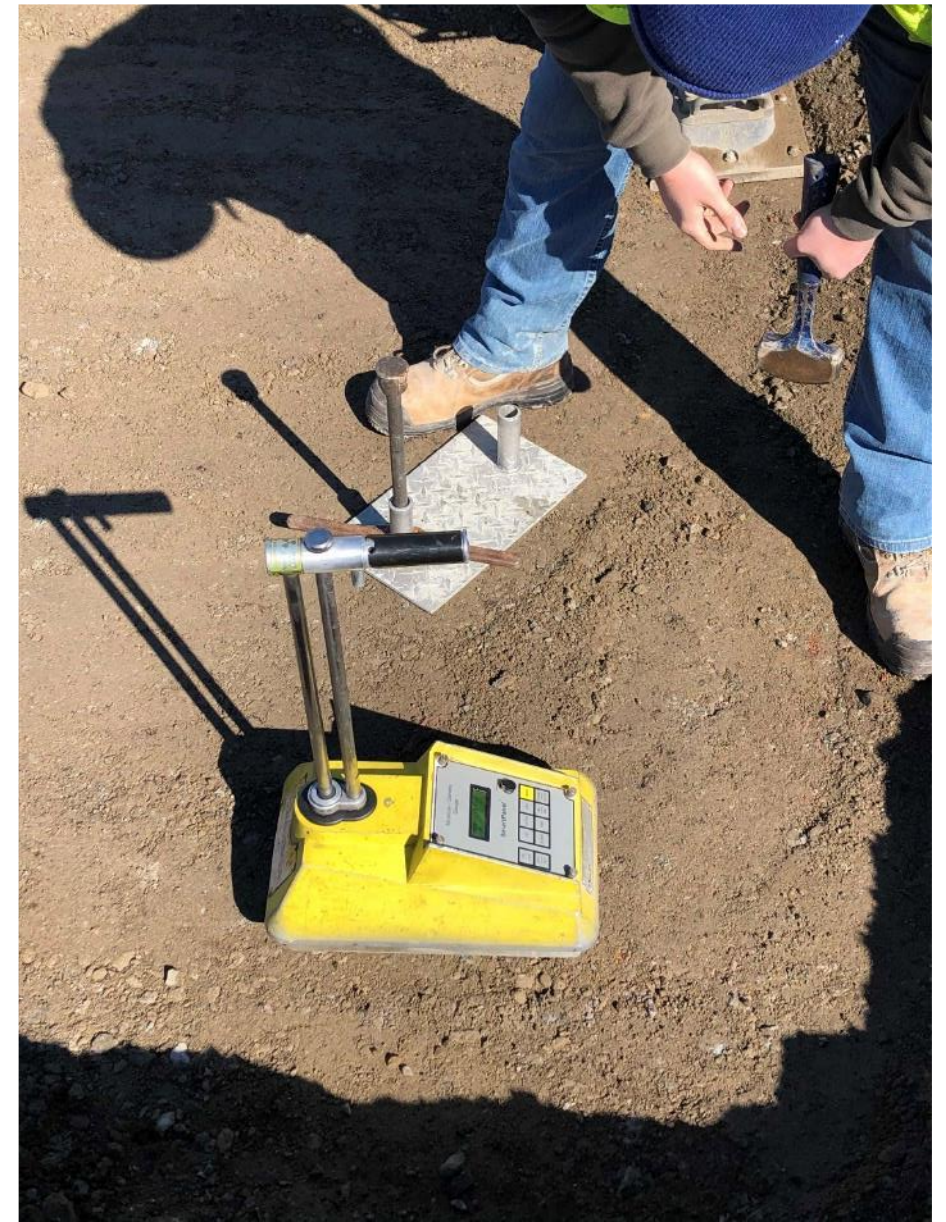
Compaction and testing

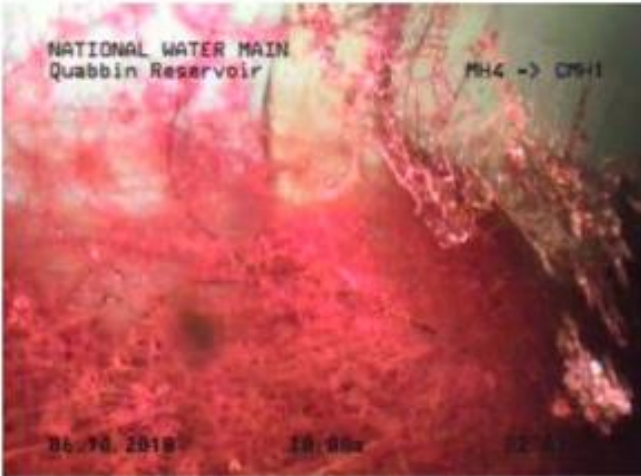
Root infiltration

Photo 1: Heavy root infiltration through slots in pipe MH4->CMH1

- Clean (jet) main outlet pipes, blanket drain pipes, and surface drain pipes
- Replace failed sections of surface drain pipes (Local DCR Quabbin task)
- Redevelop relief wells.
 - The purpose of well development is to ensure removal of fine grained sediments from the vicinity of the well screen by jetting, surging or pumping. This allows the water to flow freely from the formation into the well and on to the drain
- Clean sediment from outlet structure and ensure functionality
- Inspect source of possible leakage at drop inlet of outlet structure

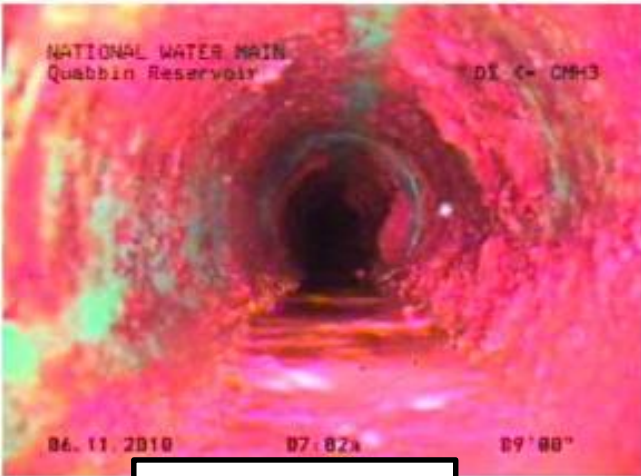
Photo 2: Heavy mineralization in pipe DI->CMH3

Mineralization

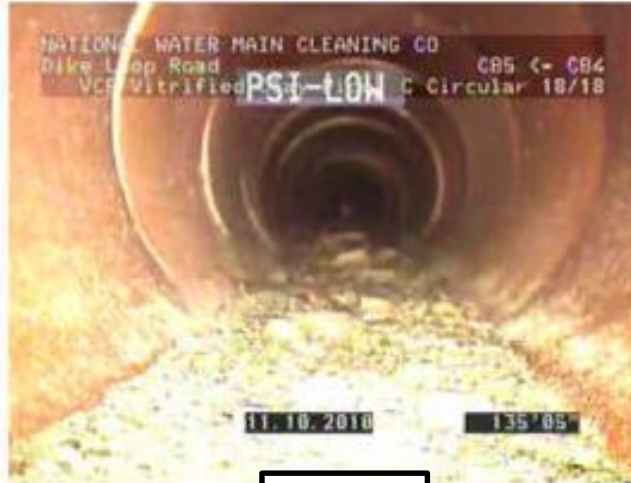
Photo 3: Example debris (CB5->CB4) section of full length of pipe.

Debris

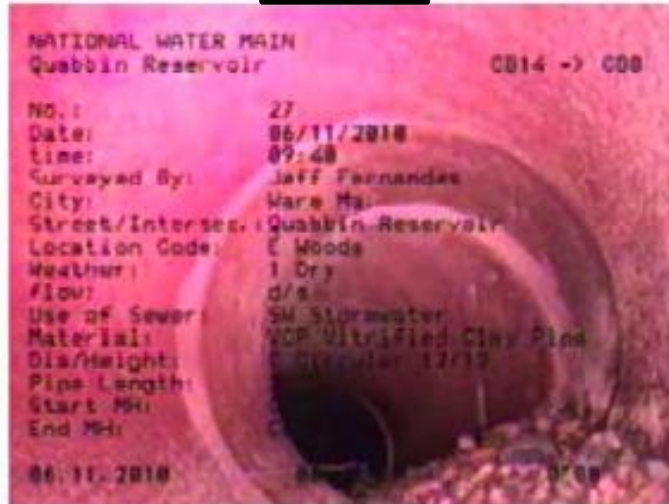
Photo 4: Example concrete debris located in some pipes.

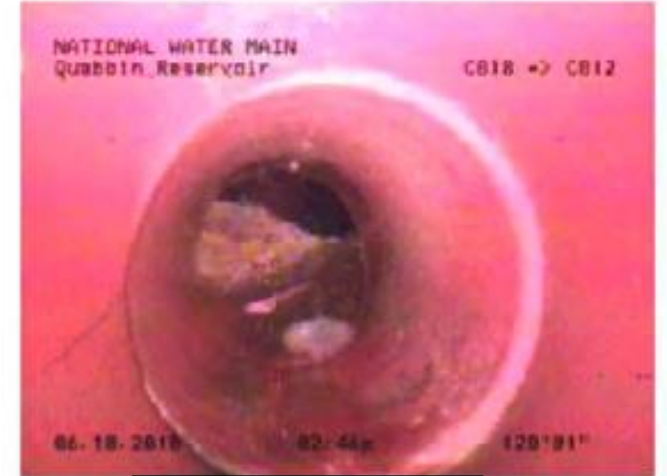
Photo 5: Concrete debris in pipe CB18->CB12.

Partial blockage

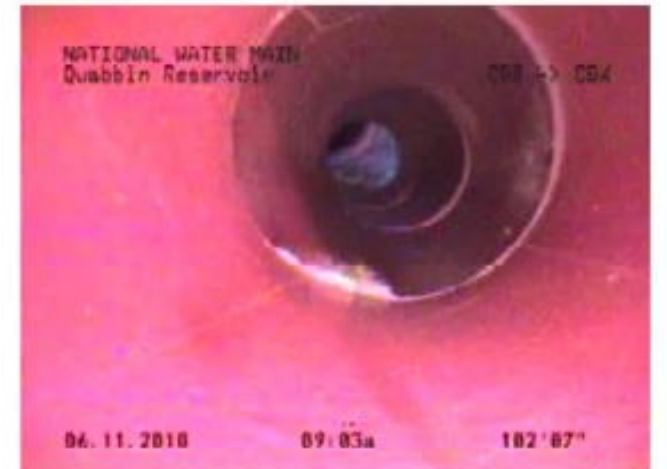
Photo 6: Example concrete deposit/mortar protruding from joint.

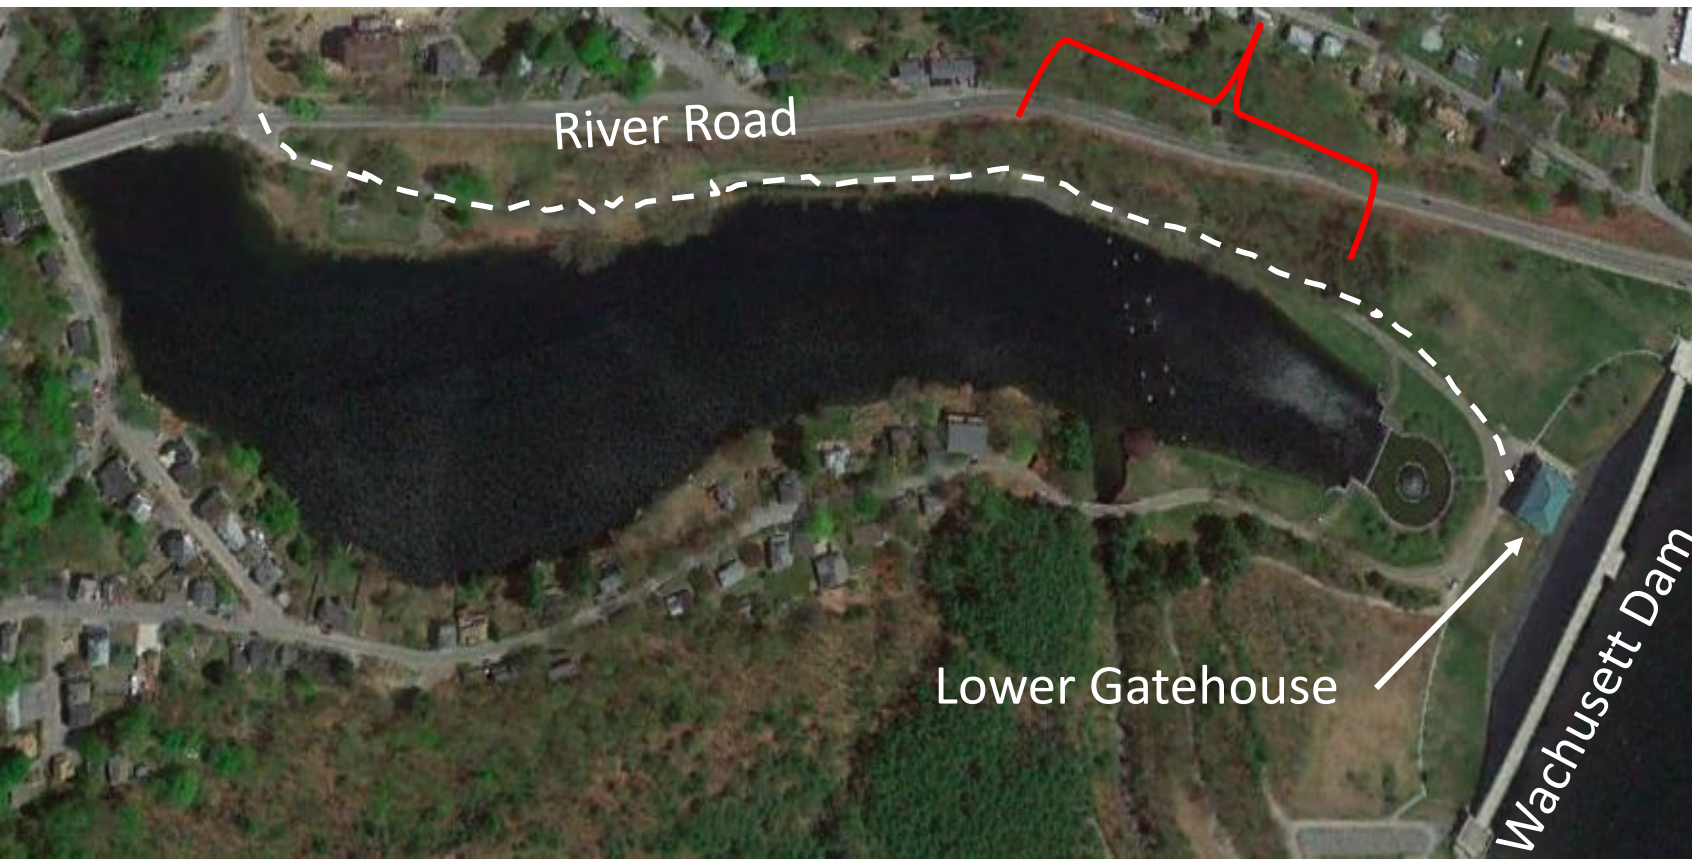
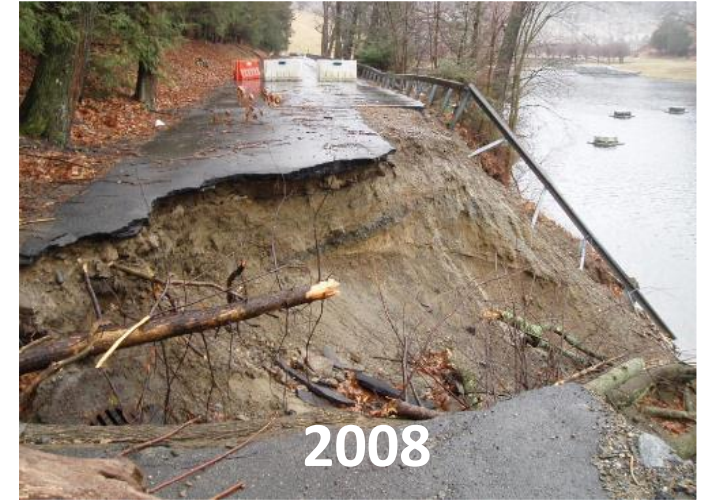
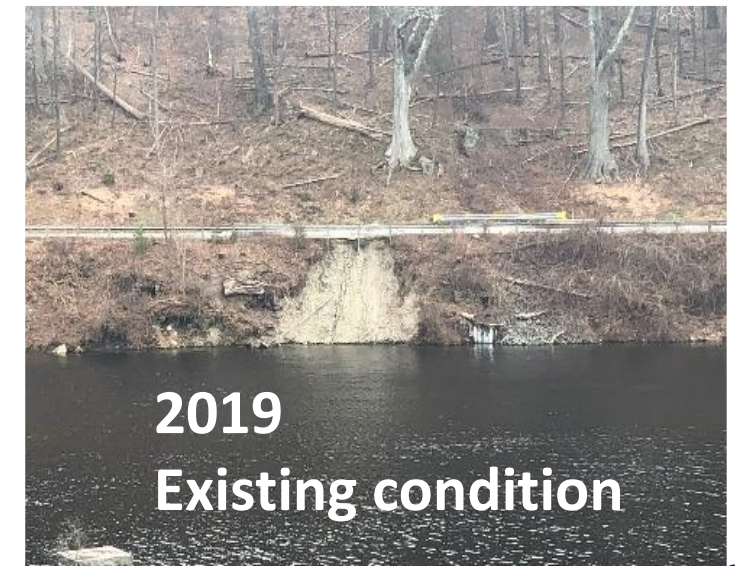
Repair zone in landslide-prone area

Repair Zone ~ 900 LF

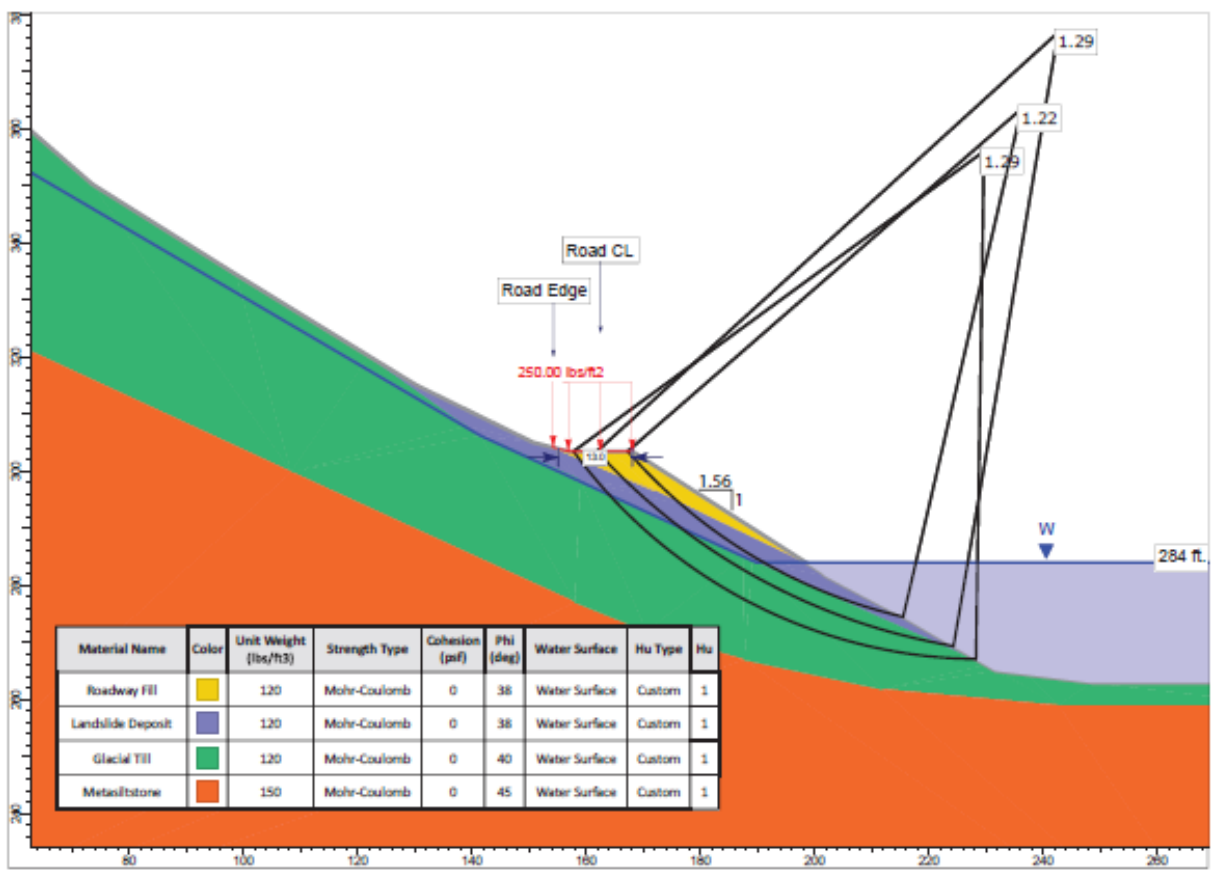
PROJECT NO.	20191018	13-FT WIDE ROAD WITH FLATTENED SLOPE:	FIGURE
DRAWN	JUN 2019	ELEVATED WATER LEVEL	E-6
DRAWN BY	MP	(CROSS SECTION A-A')	
CHECKED BY	DD	RIVER ROAD GEOLOGIC RECONNAISSANCE	
FILE NAME	13-FT wide road.ai	LANCASTER MILL POND / WACHUSETT DAM	
		CLINTON, MASSACHUSETTS

Repair Alt. = flattened slope and reduced road width

Meet FS of 1.25

Removal of 20 tons of contaminated soil (naphthalene, SVOCs, Ni) and replaced with higher strength material.

Armoring outboard slope to water line

13 ft. wide road w guard rail
