Water Supply Citizens Advisory Group
MWRA Reservoir Operations Update

Topics for today

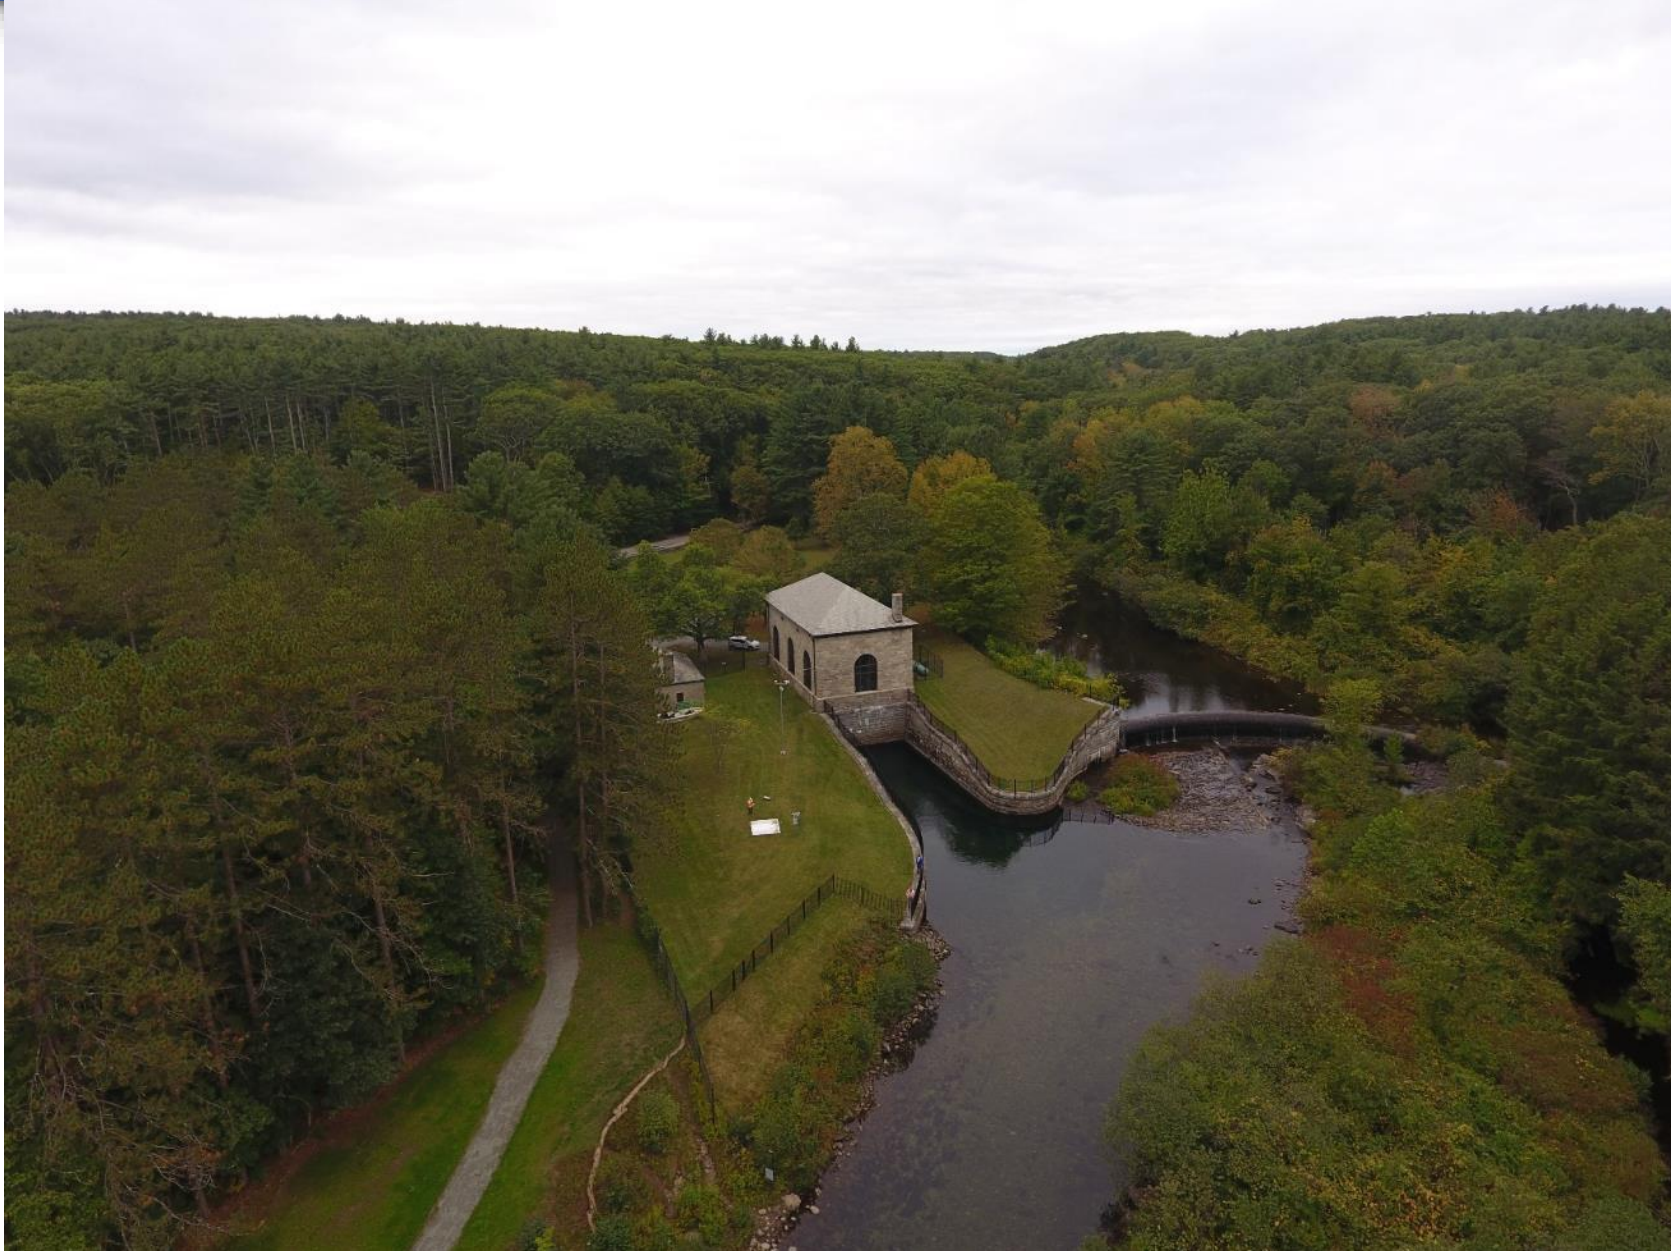
Protection of Oakdale Power Station and Wachusett Reservoir Paramount

- Structural analysis and protections for Shaft 1 during construction.
- Detailed water control plan and Sedimentation control plan for both during and post construction conditions.
