STAFF SUMMARY

TO: Board of Directors
FROM: Frederick A. Laskey, Executive Director
DATE: November 14, 2018
SUBJECT: Wachusett Dam Lower Gatehouse Pipe Break

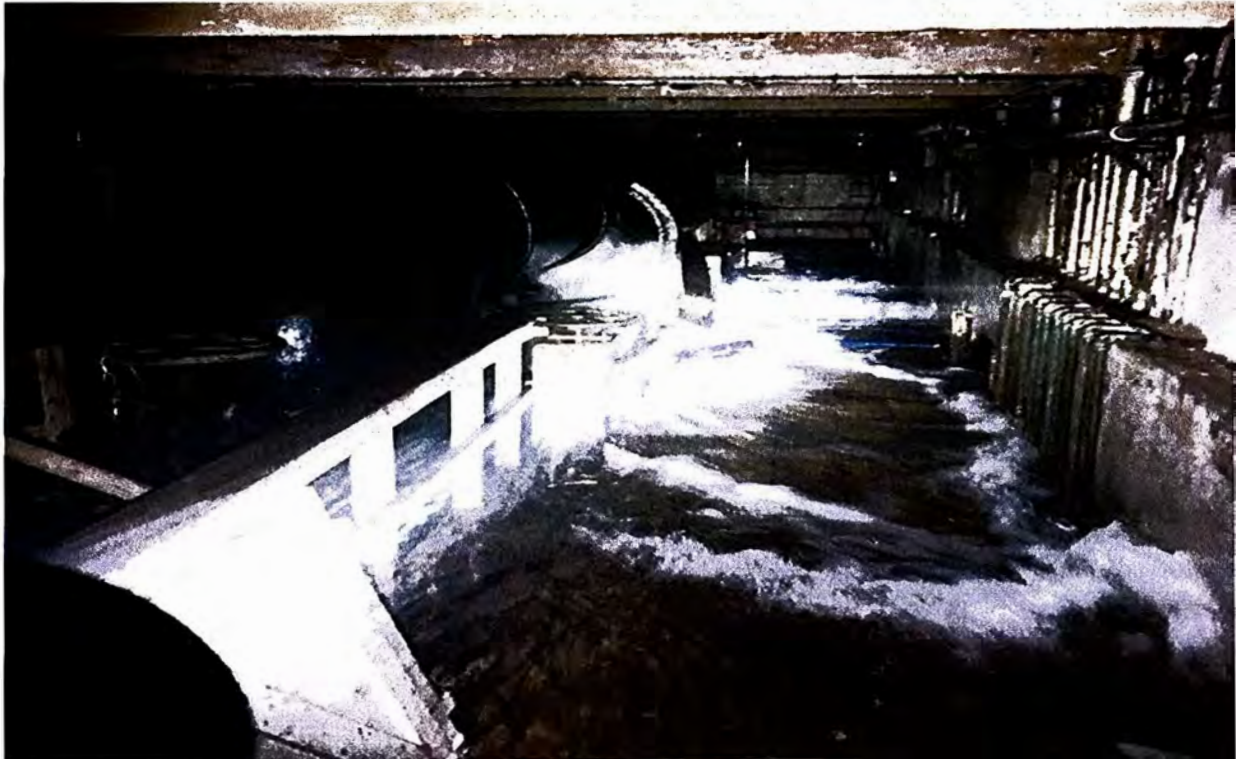
The series of tests before that must be undertaken before final acceptance involves flowing large volumes of water (as much as 240 mgd) through the lower gatehouse and the aqueduct. Some of the piping in the lower gatehouse is original cast iron pipe over 100 years old. This piping has been exposed to a variety of flow rates and volumes to move water down the aqueduct to the pump station. Some tests were run at night while water demand was low, in case the treatment plant was knocked off line. On October 18, 2018, the day after night-time testing had occurred, staff noted significantly less water flowing through the aqueduct open channel immediately adjacent to the pump station. The lack of water was traced back to the lower gate house where a 48-inch cast iron pipe had failed, with water relieving through the gatehouse to the river.

The photo below was taken when the lower gate house break was discovered. Flow to the lower gatehouse was stopped via remote closure of valves in the upper gatehouse.

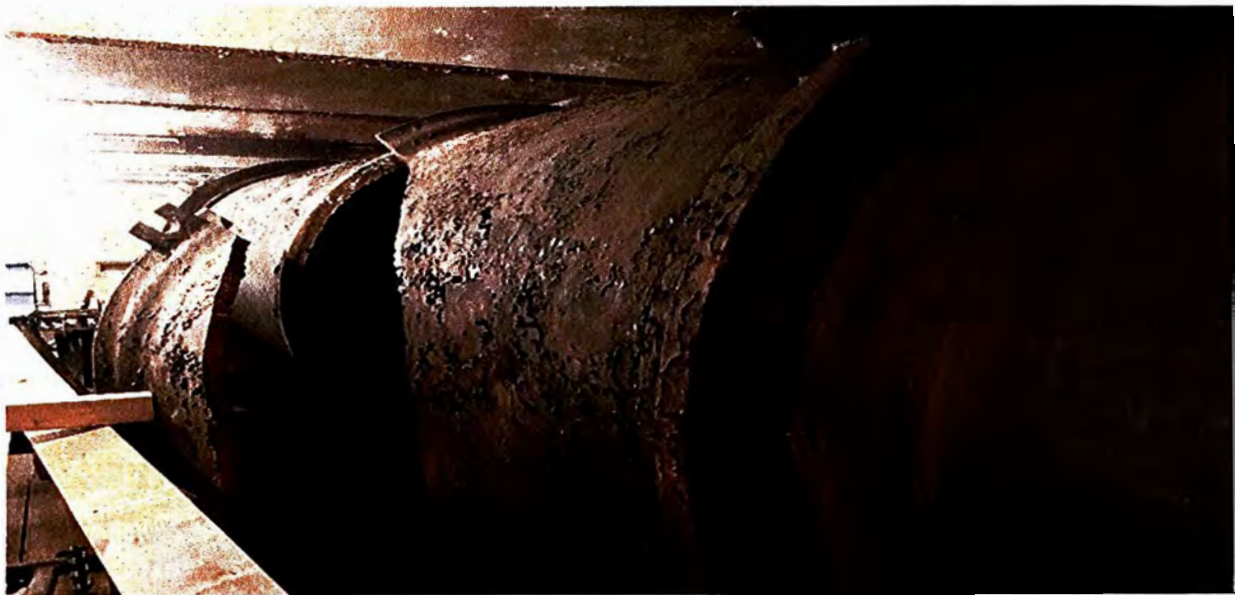
There are four pipelines within the lower gatehouse. The break was determined to be on the “tee” and the reducer in Line 2, as shown below.

Pump station testing was suspended to allow investigation of the pipe failure. Site visits by MWRA, Stantec, and Barletta staff occurred during the following days. It was determined that two of the lines could be isolated from the rest and still allow continuation of testing, up to a flow rate of 200 mgd.

The third line has a broken gate valve, which prevents it from being used. The fourth line can be used to send water to the river, if needed.

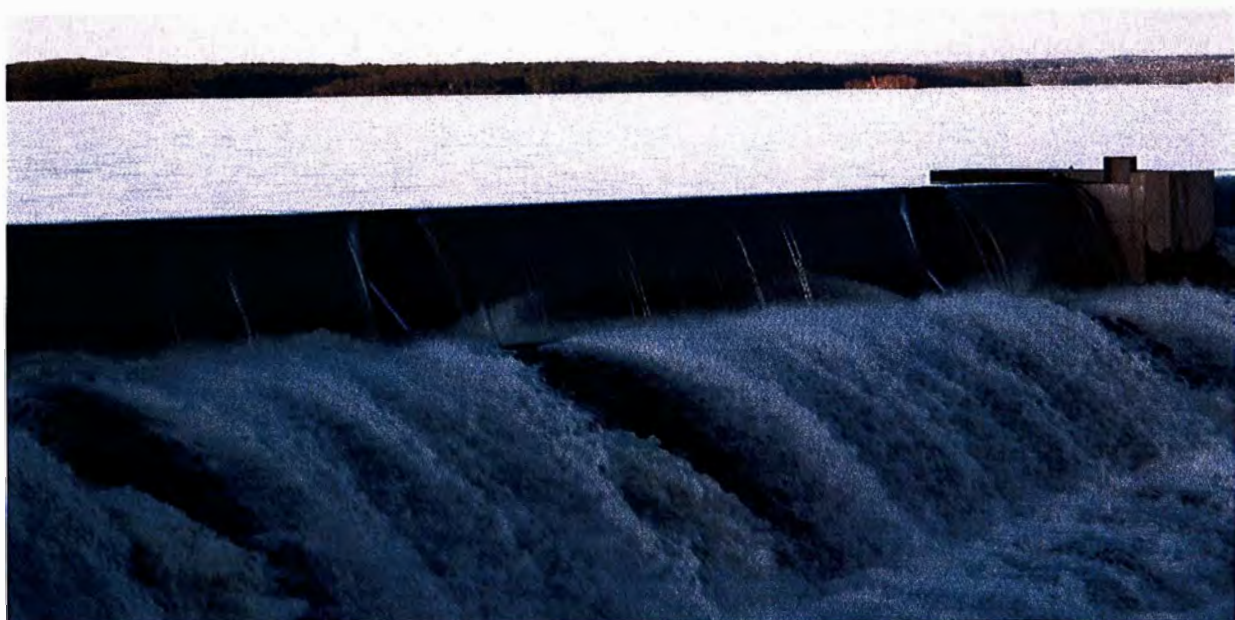
The feed to the fountain, which is normally used to meet minimum river releases, is inoperable due to a connection to the broken section of pipe. Flow to the river is currently being controlled over the dam with the hydraulically actuated crest gate installed in 2008.

An interim repair plan has been developed in the event the remaining cast iron pipe fails in either line that can currently supply the pump station. The pump station contractor has purchased the blind flanges necessary to make the interim repair if required. A long-term repair plan for the lower gate house piping is being finalized.
